Tests on Treatments for Reflective Cracking

George Way, Arizona Department of Transportation, Phoenix

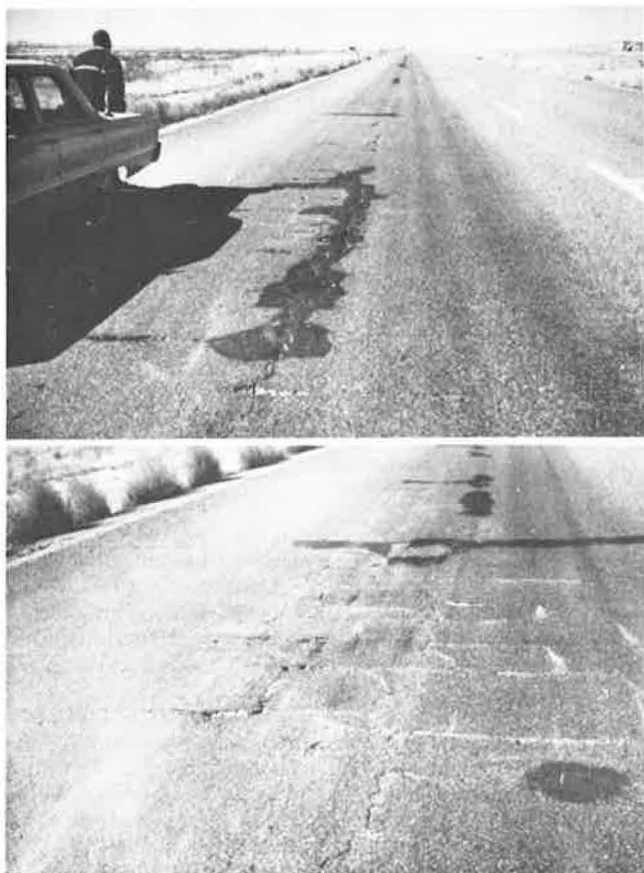
Figure 1. Typical roadway cracking on Minnetonka-East, February 1969.

Survey of the road conditions revealed extensive cracking, including block (flexural) and shrinkage (thermal) cracks. Spalling and rutting were also noted. The photographs in Figure 1 show the highway condition in 1969.

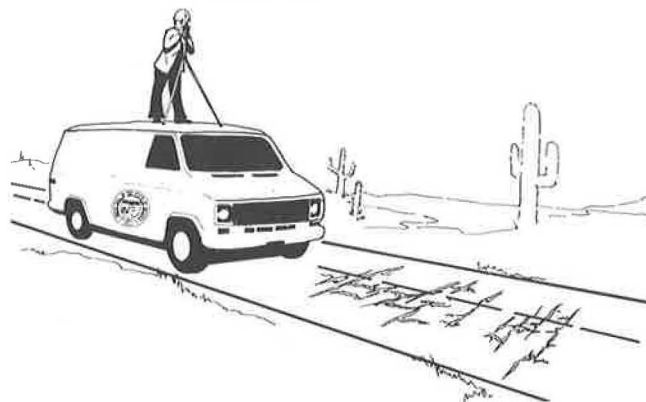
Figure 2. Mobile photography van.

The Minnetonka project was designed to select the materials and treatments that significantly reduce reflective cracking. We therefore used a special photographic technique and an optical grid to accurately determine the extent and type of cracking before and after overlay. We used 35-mm color film to photograph 7.6-m (25-ft) highway panel sections from a mobile camera platform (Figure 2). Only the most severely cracked areas in the travel and distress lanes for each test section were photographed.

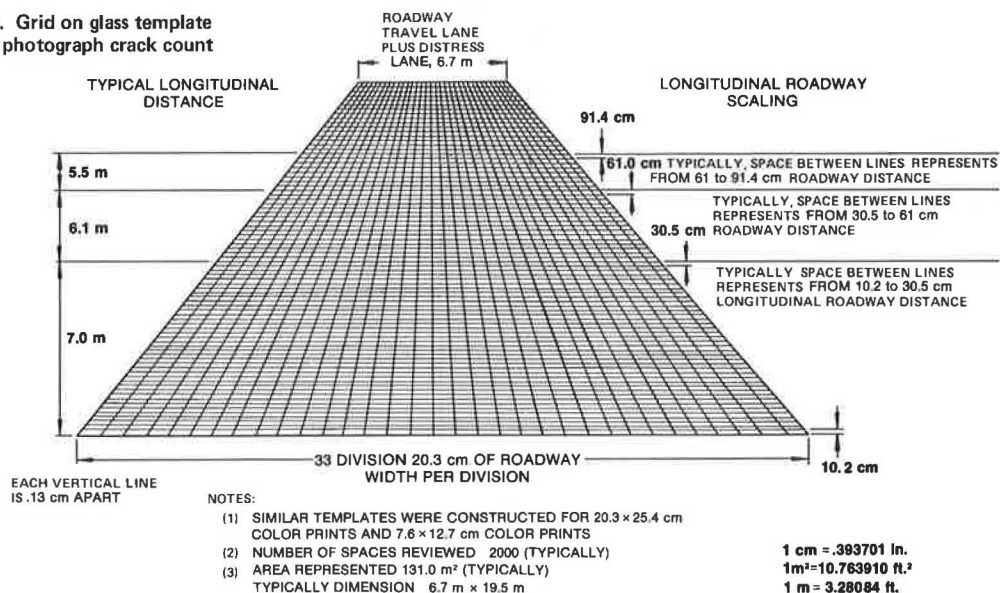
Figure 3. Grid on glass template used for photograph crack count survey.

The initial check of each print's quality led to the development of a glass template (Figure 3) to aid in our analysis. This template, designed to compensate for the distortion resulting from photographing at an oblique angle, divided each photo into several thousand parts.

We scanned each part line by line and coded each crack onto a computer form to indicate exact location. Coded forms were keypunched and processed by a special computer program that counted cracked and uncracked areas and computed the percentage of area cracked. The program also put each grid line into proper perspective by comparing the photos with the actual field cracking. We found that distortion did occur with distance, however, so we calculated the distance between each grid line up to the point where clarity was lost. Generally this point corresponded to a distance between grid lines of 0.9 m (3 ft) or more. As a result, 0.9 m was incorporated into the program as the logical end point after which no further grid lines would be counted for cracking.
