Concrete-Deck Deterioration: Concrete-Filled Steel-Grid Bridge Decks Have the Answer

Vijay Hasija, Reliance Steel Products Company,
McKeesport, Pennsylvania
Carl Angeloff, Pennsylvania Department of
Transportation, Pittsburgh

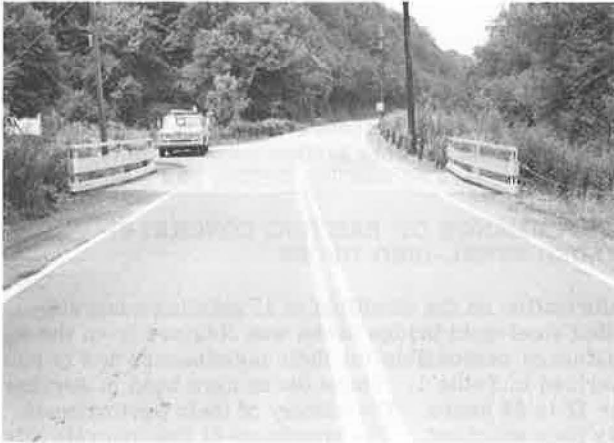
Figure 1. Concrete-filled steel-grid bridge deck built in 1934 (bridge 18).

The durability of concrete-filled steel-grid decks in a chloride-containing environment is illustrated by one of the smallest bridges investigated (Figure 1), which has a deck area of 43 m² (468 ft²). This bridge deck has been in service for 42 years. It has a mean chloride concentration of 6.22 kg/m³ (10.49 lb/yd³) of concrete, but no physical damage or deterioration is noticeable. The deck was built with concrete finished flush with the top of the grid steel, and no wearing surface was ever applied. The surface condition of the deck is shown in Figure 2, in which the heavy lines are the exposed top

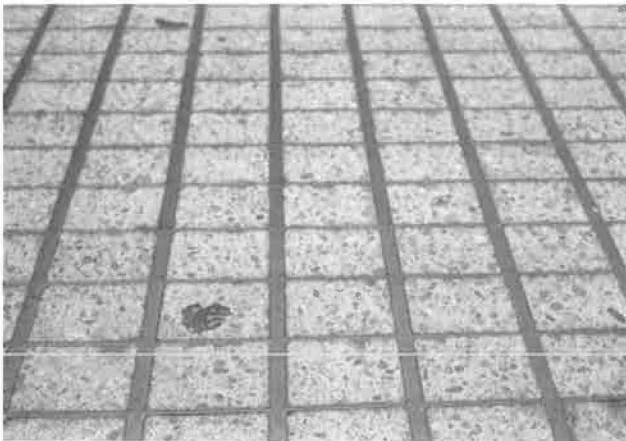
Figure 2. General surface condition of concrete-filled steel-grid bridge deck with no wearing surface after 42 years service (bridge 18).

flanges of the main beams of the steel grid, and the lines perpendicular to them are the tops of the rectangular cross bars. This surface condition is typical for grid decks where no wearing surface was ever used.

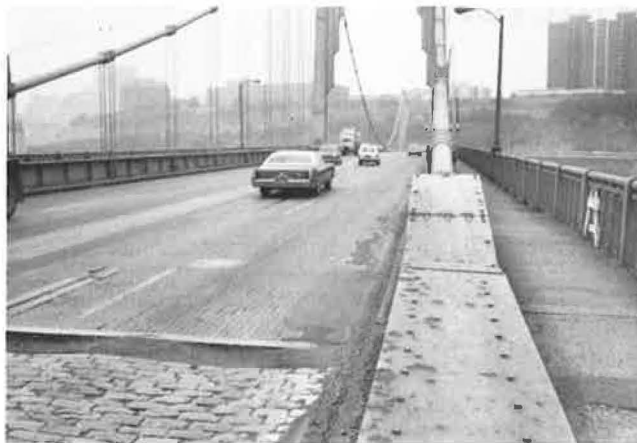
Figure 5. Tenth Street Bridge, built in 1932 (bridge 21).

The durability of concrete-filled steel-grid decks in a chloride-containing environment is illustrated by bridge 21 (Figure 5). This deck has been in service for 44 years and had a mean chloride concentration of 1.92 kg/m^3 (2.90 lb/yd^3) of concrete. The overall roadway surface of approximately 4645 m^2 ($50\,000 \text{ ft}^2$) is in a remarkably good condition, although rust staining is evident on the top surface of concrete.
