TRANSPORTATION RESEARCH RECORD 651

Concrete,
Aggregates,
Marking Materials,
Corrosion, and
Joint Seals

TRANSPORTATION RESEARCH BOARD

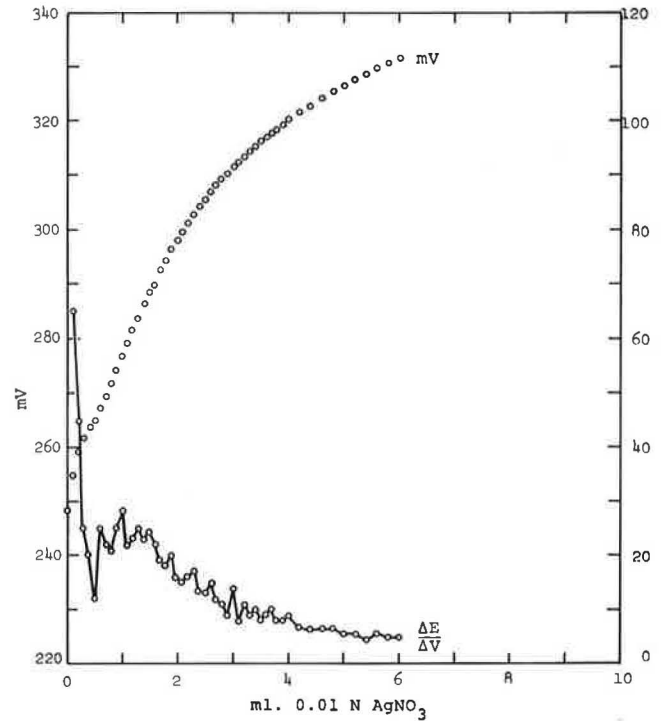
Figure 3. Titration of low- Cl^- concrete sample (without NaCl spike).

In using the Gran method, the endpoint can be clearly determined with or without spiking, regardless of the Cl^- content of the sample. To illustrate this, the potentials from the titrations shown in Figures 3 and 4 were plotted on Gran-plot paper as shown in Figure 5. The resulting endpoints were 2.58 and 0.63 ml for the spiked and nonspiked solutions respectively. And subtraction of 1.95 ml 0.010 31 N AgNO_3 (the equivalence of the 2.00 ml 0.010 08N NaCl added) also gives 0.63 ml as the endpoint for the nonspiked solution.

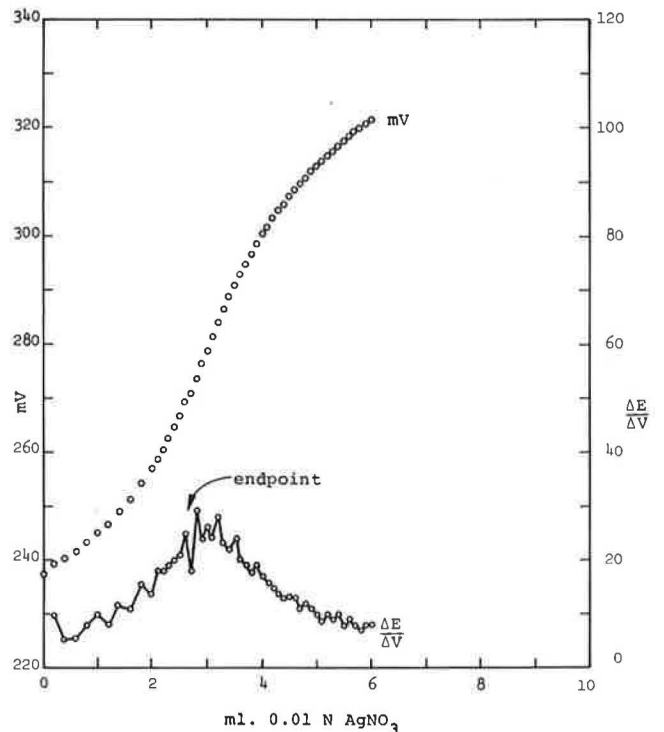
Figure 4. Titration of low- Cl^- concrete sample (spiked with 2.00 ml 0.1N NaCl).

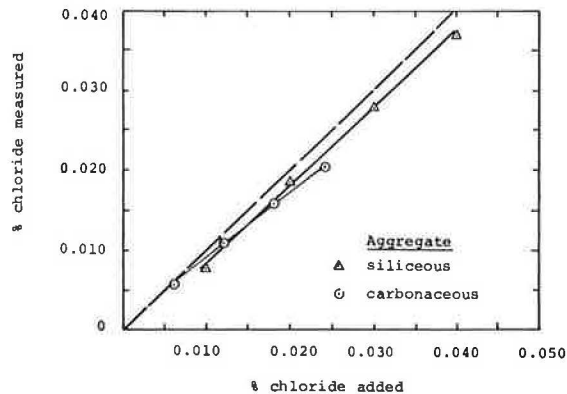
Figure 7. Analysis of Cl^- in prepared concrete specimens by atomic-absorption spectroscopy.

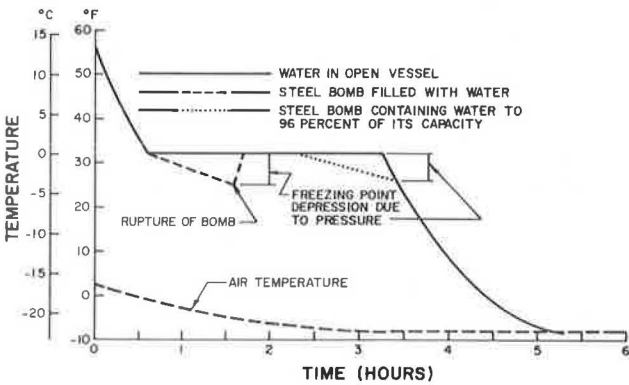
Figure 1. Typical thermographs.

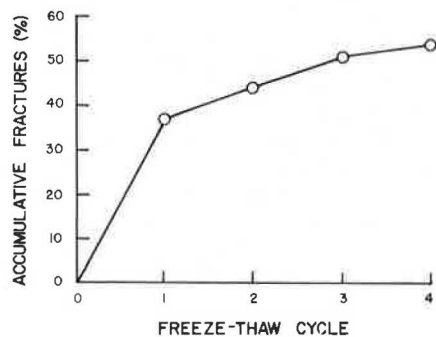
Figure 5. Cumulative percentage of fractured particles.

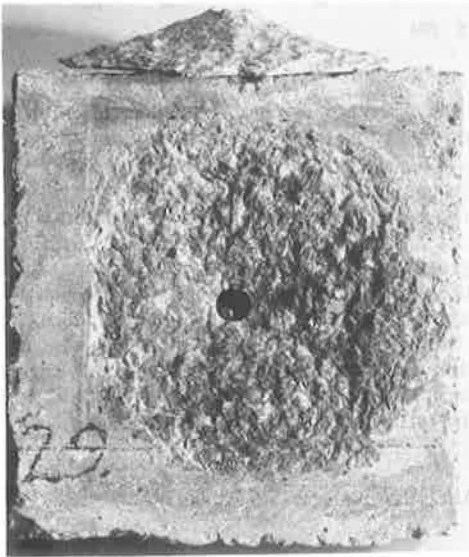
Figure 9. Test specimen showing pop-out.

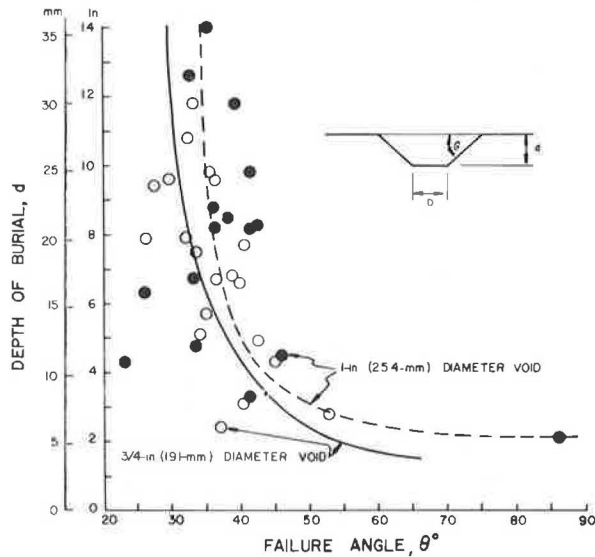
Figure 12. Relation between failure angle and depth of burial.

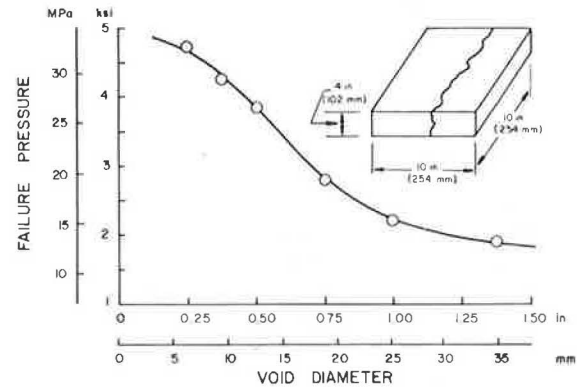
Figure 13. Pressure necessary to produce splitting failure in deeply buried voids.

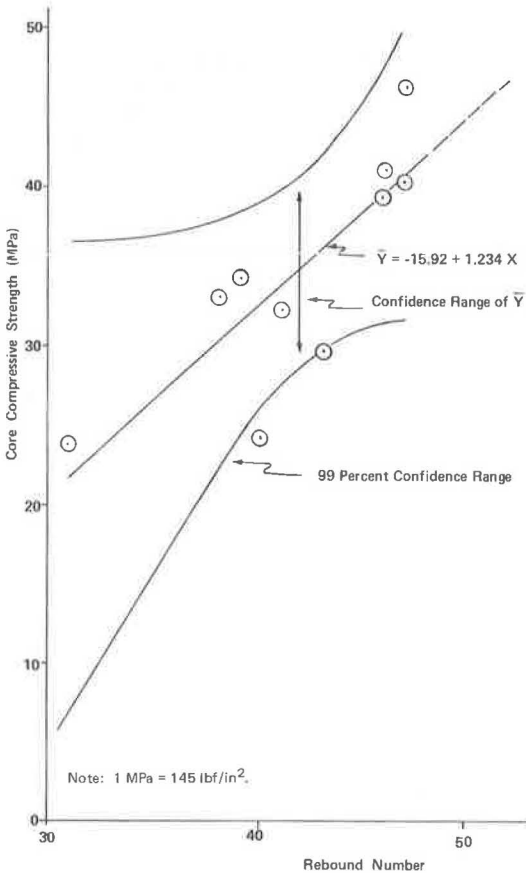
Figure 2. Core strength versus rebound-number calibration: 34.5-MPa mixture.

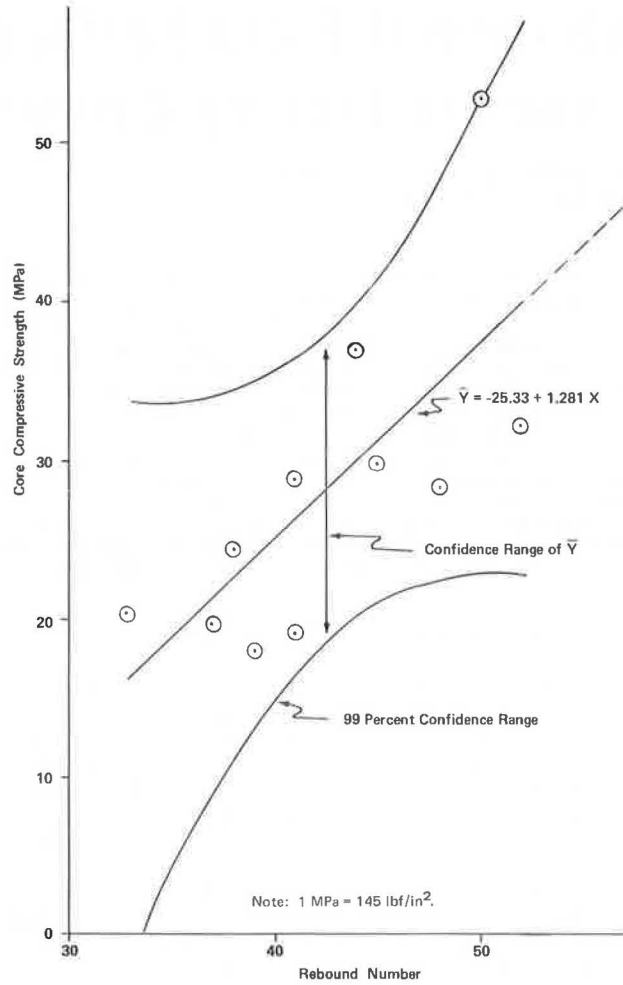
Figure 3. Core strength versus rebound-number calibration: 38-MPa mixture.

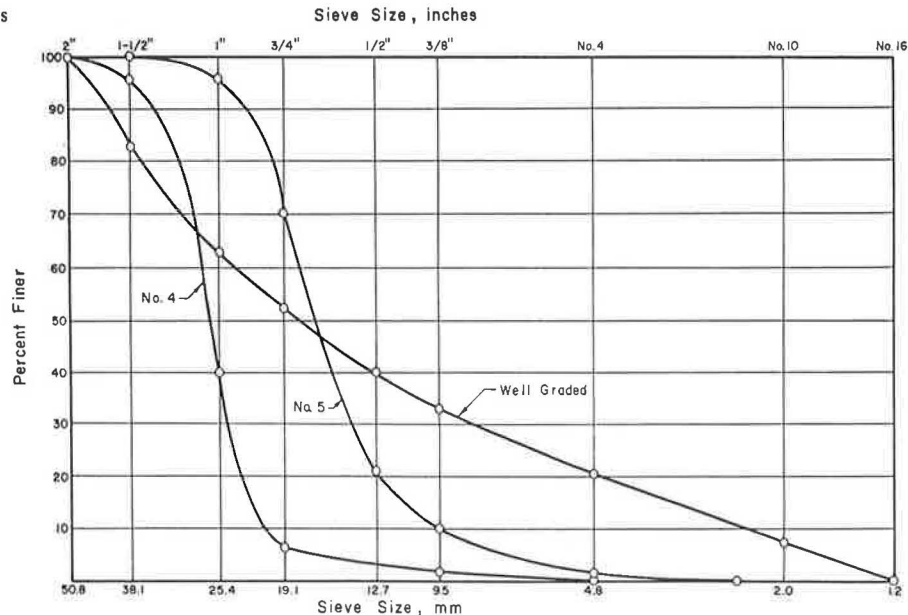
Figure 1. Gradations of specimens tested.

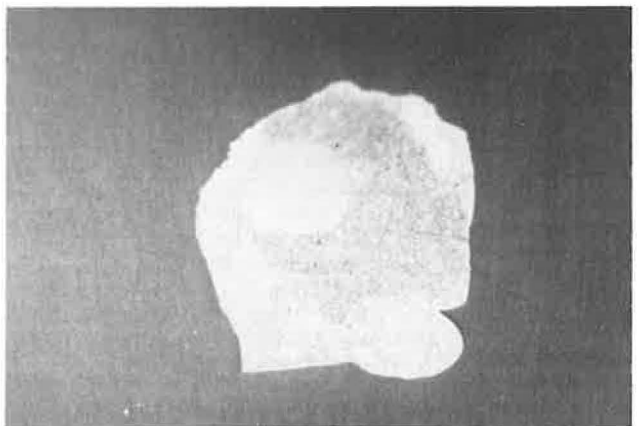
Figure 10. Previously bonded surface of thermoplastic.

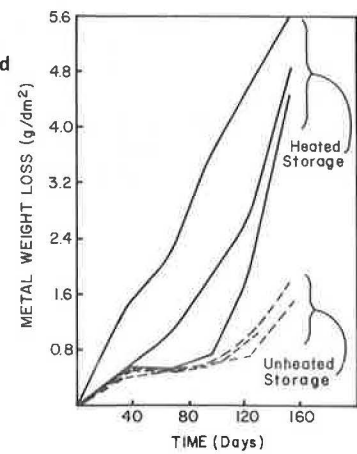
Figure 7. Corrosion rates of crevice specimens attached to vehicles in heated and unheated garages.

in the form of enclosed and heated garages. The effect on the corrosion rate, as shown in Figure 7 (12), is substantial. The lower lines represent corrosion rates in open unheated storage. The upper lines represent corrosion rates in closed heated garages.
