# Texturing New Concrete Pavements

D. C. Mahone and K. H. McGhee, Virginia Highway and Transportation Research Council

J. G. G. McGee and J. E. Galloway, Virginia Department of Highways and Transportation

Several texturing experiments on heavily traveled portland cement concrete pavements in Virginia are described. Included in the experiments were textures imparted by using a heavy burlap drag, metal tines (transverse and longitudinal striations), sprinkled aggregate, mortar removal, and imprinting. All textures were imparted to concrete in the plastic state. Some of the problems encountered in achieving the desired textures are discussed. Evaluations of the effectiveness and the acceptability of the textures included noise, roughness, and skid-resistance studies. These studies resulted in the rejection for future use of several textures for one or more reasons. A consideration of all factors gave strong indications that transversely tined grooves spaced 19 mm (0.75 in) apart (center-to-center) would be preferable on tangent roadway sections whereas longitudinally tined grooves spaced 19 mm apart in combination with transverse grooves spaced 76 mm (3 in) apart would be preferabl

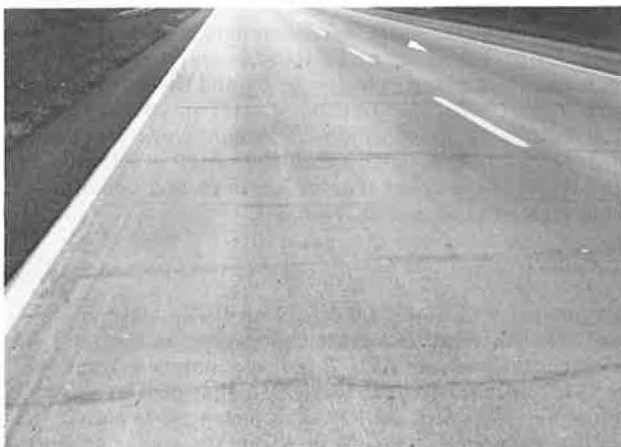
Figure 4. Heavy-burlapped texture after 6 years under traffic.

performance over the 5 years since the earlier observations and by laboratory studies reported by Ozyildirim (3). Figure 4 shows the wear in the wheel paths after 6 years under traffic.

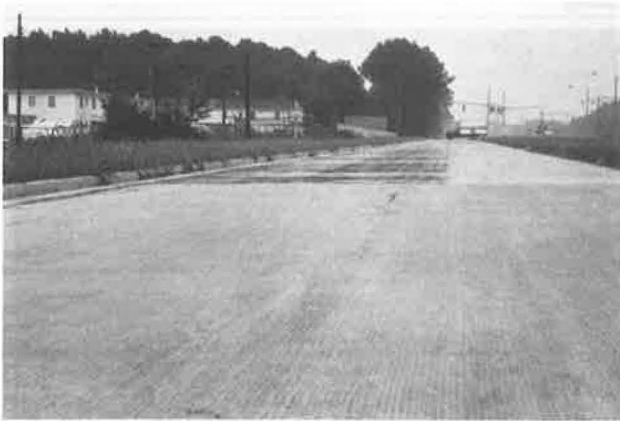
Figure 15. Contrast during rainfall between longitudinally and transversely tined texture (foreground) and conventional, longitudinally tined texture (background).

The contrast during rainfall between a section with both transverse and longitudinal striations and one with only a longitudinally tined texture is of special interest. Figure 15, a photograph taken during a steady rain, shows a texture longitudinally and transversely grooved with 19-mm (0.75-in) spacing between grooves (in the foreground) and the conventional, longitudinally tined texture produced by 19-mm groove spacing (in the background). Note that the transverse texture is providing excellent drainage; compared to the pavement in the background, it appears to be dry.
