EXTENSION OF LIFE FOR PERLEY BRIDGE

H. Vaidyanathan, M.M. Dillon Limited, Consulting
Engineers & Planners, Ottawa
M.S. Cheung, and J.C. Beauchamp, Public Works
Canada

This paper describes a comprehensive evaluation procedure undertaken to decide the future of the 45-year old Perley Bridge, a multi-span, 696.16 m (2284 foot) steel structure, traversing the Ottawa River between Hawkesbury, Ontario and Grenville, Quebec. The bridge was originally designed for approximately H-15 live load and this was to be increased substantially. The bridge consists of an assortment of trestle, deck-truss, through-truss and bowstring-truss spans. The evaluation procedure included a number of phases, such as a review of past performance records and field inspections, theoretical analyses, field and laboratory tests etc. which resulted in recommendations for repairs and/or replacements of deficient members of the bridge. Each phase of the study is discussed in detail, in the hope that it might prove useful as a guide in the evaluation and upgrading of other existing bridge structures. Special attention is drawn to the need for field and laboratory tests to complement the theoretical analyses in asses

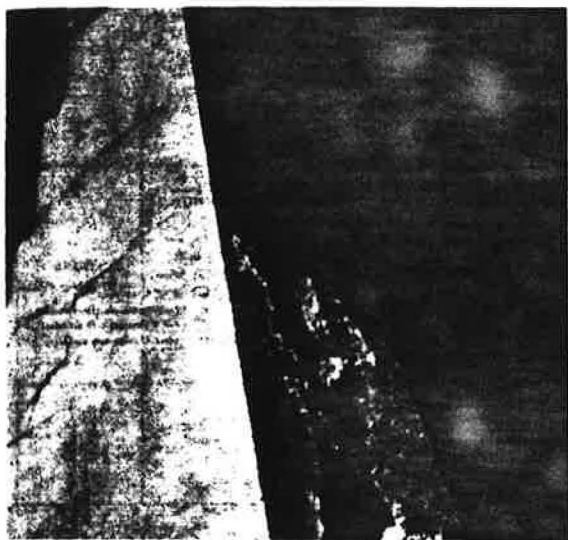
Figure 4a. Local spall areas in pier.

1. A visual inspection was carried out at all piers and abutments above water or ground level. Apart from some minor cracks, spalls and honeycombed areas, the substructure appeared generally sound (Fig. 4a).
2. Bearings varied from good to severely corroded or completely frozen (Fig. 4b).
3. Some header angles connecting girders to columns appeared to be undergoing possible fatigue problems. While no apparent evidence of surface cracking was observed, the heavy magnetic particle equipment detected possible fatigue problems at the top of the heel of some header angles.

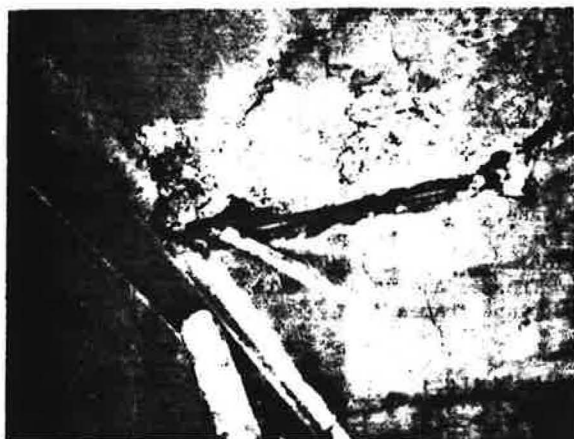
Figure 4e. Spall areas (underside of the deck)

7. Concrete deck and sidewalk, from a visual inspection and the chain-drag method, showed localized areas of spalling and delamination over 5 per cent of the deck. The spalls were mainly confined to the top of deck slab, but also occurred on the underside of the slab (Fig. 4e).

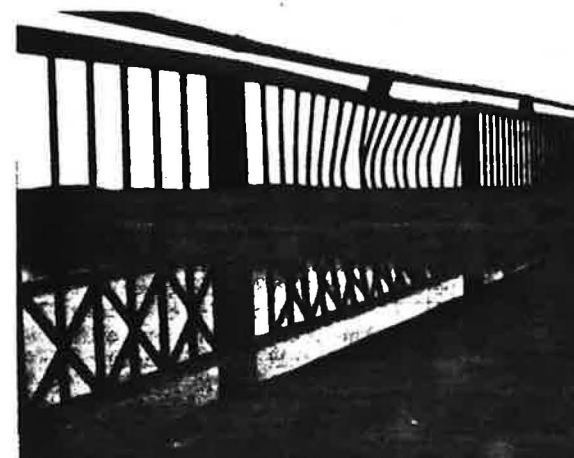
Figure 4f. Inadequate railing.

8. The railing generally appeared to be in poor to fair condition, and did not meet current traffic rail standards (Fig. 4f).

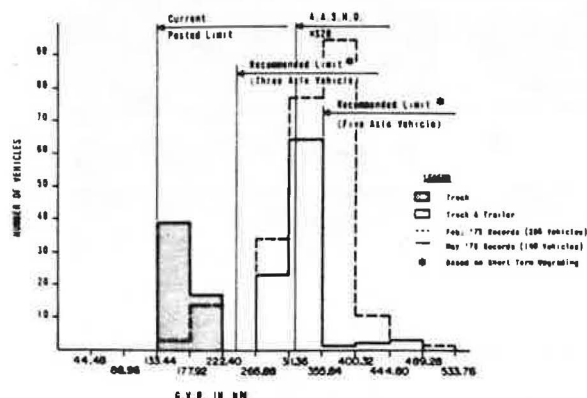
Figure 6. Status of traffic on bridge at time of inspection (May, 1973) - abstract from C.I.P. weight records.

It was considered prudent to obtain and collect information on the traffic using the bridge before settling down to any theorizing. Based on the traffic data gathered in 1972 and a series of one-hour and half-hour counts in October 1973, the SAWDT (Summer Average Weekday Traffic) was estimated to be about 11,000 to 12,000 vehicles per day, 20 to 30 per cent being trucks. Apart from logging trucks bound for the Canadian International Paper mill (C.I.P.), other heavy vehicles using the bridge included liquid and solid bulk carriers, floats with heavy earth-moving equipment, and flat-beds with loads of concrete blocks or concrete pipe (Figs. 5a, 5b). The following information was extracted from C.I.P. weight records in 1973 (Fig. 6).

Clearly, the bridge structure had been subjected to loads much heavier than those for which it was designed.

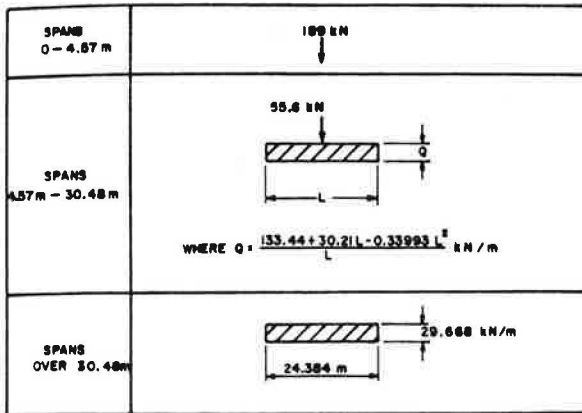
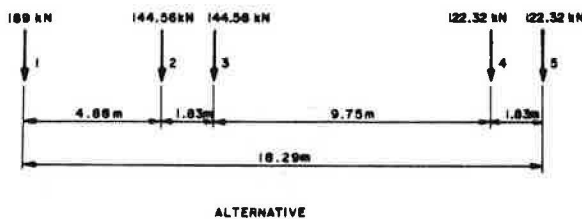
Figure 7. Proposed Ontario bridge design load - RR186 (modified since this project to form the basis of the forthcoming Ontario Highway Bridge Code).

3. The types of vehicular loadings investigated were; proposed Ontario Bridge Design Load (Fig. 7) and axle combinations permissible by the Ontario Bridge formula [17].

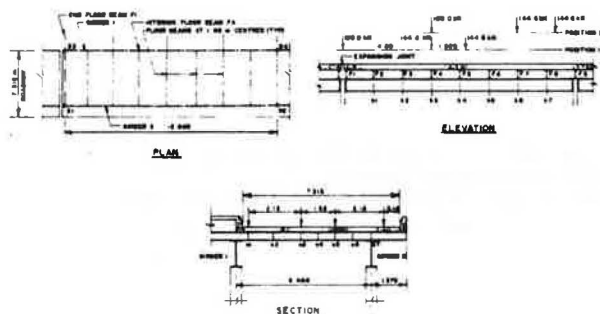
Figure 8. Trestle span (typical).

Numerical Example. An example shown in Figure 8 and Table 3 illustrates the differing results obtained depending on the type of analysis employed; Analysis I - simplified method according to AASHTO code Section 3 (13, 16); Analysis II - Finite Element Analysis Using "STRUDEL" Program.

In Analysis II, the structure was modelled into an assemblage of beam and plate elements and the following assumptions were made:

1. Linear elastic analysis
2. Isotropic slab resting on floor beams without composite action; sidewalk slab ignored.
3. Concentrated wheel loads assigned to nodal points.

Comparative study of the two methods indicated that simplified methods could lead to overestimation of capacity requirements as noted below:

1. Maximum bending moments in floor beams obtained from Analysis I are far in excess of those obtained from Analysis II (41% for Load Position 1 and 279% for Load Position 2).

2. Maximum bending moments in girders determined by Analysis I are slightly in excess of those obtained from Analysis II (5 to 15%); the aspect ratio (span/width = 2.33) of this grid reflects its predominant behaviour in the longitudinal direction.

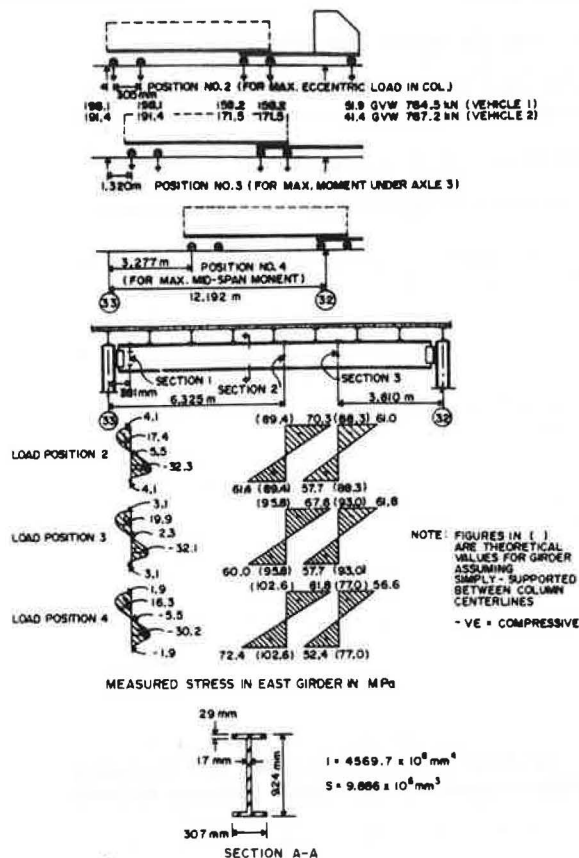
Figure 10. Test and analytical results (Trestle span).

2. Figure 10 indicates a comparison of test and analytical stresses in the longitudinal girder of the trestle span. The theoretical figures are consistently higher than the corresponding measured ones. This is explained by the existence of partial continuity of the girders through columns and non-functioning expansion joints restraining joint rotations over the supports. Measurement of thermal stresses in the girder suggested the desirability of reducing these by functioning expansion devices. Though the existing header angle connection between girder and column is theoretically a flexible one transferring pure shear only, field tests revealed the presence of some restraining moments at the junction.

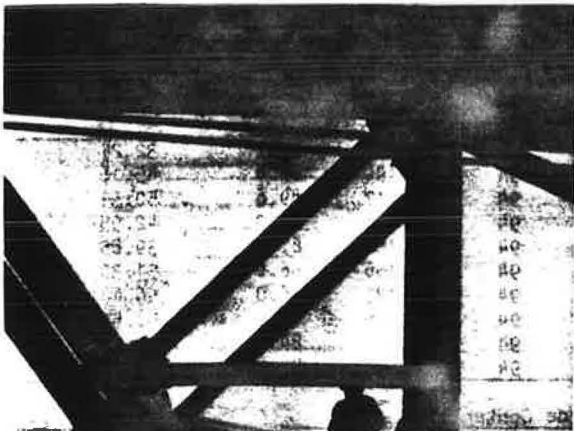
Figure 11a. Bracing details.

At the time of writing this paper, the project is in various stages of design and construction. Some repair techniques are discussed briefly here. Strengthening in general, has been done by the addition of materials using both bolted and welded arrangements. Welded details have been avoided on tensile members and members subjected to reversals. This is to ensure lesser burden on future inspection and maintenance. Some compression members have been upgraded by bracing them against buckling (Fig. 11a). A combination of knee braces between columns & girders and cross braces between the webs of floor beams at the trestle spans

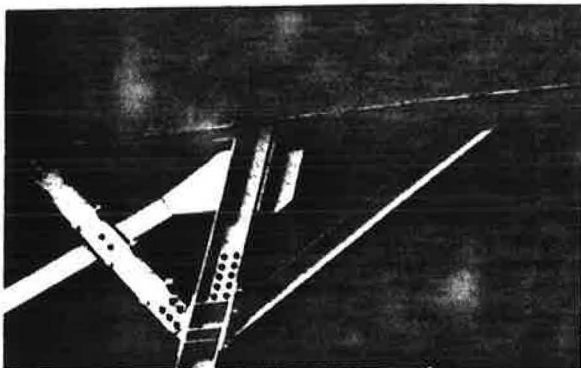
Figure 11b. Kneebraces.

(Fig. 11b) reduces the possibility of failure of floor beam webs, improves the capacity of longitudinal girders by providing continuity over spans, strengthens the supporting columns against buckling and relieves partly the load on the header angle connections between girders and columns by sharing in the joint effects. Existing cast-steel bearing assemblies under expansion ends of trusses have been replaced by elastomeric type bearings. Trestle span expansion devices have been modified as shown in (Fig. 11c). Figs 12a, 12b, show details of some strengthening items.
