ORTHOTROPIC BRIDGE SAVES OLD COVERED BRIDGE

Robert F. Victor, P.E., Connecticut Department of Transportation

When inspection of the Old Covered Bridge at West Cornwall, Connecticut revealed extensive deterioration of its floor system and trusses, a new bridge was proposed to be built just upstream. The old bridge, dating from 1841, would have been left open to pedestrians only. This proposal angered local residents who wanted the old bridge restored. Because of tight vertical clearance restrictions, structure depth was severely limited. Preliminary computer analyses showed that a slender orthotropic steel deck bridge could be independently built within the old bridge and designed for AASHTO HS20 and alternative loadings. The construction consisted of building a parallel temporary bridge, raising the old structure 61 cm (2-ft.) higher to clear future floodwaters, painting, reshingling and whitewashing the interior and, erecting the steel deck bridge within. A timber floor was bolted to the steel deck plate. The total project cost \$360,000 which is a savings of more than \$1,500,000 over the cost of the proposed upstream bridge. More importantly, a historic nineteenth century stru

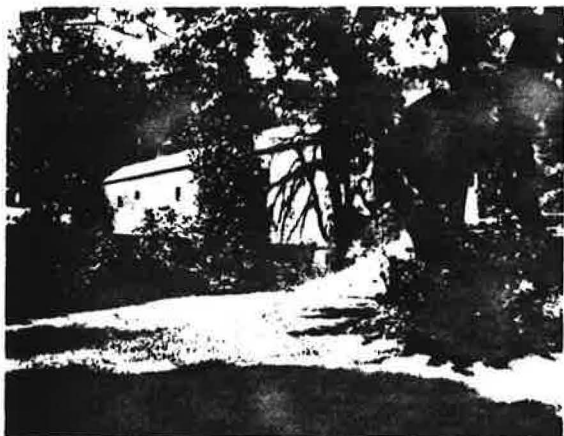
Figure 1. Bridge Before Restoration

When inspection revealed deterioration of the floor system and trusses of the Old Covered Bridge at West Cornwall, Connecticut (Figs. 1 & 2), a new modern two-lane bridge was proposed to be built just upstream, bypassing the village of West Cornwall. The old bridge, dating from 1841, would have been left open to pedestrians only. This proposal angered local residents, who insisted that some way be found to strengthen the old structure without changing its appearance in any way!

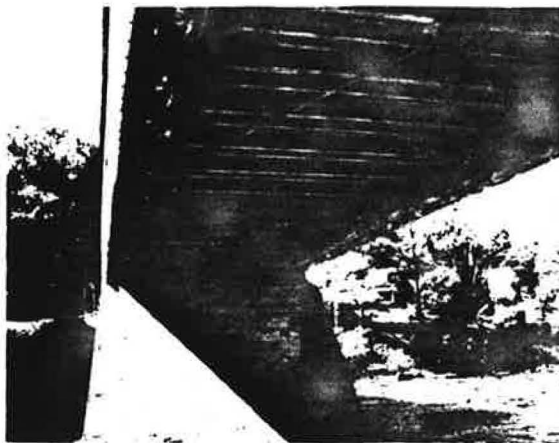
Figure 2. Floor System Before Restoration

With traffic thus diverted, the floor system of the covered bridge, consisting of steel floorbeams and a two-layer wood decking, was removed. The covered bridge was then jacked to an elevation 61 cm (two feet) higher in order to clear possible debris from design floods. New stone rubble masonry was added to the abutments and concrete to the pier (matching the existing appearance as much as possible). At the same time, new abutments consisting of a crossbeam, column and footing were built and buried inside the old abutments. The old abutments are thus relieved of much dead weight and all live load.

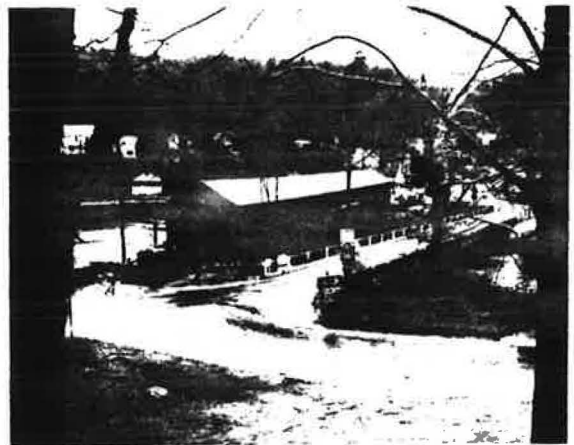
Figure 8. Bridge Site (Bulldozer Foreground)

The three sections (measuring 18.6, 18.6, and 15.4-m; 61, 61, and 50.5-ft.) were trucked to the bridge site where they were assembled on the east bank of the river. The contractor had previously erected skid beams spanning from the abutments to the pier, over which the steel bridge would be pulled to the west abutment. Heavy duty machinery skates were attached to the bottom flange at the west end of the west section and another pair were set upside down at the east abutment. After each splice was completed, the steel bridge was pulled by a bulldozer winch on and over the skates (Fig. 8). Another set of skates were positioned at the pier while making the second splice in order to keep stresses within allowables during erection.

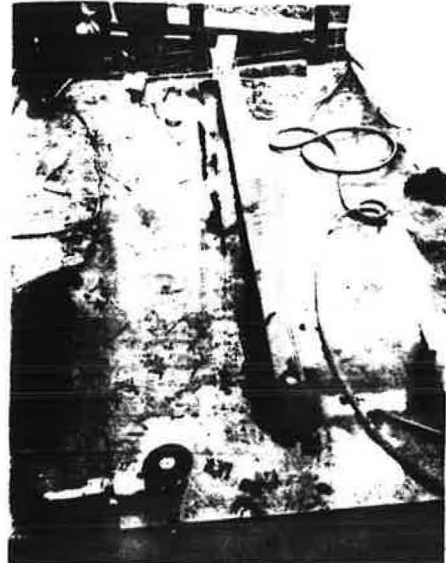
The two transverse field splices consisted of high-strength bolted ribs and girders (Fig. 9) and a welded deck splice and edge plates (Fig. 10). The welded deck gave a smooth surface for the deck planking. The sections were first aligned and the bolts placed without tightening. After fillet welding the backup strips to one side, the transverse groove weld was made. With this procedure, weld stresses were minimized. The transverse welds were inspected by the ultrasonic method (as were all butt welds in this bridge). This bridge required 1229 m (4030 feet) of welded joints, only 9.1 m (30 ft.) of which were required in the field.

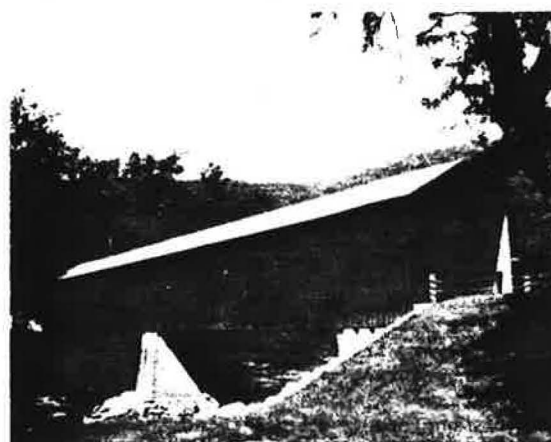
To put finishing touches on the bridge, timber curbing was installed and the interior whitewashed (Fig. 12). Outside, the roof was resingled with white cedar shingles and the siding painted barn red (Fig. 13). Temporary approaches were constructed and the bridge reopened with appropriate, colorful ceremonies. Later the temporary bridge was removed, new approaches built and the area restored to its former condition.
