TRANSPORTATION RESEARCH RECORD 676

Bridge Design, Evaluation, and Repair

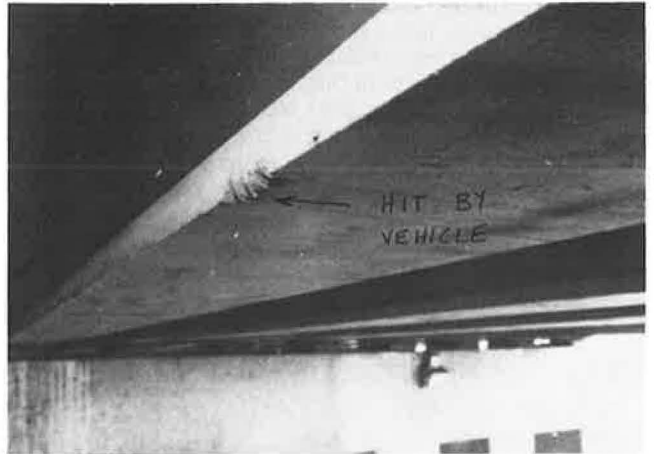
Figure 13. Notch caused by impact from truck.

12. Welds and notches that do not meet the design codes are a source of almost certain future cracking, as are notches caused by impacts from trucks (see Figure 13), loose shipments (see Figure 14), or even ships. The rapid rate of dynamic loading caused by a shipment collision usually causes immediate brittle fracture. An example of the damage that a loose shipment can cause is shown in Figure 15; the bridge truss collapsed when one of the tension members was severed by a load of culvert pipe.

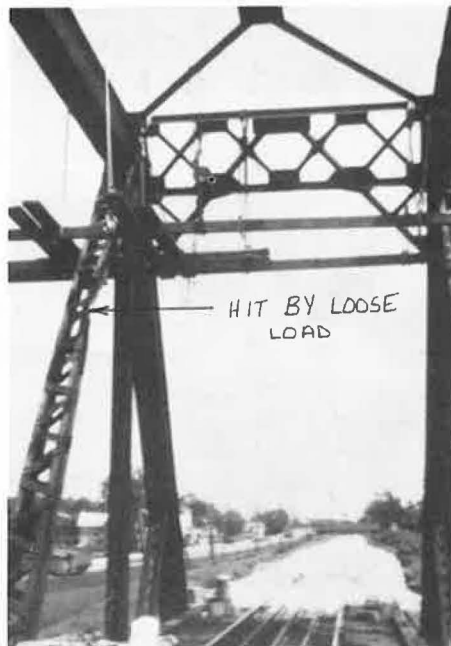
Figure 11. Crack caused by insufficient or badly fitting stiffeners.

10. In many beam-and-deck-plate girder spans that have open timber decks, the inside part of the top flange must resist the bending of the ties (Figure 11). A larger than average tie will carry excess load. If there are insufficient stiffeners or if the stiffeners do not fit snugly to the flange, the flange will crack. If the crack is not arrested, it can turn down at the first vertical weld and split the web in half.

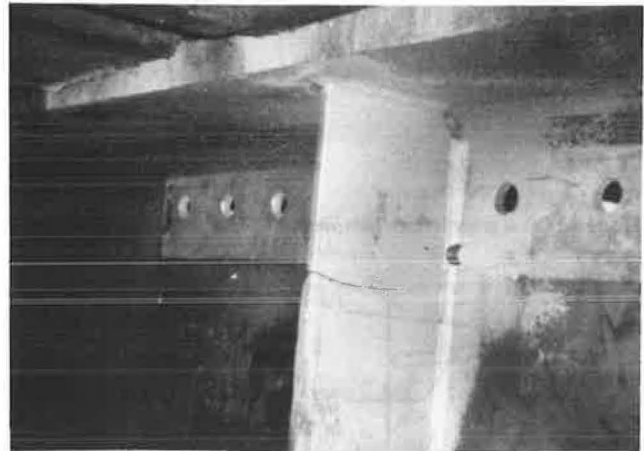
Figure 17. Procedure for stopping crack propagation.

1. Drill 1.11-cm ($\frac{7}{16}$ -in) diameter holes on both sides at the stiffener through the web at an approximate angle of 30° away from the stiffener (Figure 17a), ensuring that the hole is truly circular and has as few rough edges as possible.

Figure 17b shows the two holes drilled from the inside as shown in Figure 17a before the web was reamed to produce one smooth hole. Figure 17c shows the appearance after the two holes drilled from the inside had been reamed to one hole from the outside flush with the stiffener on the inside. (The white metal along the vertical centerline of the hole is the stiffener.)

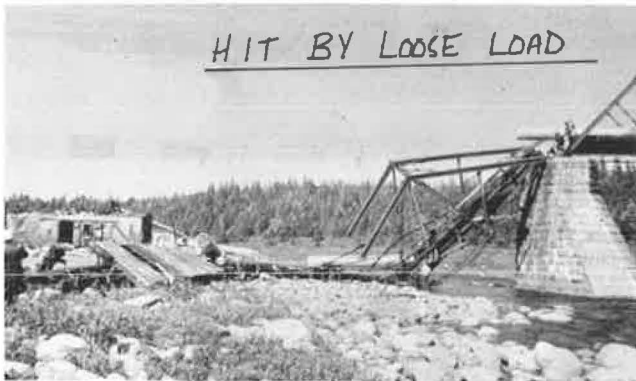
Figure 15. Truss collapse caused by impact from loose load.

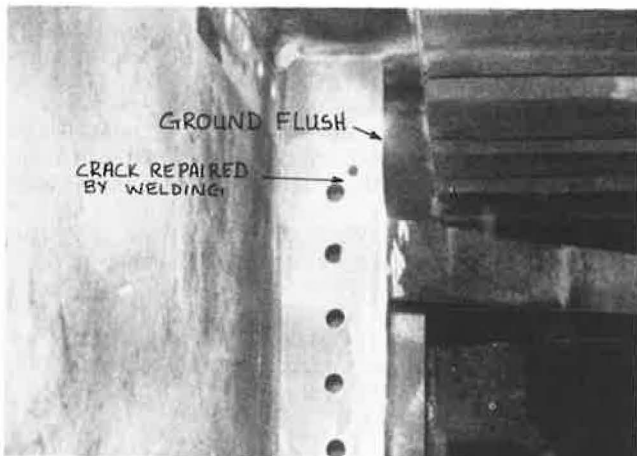
Figure 20. Illustration of procedure shown in Figure 19.

1. Use a chisel to vee out the crack,
2. Fill the resulting groove by using 7018 electrodes, and
3. Grind flush.

tail for the brace frames (Figure 19). Before doing this, all cracks were repaired by welding (Figure 20) and the top and bottom 7.6 cm (3 in) of the stiffener, where the gusset was removed, were ground smooth to remove any incipient cracks.
