Movements of Bridge Abutments and Settlements of Approach Pavements in Ohio

Raymond A. Grover, Ohio Department of Transportation

The Ohio Department of Transportation experienced intolerable movements of bridge abutments and adjacent approach slabs within a short time after construction of a new highway facility. Two accurate field surveys measured the extent and magnitude of the settlements against the data on embankment heights, subsoil conditions, type of abutment design, and other conditions. The first study, in 1961, indicated that 90 percent of the surveyed bridge abutments had settlements of 10 cm (4 in) or less and only 20 percent of the settlements were 2.5 cm (1.0 in) or less. In most cases, the abutments were supported on spread footings, without piles, in the approach embankment. Major revisions were incorporated in the design and construction specifications. The two most important ones were the use of piles at the abutments and the increase of compaction requirements for the embankments. The second survey was conducted in 1975 to evaluate the revised policies. These data indicated that 70 percent of the surveyed bridge abutments had no measurable settlements and 20 p

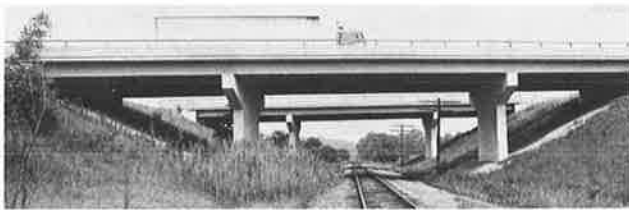
Figure 1. Steel beam bridge—continuous over piers.

By the end of 1960, the Ohio Department of Transportation had completed a large portion of their Interstate highway system as well as the construction of other major highway facilities. This construction program included hundreds of kilometers of new highways and hundreds of new bridges. Over 90 percent of the bridges were steel beams or girders of multiple spans with continuity over the piers, as shown in Figure 1.

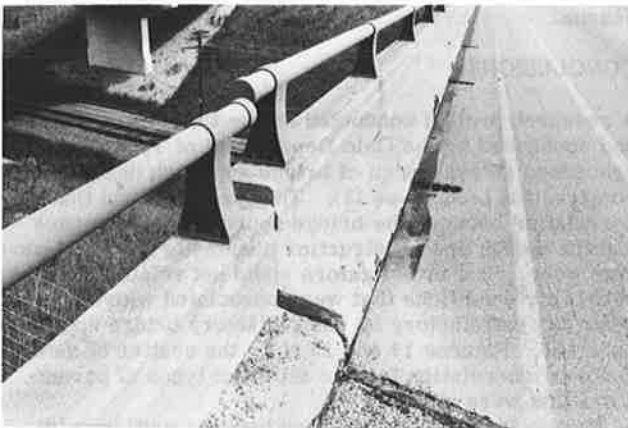
Prior to the survey, steel shims had been placed at 28 of 133 abutments under the abutment bearing devices to correct settlements that occurred during or shortly after construction. Figures 6 and 7 show the two common bearing devices used in Ohio, one consisting of sliding steel bars and the other consisting of a fabricated rocker, but the sliding device has been shimmed 6.5 cm (2.5 in). When the bearing devices were shimmed, an unsightly differential displacement between the abutment and the superstructure was the end result, as pictured in Figure 8.

Figure 8. Differential displacement in curb and railing.

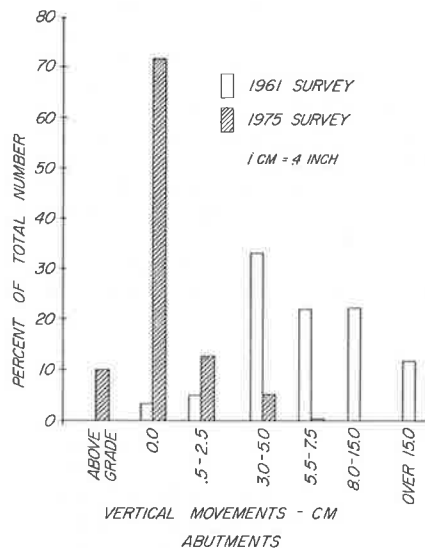
A phenomenon was measured in the 1975 survey that did not appear in the 1961 survey. At 10 percent of the abutments, the profiles showed that the existing field elevations were above plan grade from 1.0 to 4.0 cm (0.5 to 1.5 in). No rational explanation can be offered to explain these data. Two districts noted the occurrence of a few rotational or lateral movements of approximately 5 cm (2 in). Figure 10 shows a comparison of abutment settlements between the 1961 and 1975 surveys.

Figure 10. Comparison of abutment settlements.

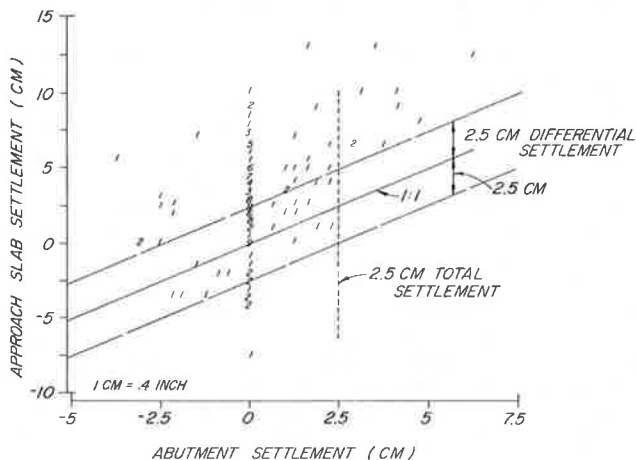
The difference in performance of the two abutment types (supported by piles or spread footings) can also be seen by a comparison of Figures 11 and 12. Deviations from the 1:1 slope line indicates differential settlements between the abutment and the end of the approach slab. Differential settlements are more common for the pile-supported abutments—63 percent of the cases exceeded 2.5 cm (1 in). In the differential settlements for abutments supported by spread footings, only 31 percent of the cases exceeded 2.5 cm.

Figure 11. Performance of pile supported abutments.

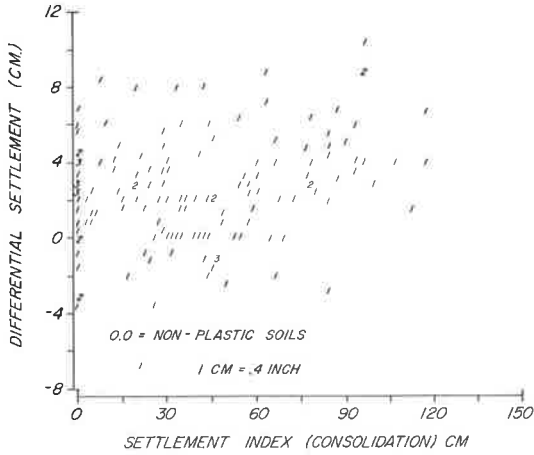
Figure 15 relates the same differential settlements with a settlement index, where the settlement index incorporates several effects but essentially is an anticipated consolidation of the existing foundation soils. The greater the value of the settlement index, the more plastic the subsoils. The data of the graph are random: Nonplastic soils indicate settlement distress as great as that with cohesive soils.

Figure 15. Differential settlement versus settlement index.
