Evaluation of Bolted-Base Steel Channel Signpost

Hayes E. Ross, Jr., and Michael J. Effenberger, Texas Transportation Institute, Texas A&M University, College Station
Lawrence J. Sweeney, Franklin Steel Company, Franklin, Pennsylvania

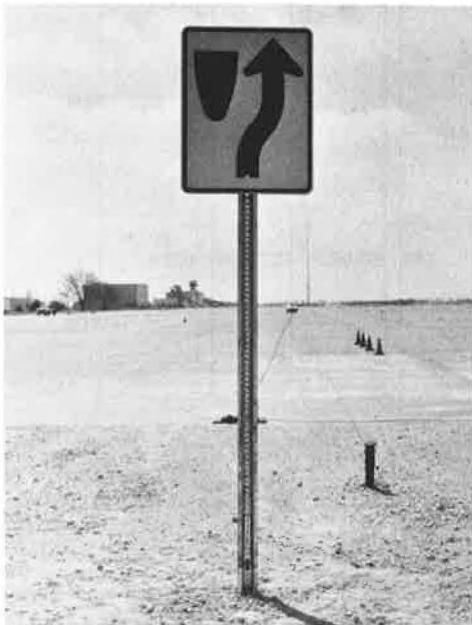
Figure 4. Single-post sign installation.

Figure 5. Close-up of Eze-Erect assembly.

assembly was used. The single-post installation and the Eze-Erect assembly are shown in Figures 4 and 5. Details of the installation appear in Figure 6. The three-post installation is shown in Figures 7 and 8.

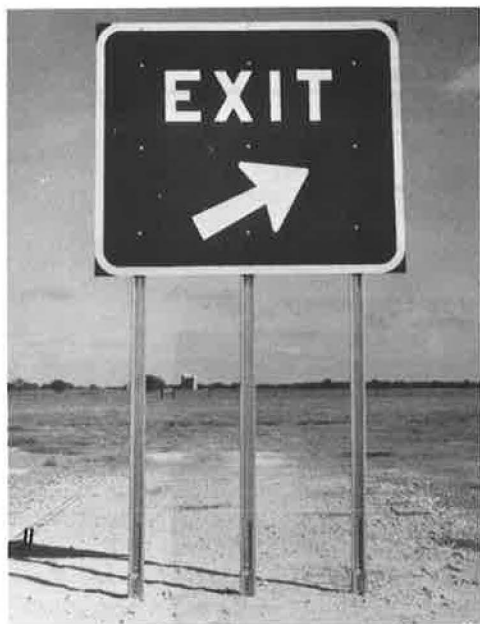
Figure 7. Three-post sign installation.

Figure 8. Three-post installation details.

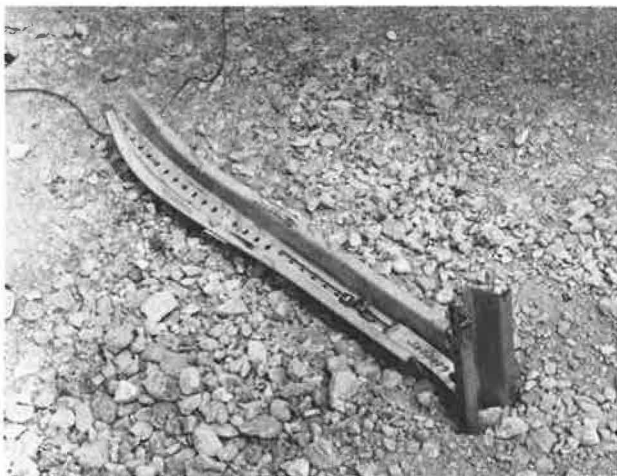
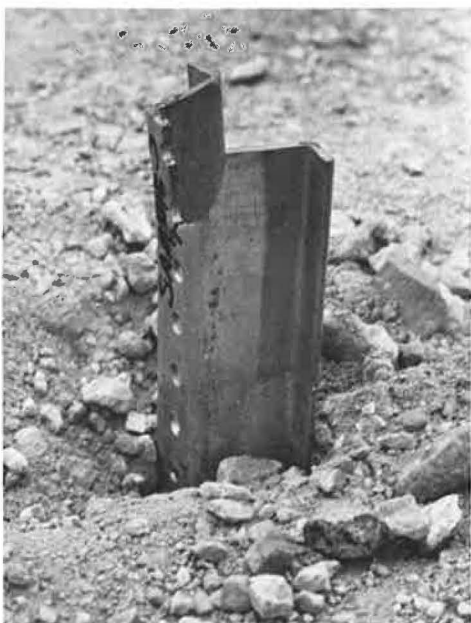
Figure 9. Stub after test 1.

Figure 10. Stub after test 2.

Considerable improvements were observed in the dynamic behavior of the second-generation Eze-Erect assembly (tests 5 and 6) over that of the first-generation assembly (tests 1 through 4). Figures 9 and 10 show the assembly damage after tests 1 and 2. Note the tear in the top of the stub post. Figures 11 and 12 show the assembly after tests 5 and 6. In tests 5 and 6 there was no damage to the stub, and with minor soil retamping the stub would be reusable.

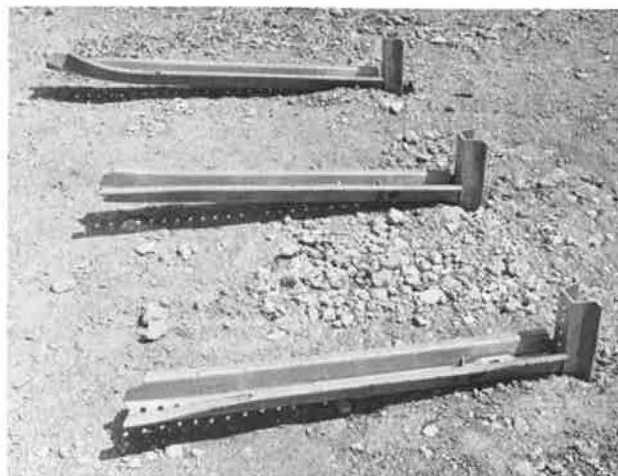
Figure 11. Stubs after test 5.

Figure 12. Stubs after test 6.
