TRANSPORTATION RESEARCH RECORD 693

Safety in Construction
and Maintenance
Work Zones and
Transportation of
Hazardous Materials

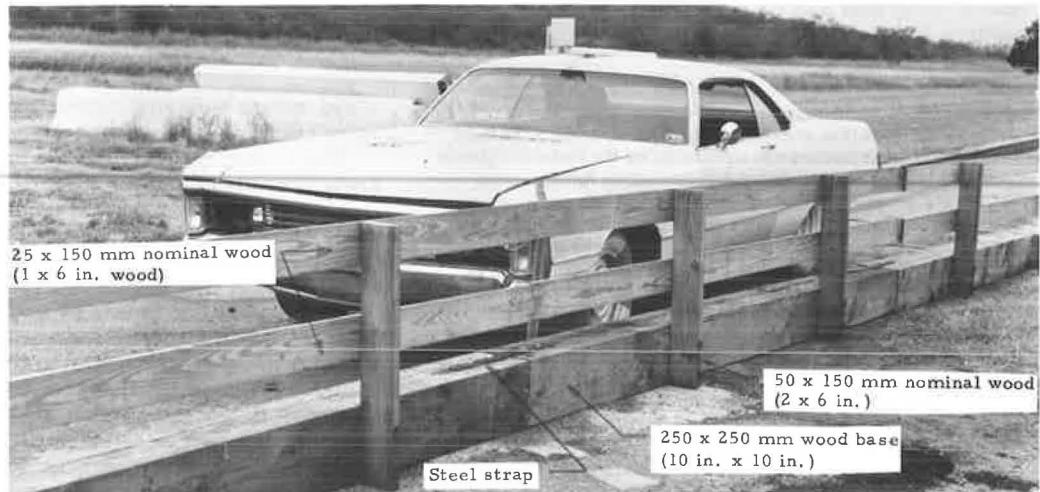
Figure 1. Temporary barrier test installations.

(a) Timber barrier
[Test installation length = 43.9 m (144 ft)]

(b) W-beam/barrel barrier
[Test installation length = 30.5 m (100 ft)]

(c) Type X concrete curb
[Test installation length = 30.5 m (100 ft)]

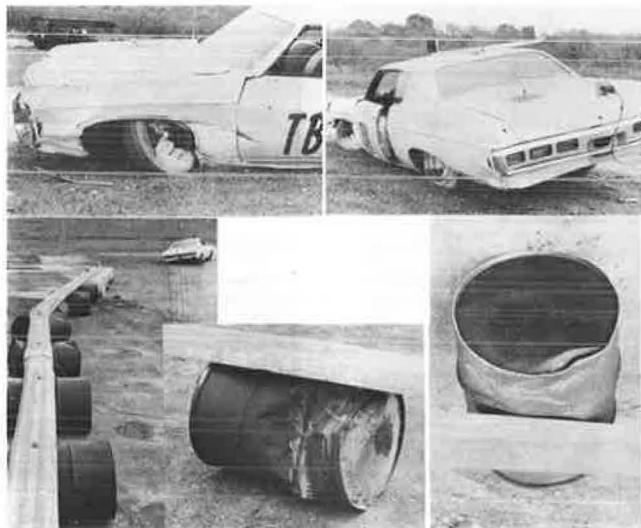
Figure 9. Test TB-4 vehicle and barrier damage.

The vehicle sustained minor sheet metal damage to left-front and rear fenders, as shown in Figure 9. In ad-

dition, the lower ball joint at left-front wheel was separated and both left tires were punctured during impact. Damage to the installation was limited to three barrels, which were replaced prior to the next test.

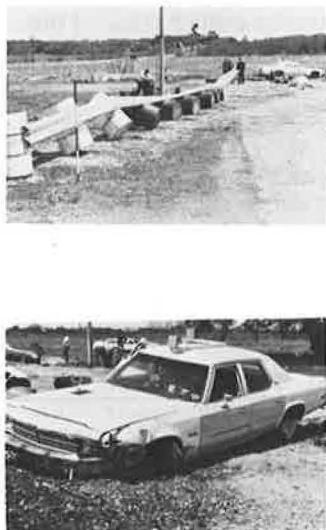
Figure 12. Test TB-6 sequential photographs.

Vehicle impact conditions were 56 km/h (35 mph) and an 8.1° angle. Initial impact was 9.8 m (32 ft) from the upstream end. As shown in Figure 12, the left wheels immediately climbed up the sloped curb face. The vehicle pitched (nose up) initially, and then as it straddled the barrier, the front underside snagged on one of the 25-mm

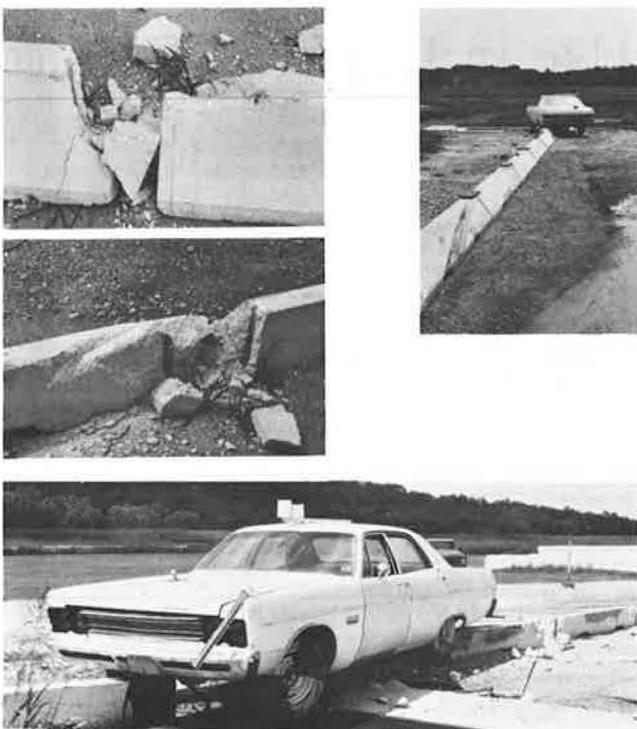
Figure 13. Test TB-6 vehicle and barrier damage.

(1-in) thick splice plates. Significant deceleration forces were then applied to the vehicle by this splice plate and the one immediately downstream. These forces were sufficient to prevent the vehicle from proceeding over the barrier; however, considerable damage to the vehicle's underside and three barrier sections was observed. Final position of the vehicle and the barrier damage are shown in Figure 13.

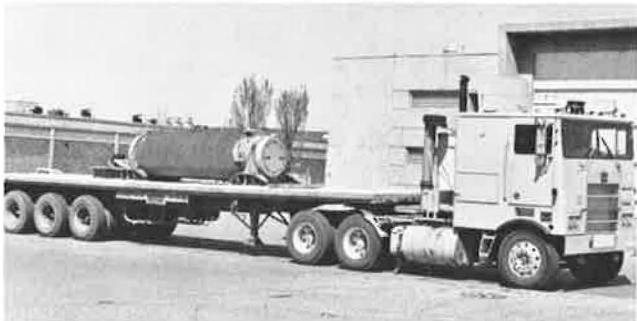
Figure 4. 15 x 140 cask used in grade-crossing test.

For the grade-crossing test, a 23-Mg cask, complete with trailer and tiedown structure, was obtained. The cask, similar in construction to the cask used in head-on barrier tests, was mounted on the trailer by a band tiedown system, as shown in Figure 4. A tandem-axle, gasoline-powered tractor supported the cask and trailer during the test.

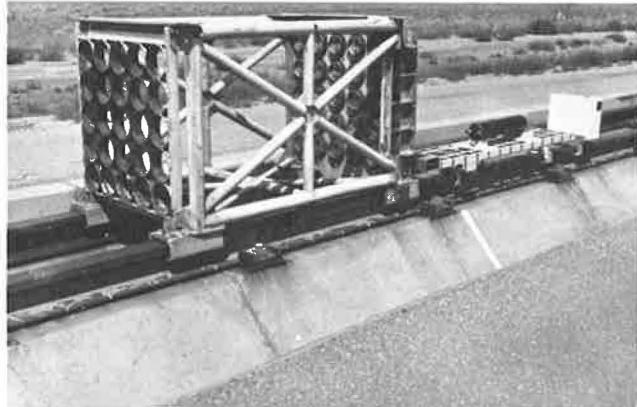
Figure 7. Cask transport model.

A $\frac{1}{8}$ -scale model of the cask transport system shown in Figure 7 was tested at our rocket sled track facility. To assess damage to the cask structure, an adequate model (excluding fins) of the cask and impact limiter was constructed. The tractor-trailer model was designed with emphasis on the major masses and structural elements. Only those elements expected to contribute

significantly to the cask dynamics were included. The model, therefore, simulated the major dynamics and resultant damage expected in the full-scale test.

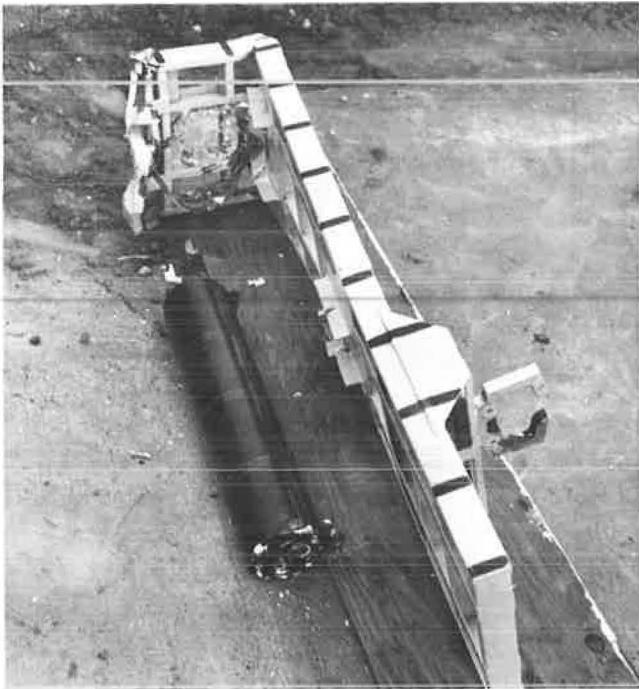
Using a rocket, the model transport system was propelled into a scaled concrete wall at 97 km/h. A posttest view of the damage is shown in Figure 8. Scale-model results agreed closely with analytical predictions. High-speed data films showed that the transport and cask system response closely followed that predicted in the case where the tiedown did not fail. The impact limiter was partially crushed, and the cask was undamaged, except for minor deformations around the tiedown attachment points.

Figure 8. Posttest damage—scale-model test.

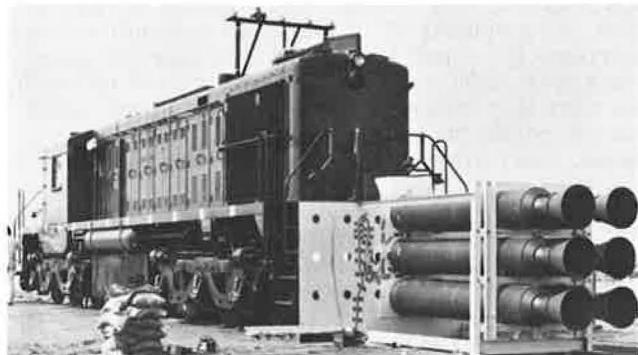
the 109-Mg locomotive to test speed (Figure 19), after which it coasted to an impact at 131 km/h. As predicted by pretest analysis and scale-model test results, the frame of the locomotive was crippled and formed a ramp, which allowed the cask to rise into the superstructure (Figure 20). As shown in Figure 21, failure of the locomotive frame closely resembled that in the model test. After superstructure crush up, the cask rolled to the right side of the locomotive, tumbled in the dirt, and came to rest between the rails. Posttest inspection of the cask indicated that the deformation behavior of the cask was very similar to that of the scale model. Two 26-mm depressions, which were caused by the impact with the I-beam members of the frame, were left on the surface of the cask. Leak testing of the cask after impact indicated a small leak in the head seal when the cask was pressurized. This leakage, had the cask contained water, would have caused essentially no risk to the public. The cask head was removed without difficulty and the fuel assembly was found to be intact. There was some bowing of the fuel pins; however, no clad failure was detected.

Figure 19. Rocket-powered locomotive—full-scale grade-crossing test.

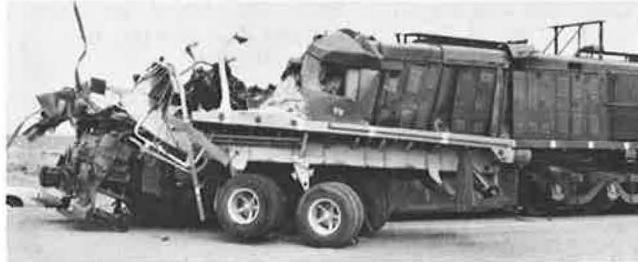
Figure 21. Frame buckling damage—full-scale grade-crossing test.
