FOREST SERVICE EXPERIENCE WITH IN-PLACE REDUCTION OF
OVERSIZED ROCKS IN UNSURFACED ROADS

Martin C. Everitt and Ernest L. Hoffman, U. S.
Department of Agriculture, Forest Service

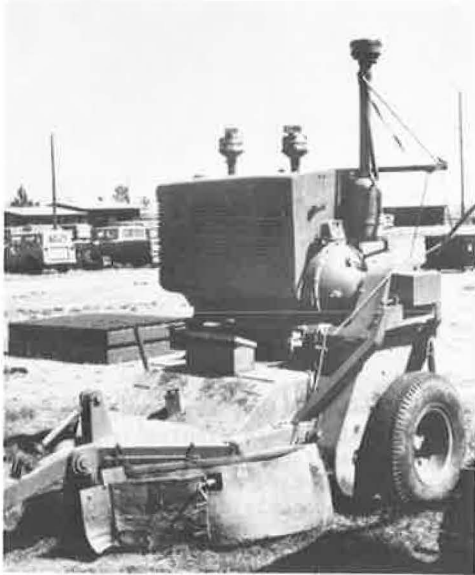
Front view.

Figures 1 and 2. Browning RB-4 parked without towing unit. Hammer chamber is under sloping cover on front view. Note many hand-operated adjustment cranks, turnbuckles, levers, etc., which have been eliminated in newer equipment. Rubber skirts control flying fragments.

was somewhat smaller than the Pettibone Model P-500 used in the San Dimas test, but otherwise similar (Figures 1 and 2).

The machine obtained is quite old and does not represent current equipment technology. It was built in about 1952. It is 2.44 m (8 ft.) wide, 5.00 m (16 ft. 5 in.) long, 2.75 m (9 ft.) high, and weighs 5,443 kg (12,000 lbs.). The engine is an International Model UD-14 diesel rated at 180 hp. The engine drives the hammers through a multiple V-belt. The machine rides on two wheels which are adjustable for height, and is towed by a tractor. The only controls are the clutch and throttle, which are operated by ropes to the tractor. All other adjustments are manual. The arrangement is awkward but workable. There are some problems with parts availability resulting from the age of the machine.

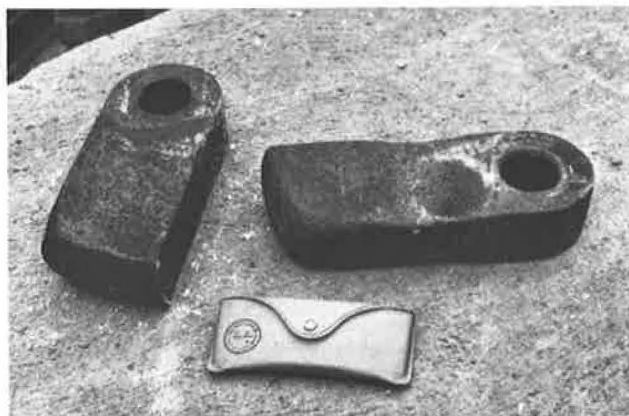
Figure 5. Worn hammers from Browning RB-4. Hammer on left is about 25 cm (10 in.) long.

Crushing is done by 18 free-swinging hammers which are mounted on four pivot pins arranged parallel to a central driveshaft (Figures 3, 4, and 5). The hammer speed is 1,000 rpm, and with new hammers the total assembly has a diameter of 96 cm (38 in.). The rated capacity is 115 to 153 m³ (150 to 200 cu. yds.) per hour. The width of the impact area is 1.22 m (4 ft.), and the loose depth of the processed material behind the machine is 20 cm (8 in.). This is a maximum capacity of 0.07 m³ (2.67 cu. ft.) per 30 cm (lineal foot) of travel, or about 0.76 m³ (1 cu. yd.) per 3 m (10 ft.) of travel.

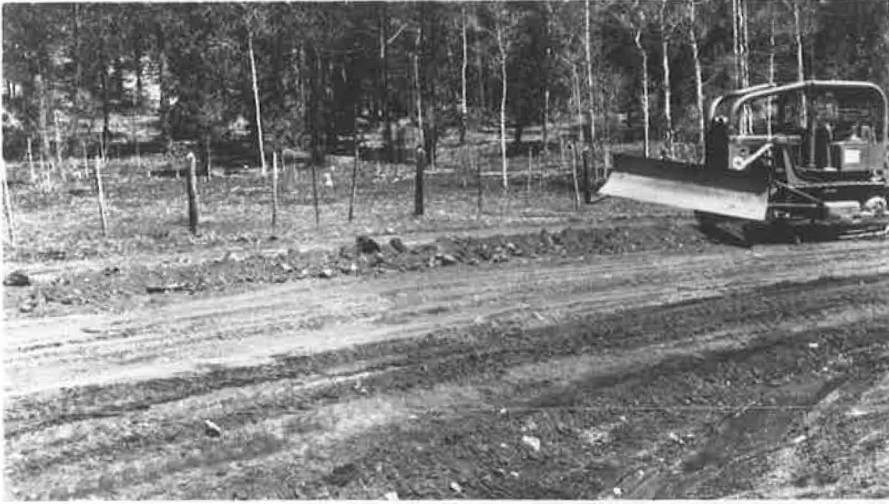
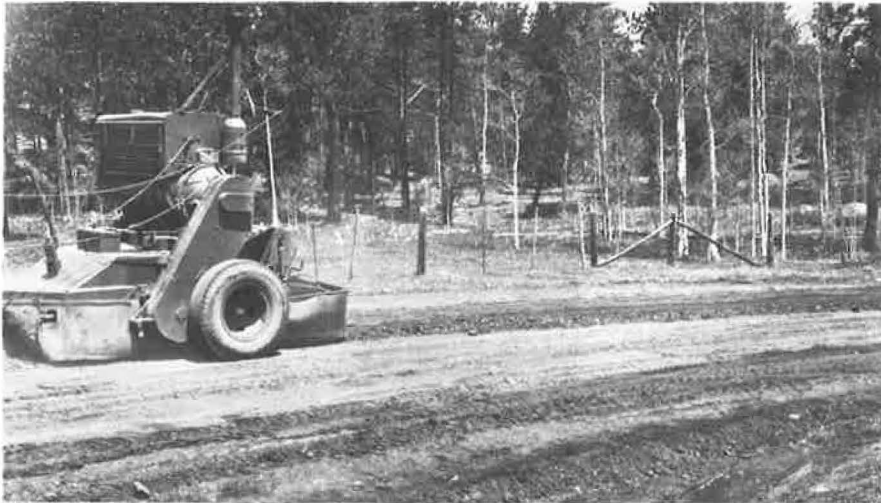
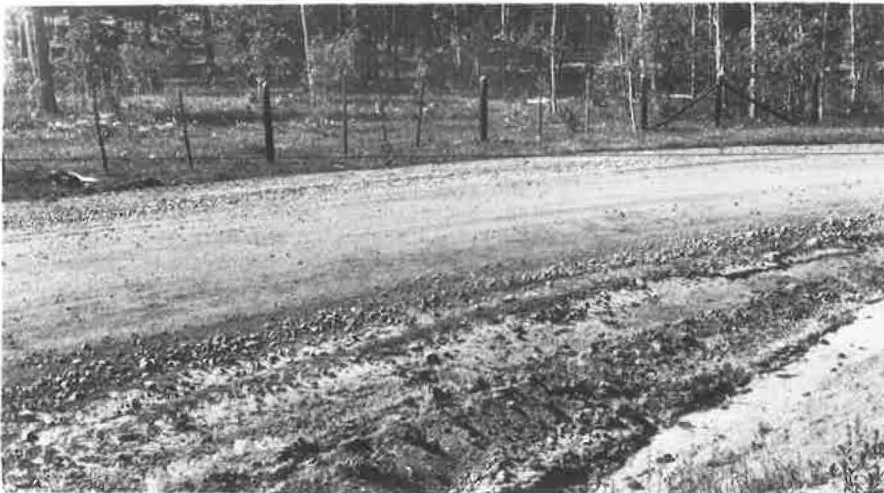
Figure 6. Windrow before and after processing by the RB-4 and the same spot about 3 weeks later. This windrow is smaller than the maximum which can be handled, but is otherwise typical. This section was not ripped.

The first trial, while getting the crew acquainted with the equipment, was simply to eliminate loose rocks pulled out of a road by previous normal blading operations. Rocks were pulled out of the ditches, etc., and brought onto the road surface, which was not disturbed. A single pass of the machine crushed and scattered them. A layer of gravel about one pebble thick was produced over the road width, and within a week or two most of this had been whipped off by traffic (Figure 6). Rock that might otherwise have been loaded and trucked to a dump site was
