Effect of Longitudinal Edge of Paved Surface Drop-Offs on Vehicle Stability

Roger L. Stoughton, Douglas M. Parks, J. Robert Stoker, and Eric F. Nordlin,
Division of Construction, California Department of Transportation

The effect of edge of pavement drop-offs on vehicle stability is reported for 50 tests of professional drivers handling small-, medium-, and large-sized automobiles and pickup trucks off, along, and back onto drop-off heights of 38 mm (1.5 in), 89 mm (3.5 in), and 114 mm (4.5 in) at about 26.8 m/s (60 mph). Tests of two- and four-wheel drop-offs were conducted from an existing asphalt concrete shoulder onto both compacted soil and asphalt concrete surfaces. The drop-off heights had little effect on vehicle stability: steering wheel angles were generally 60° or less; vehicle roll angles were 10° or less. A significant jolt and accompanying front-end noise were experienced by the driver at the larger drop-off heights; there were no problems with vehicle alignment. Less than one wheel revolution was required for the first wheel to mount the drop-off heights. Varying amounts of front-wheel wobble caused mainly by an irregular drop-off edge were detected. There was virt

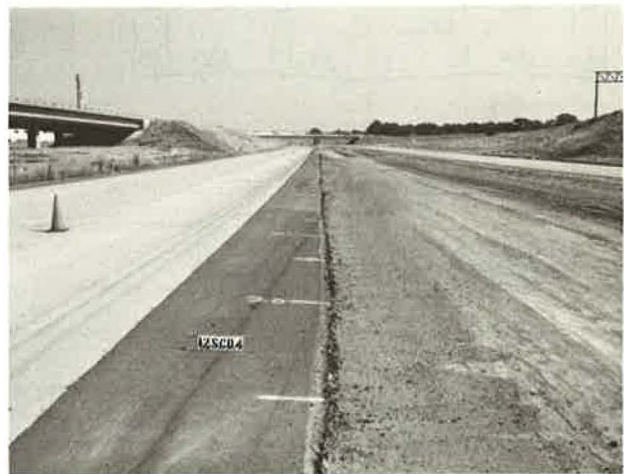
Figure 2. Test site.

The test site was located on an unopened portion of I-80 between Del Paso Park Separation and Overhead and Longview Drive Overcrossing in Sacramento County near Sacramento, California (Figure 2).

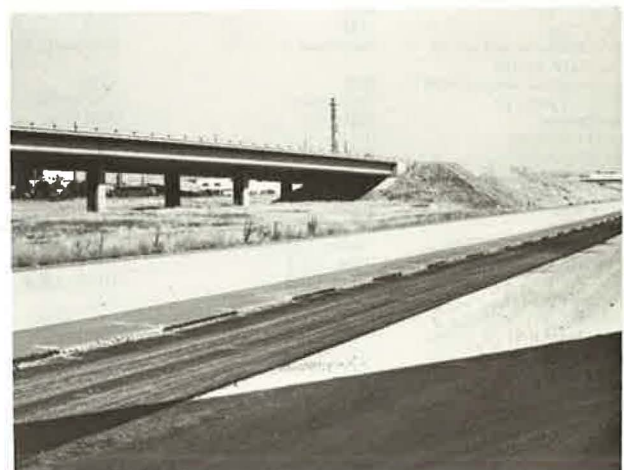
Figure 3. AC-to-AC test site.

Drop-off heights of 114 mm (4.5 in), 89 mm (3.5 in), and 38 mm (1.5 in) were constructed along the edge of an existing 1.5-m (5-ft) wide AC shoulder adjacent to a 15.3-m (50-ft) wide unpaved median. Each drop-off height was maintained for a 153-m (500-ft) length with short spaces between the three 153-m test strips. Field measurements of drop-off heights were taken at 3.1-m (10-ft) intervals. Each 153-m strip was used for both series of tests, asphalt-to-soil and AC-to-AC. After the AC-to-soil tests were completed, an additional 25-51 mm (1-2 in) layer of soil was removed from each strip and replaced by a layer of AC so that the AC-to-AC drop-off tests could be conducted (Figure 3). Originally it was planned that a 140-mm (5.5-in) drop-off height be used. However,

10. Curved roadway—The 38-mm (1.5-in) drop-off test strip was constructed on a 1525-m (5000-ft) radius curve to the left along the test site (Figure 3). The vehicles were not affected by this gradual curve during any of the two- or four-wheel drop-off tests conducted at this height.

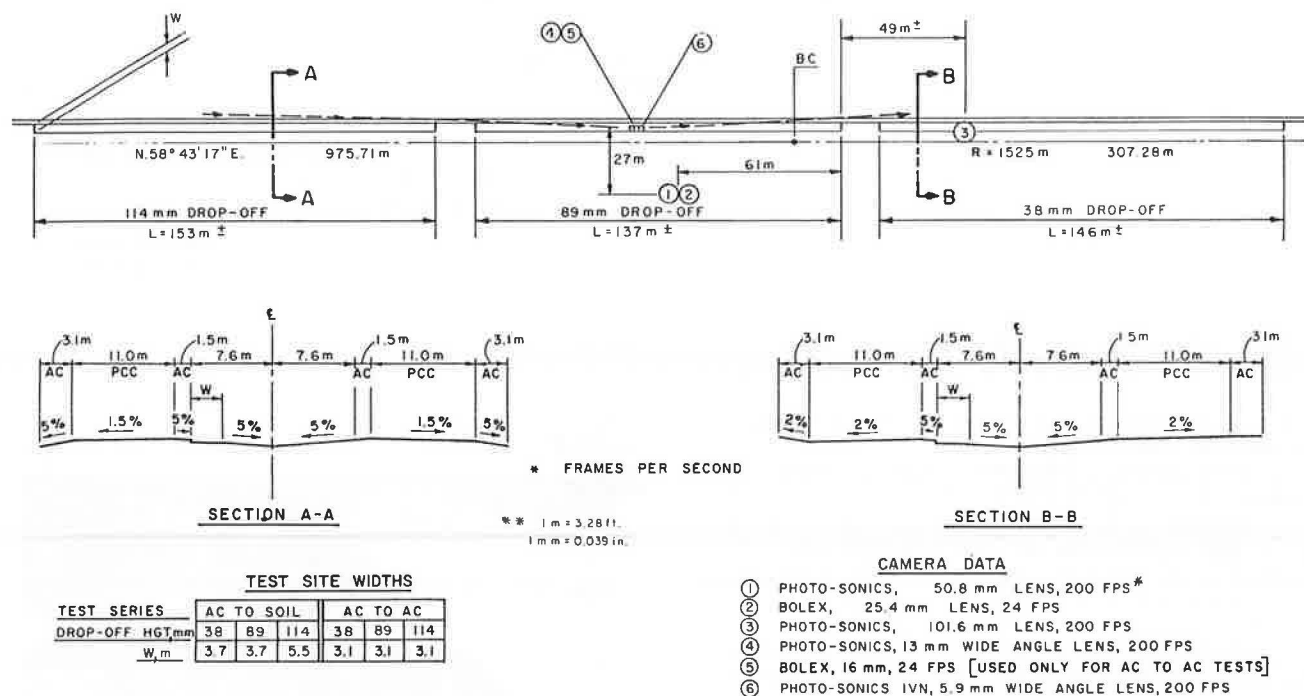
Figure 4. Test site and typical camera layout.

The tests were conducted from September to October 1974. The test strips were dry and the weather was good for all tests. Figure 4 shows a layout of the test site, test-site widths, and typical cross sections for the existing roadway used for this project.

Four high-speed movie cameras and a normal-speed movie camera were used to document each drop-off test. The camera positions are shown in Figure 4. Cameras 1 and 2 were mounted on the ground and panned the action. Camera 3 was mounted on the ground downstream of the test and viewed the action parallel to the drop-off edge. Camera 4 was mounted inside the vehicle to view the driver, the rotation of the steering wheel, and a large speedometer mounted on the dash (Figure 5). Camera 6 was mounted on the front bumper of each vehicle to view the action of the vehicle's right-front or left-front wheel as the wheel dropped off and then mounted the drop-off edge (Figure 8). This camera was moved from the right side to the left side of the vehicle, depending on whether two- or four-wheel drop-off tests were conducted. Camera 5, mounted inside the vehicle, viewed the driver and steering wheel rotation for the AC-to-AC drop-off tests in addition to the other cameras.

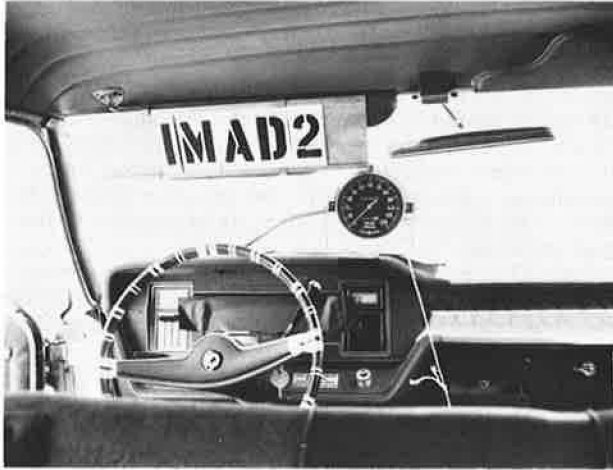
Figure 5. Vehicle interior showing taped steering wheel and large speedometer.

The perimeter of the steering wheel in each test vehicle was taped every 15°. A black vertical reference line was marked on the white background of a sheet-metal angle bracket taped to the dashboard of the vehicles. When the interior camera was bore-sighted, the vertical reference line was adjusted to line up with the tape on the steering wheel corresponding to a zero steering wheel angle. These taped angle markings were used to measure the angles through which the steering wheel was turned during each test. An interior view of the automobile is shown in Figure 5.

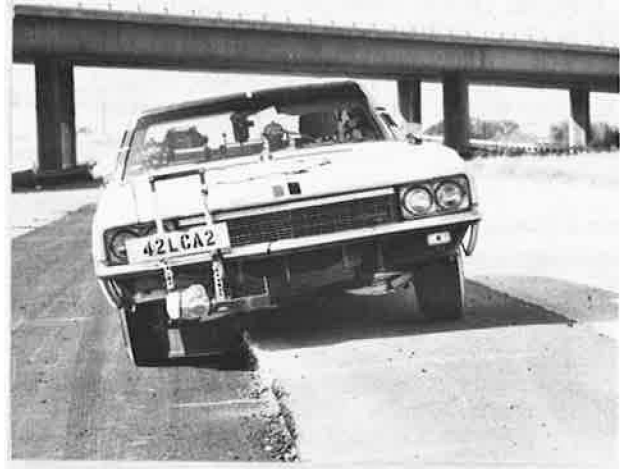
Figure 6. Large-sized vehicle.

A typical view of a test vehicle straddling a drop-off edge is shown in Figure 6. Entrance angles (Table 2, Figure 7) were purposely small to simulate a driver drifting off the edge of the traveled way. Curb jump tests (1-3) showed that vehicles easily traverse curbs

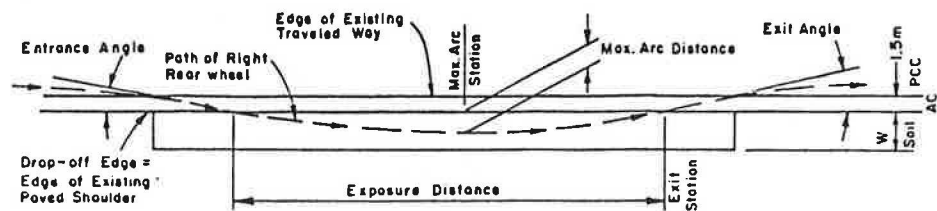
Figure 7. Trajectory measurements—AC-to-soil drop-off test series.

Test parameters, trajectory measurements, maximum vehicle roll angles, maximum steering wheel angles, and vehicle velocities are tabulated for the AC-to-soil drop-off tests in Tables 2, 3, and 4 and Figures 9 and 10. Data for the AC-to-AC drop-off tests were similar and are not included in this paper, but are included elsewhere (4).

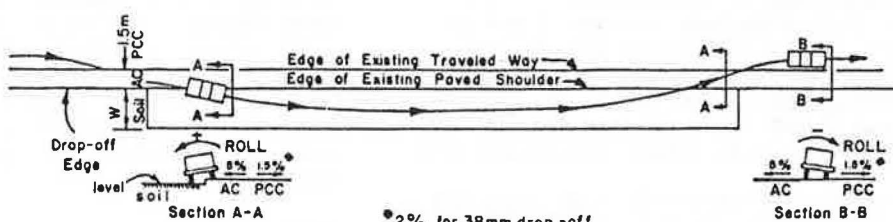
Figure 9. Vehicle roll angles—AC-to-soil drop-off test series.

2. Vehicle roll—Vehicle roll angles did not increase significantly in relation to the height of the drop-offs. A maximum value of 10° was recorded, which is far from an impending rollover condition. The driver for these tests did not become disoriented or feel any discomfort during vehicle roll.

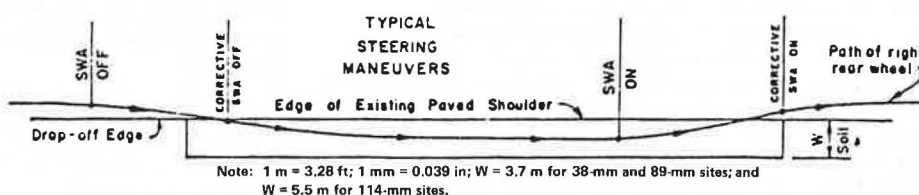
Figure 10. Steering data—AC-to-soil drop-off test series.

Steering wheel angle (SWA) (Table 4) is defined as the angular displacement of the steering wheel measured from the straight-ahead position (position corresponding to zero average steer angle of a pair of steered wheels) (5).

1. Steering—Relatively small steering wheel angles were measured during these maneuvers, usually 60° or less. The driver for these tests handled the steering wheel with minimal effort, which included control with
