Importance of Redundancy in Bridge-Fracture Control

R. A. P. Sweeney, Canadian National Railways, Montreal

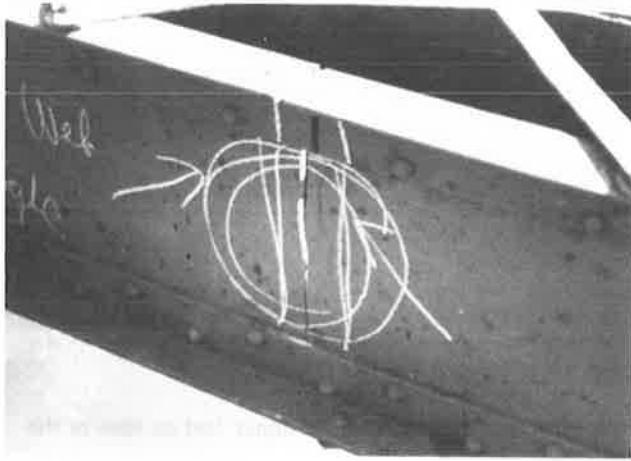
Figure 2. Cracked chord member.

The chord member of the truss shown in Figure 2 cracked on only one side of the member and carried rail traffic for some time before detection and repair. In a welded-box member the crack would have propagated all around (Figure 3).

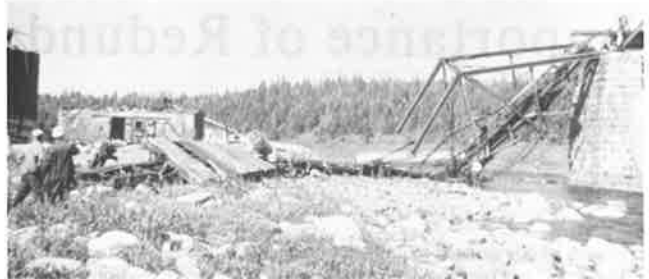
Figure 5. Result of inadequate bracing.

In spite of the above principles, most trusses were multi-load-path structures. The truss in Figure 4 had its bottom chord completely severed and yet remained standing because of the alternate load paths provided by the bracing, floor system, etc. Unfortunately, the truss shown in Figure 5 did not follow Waddell's rules for adequate bracing and did not remain standing when one of its diagonals was severed by a shifting load. It had insufficient redundancy.

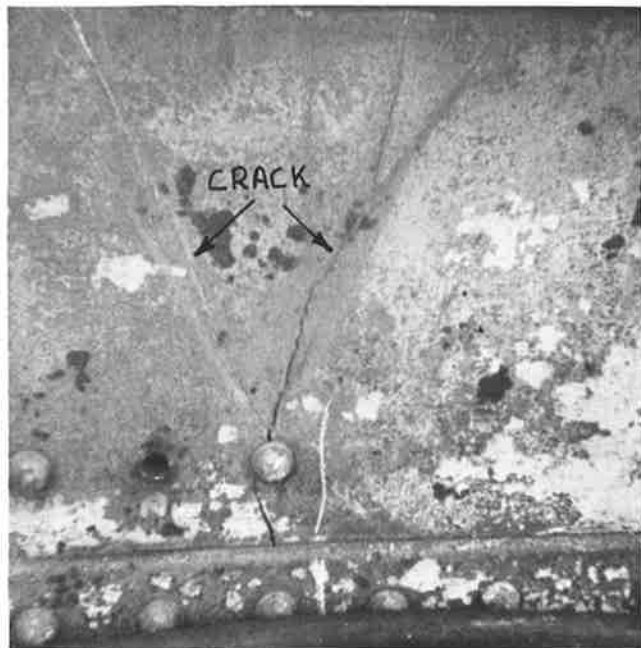
Figure 7. Crack developed three weeks after deck fire.

tions. The crack shown in Figure 7 developed three weeks after the fire.

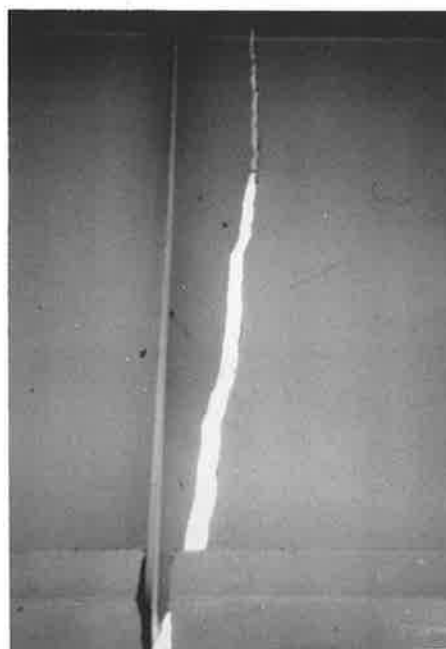
Figure 11. Crack becoming a fracture.

Remember (Figure 11) that in this welded-plate girder a single crack was sufficient to split the member in half,

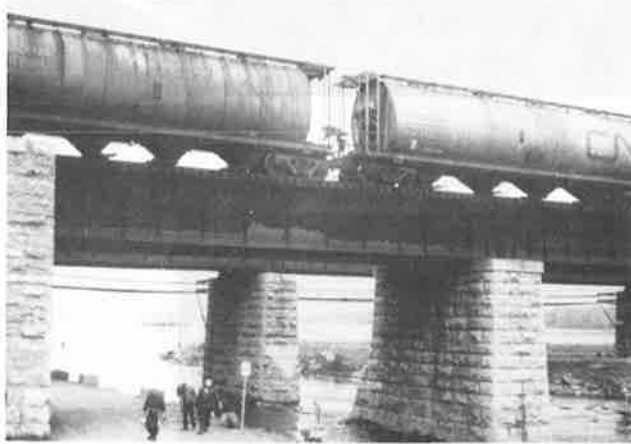
Figure 13. Girders with a Pratt truss.

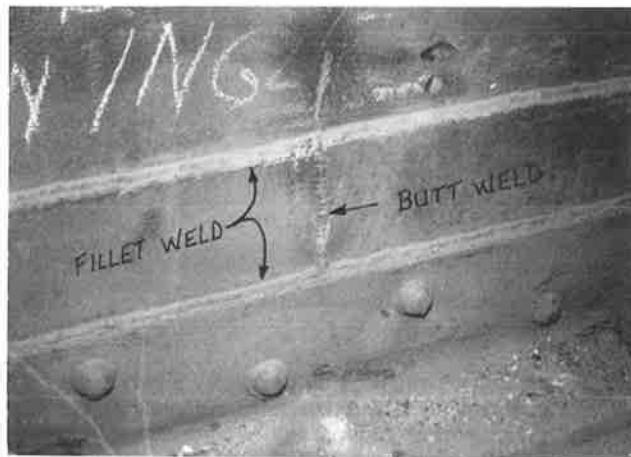
Figure 14. Butt and fillet welds.

Because of the production operation, patch plates varied in length and were butt welded as required (Figure 14). After 10 years these welds started to crack under very low stress ranges. The maximum measured stress range was 36.2 MPa (5250 lbf/in²) with a mean peak per train of 31.92 MPa (4630 lbf/in²) with a sample of 12 trains. The mean plus two standard deviations of these peak stress ranges per train was 36.47 MPa (5290 lbf/in²). There was little if any apparent dynamic augment.

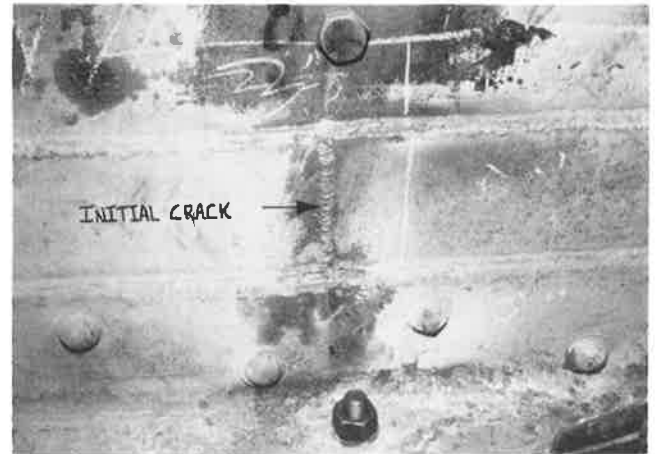
Figure 15. Crack propagated into the web.

The welds were not of AWS quality, which was not surprising for field welding of this nature. Nevertheless, it probably means that they would have cracked after 15-18 instead of 10 years. The cracks (Figure 15) in these welds were very hard to detect and in fact were not detected until they had propagated from the patch-plate welds into the web.

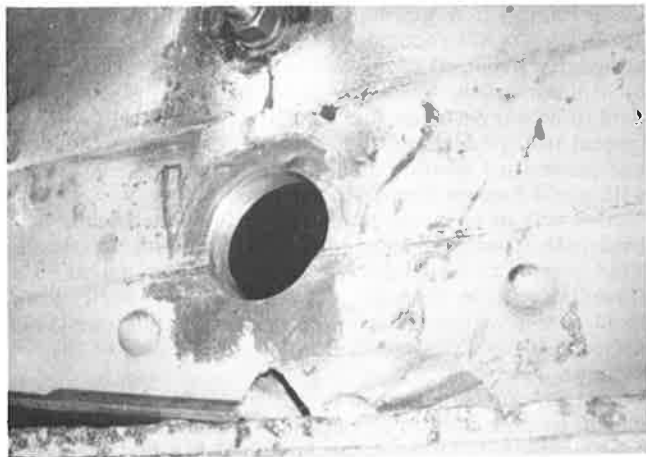
Figure 17. Core cut for plug.

Several plugs were taken to confirm the above process. From the location shown in Figure 17, a core 76 mm (3 in) in diameter was cut out with a hole saw. The core was then cut through the upper leg of the bottom flange angle and patch plate and then web to patch plate and web and patch on the other side. The plug (Figure 18) shows the vertical (just right of center) and horizontal (just below center) welds. The left piece in Figure 19 shows the patch plate, which was above the leg of the flange angle, that had the crack in it from the inside. The center piece is the web corroded just above the horizontal line. The right piece is the opposite-side patch plate and bottom flange angle and shows its crack

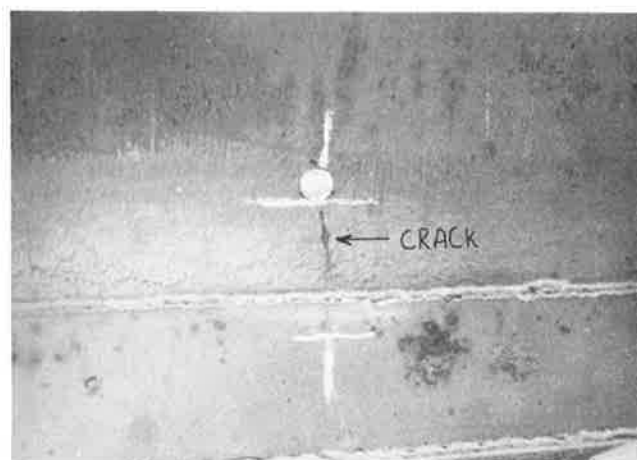
Figure 20. Inside of girder before core was drilled.

Figure 20 shows the same location, before the core was drilled, from the inside of the girder. Note that there is no butt weld on the inside at the location of this crack, which propagated from the opposite side.

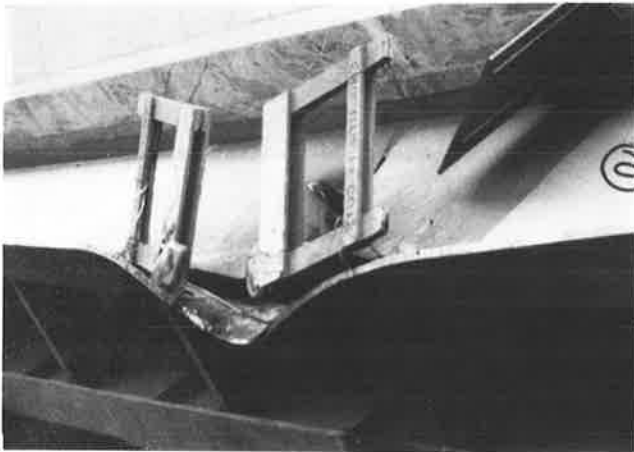
Figure 21. Damage caused by backhoe.

A rather striking example is the multibeam welded structure with a composite deck that was hit by the top of a backhoe (Figure 21). Although several girders were badly damaged, the structure did not collapse under train traffic. Several trains are known to have crossed on the adjacent track after the accident. Imagine what could have happened if that had been a two-girder non-composite welded system.

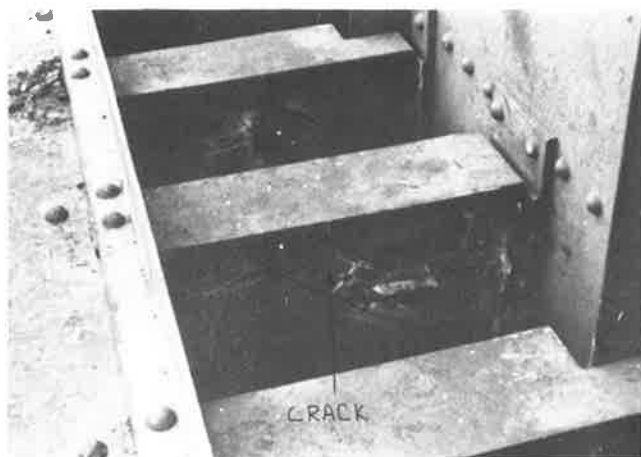
Figure 23. Crack caused by torsional fatigue.

The structure in Figure 23 cracked from torsional fatigue caused by constant train braking. Although the floor beams were not welded, there was no component redundancy as the beams were rolled. Nevertheless, the redundancy of the deck system permitted regular train operations for over a year even though four adjacent floor beams failed.
