Multi-Load-Path Structures for Highway Bridges

Paul F. Csagoly, Engineering Research and Development Branch,
Ontario Ministry of Transportation and Communications, Downsview
Leslie G. Jaeger, Acadia University, Wolfville, Nova Scotia

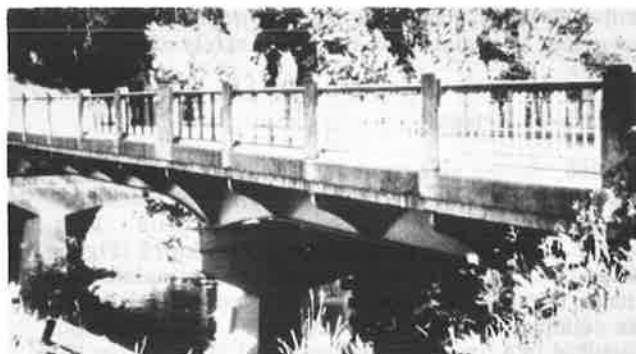
Figure 4. Ontario-35 bridge at Minden.

During the summer of 1976, a bridge on Ontario-35 at Minden, which consisted of four steel girders continuous over three spans, was discovered to have one girder completely fractured in the northern span. A photograph of the bridge, after discovery of the failure, is shown in Figure 4. The fracture, located about 2 m (6 ft) from the pier, was caused by two major inclusions in the welds of the girder web. As usual, the failure was identified as a combination of brittle fracture and fatigue.

After discovery of the failure by a boatman, the fractured girder was supported by an emergency false-work and later reconstructed by installing a fully bolted connection. The bridge was closed to traffic for only one day. It is obvious that the three intact girders, helped by their continuity over the internal piers, had been able to redistribute the loads safely after the failure.

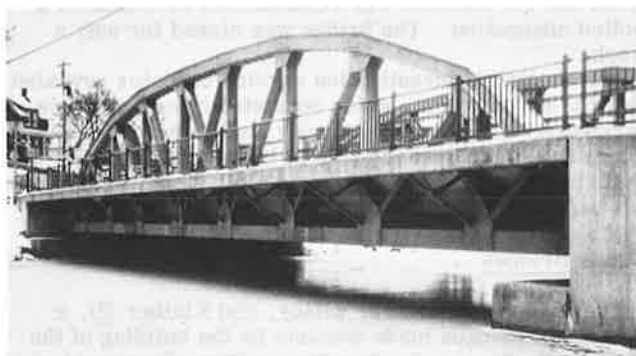
Figure 5. Ontario-33 bridge at Frankford.

In 1969, during an extremely cold winter night, the lower chord of one steel truss of a bridge fractured completely at the end of a welded cover plate. This bridge is located on Ontario-33 at Frankford (Figure 5). Since this bridge is simply supported, complete separation in a chord member would be expected to precipitate its collapse. Such was not the case. The separation resulted in a one-sided deflection of about 13 cm (5 in), which helped to bring the problem to light. When the separation was found, the structure was jacked back to its original shape by an ice-supported temporary false-work and the member was rehabilitated by means of a bolted connection. The bridge was closed for only a week.

An analytical investigation carried out later revealed that the deck system, which consisted of cross beams, stringers, and an unintentionally composite concrete deck, had taken over the role of the tension chord of the main truss on a temporary basis after some considerable but harmless deformation of the superstructure.

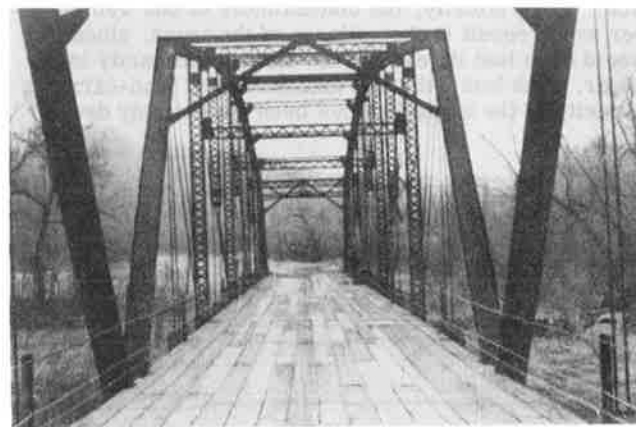
Figure 6. Hubby bridge over the Des Moines River.

As described by Sanders, Elleby, and Klaiber (3), a number of bridges made obsolete by the building of the Saylorville Dam on the Des Moines River were subjected to load tests in Iowa during 1974. One test on the single-lane truss bridge illustrated in Figure 6 included cutting its vertical members at one cross section. Theoretically, the discontinuity of one web member would result in the collapse of the truss, since it would have lost its entire load-carrying capacity in shear. The test indicated that the actual load-carrying capacity of the bridge had not been appreciably de-

creased by this induced discontinuity. Subsequent investigations revealed that the combined effect of the frame action inherent in trusses and the semicontinuous nature of the deck system could provide an adequate level of shear capacity.

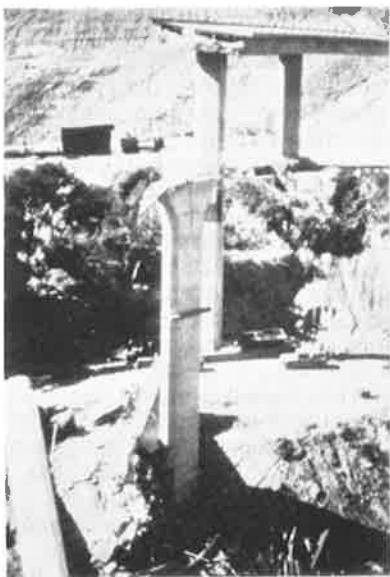
Figure 7. A bridge collapsed by the San Fernando earthquake.

A similar phenomenon, although on a much larger scale, was observed in California after the 1971 earthquake, which caused the collapse of at least six bridges and damaged scores of others. One of these bridges is shown in Figure 7. In order to prevent a similar happening in the future, the California Department of Highways ordered a major investigation that included the construction of a number of silicon rubber models that were properly compensated for mass distribution. Excitation of the models was attained by using specially designed shaker tables that permitted any combination of frequency, amplitude, and direction of application.

The model tests revealed that it was rather unlikely that any earthquake-induced force effect greater than those due to dead loads could cause failure of the superstructure. It was found, however, that bridges, especially those that incorporate tall piers, could exhibit excessive relative dynamic movements among their components that would permit the bearings to jump their seats.
