Measurement of Stress in Concrete Pavements

A. M. Richards, Department of Civil Engineering, University of Akron, Ohio

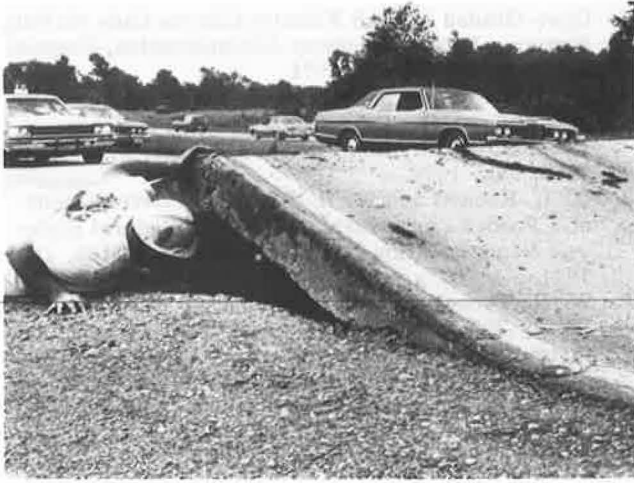
Figure 1. Blowup on OH-21, Summit County, 1975.

An unusually large blowup, which occurred on June 24, 1975, on OH-21 in Summit County, is shown in Figure 1. This blowup was 0.53 m (21 in) high and involved both northbound lanes for approximately 4.57 m (15 ft).

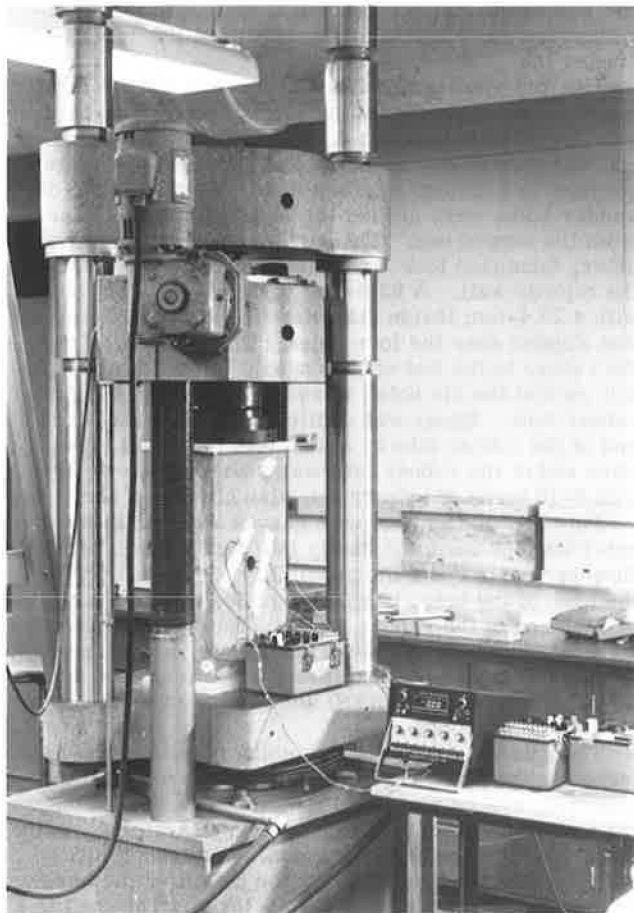
Figure 8. Specimen in testing machine.

One specimen contained 6x12-2/4 mesh; the other did not. Both contained a 38.1-mm diameter hole at the center of the 305x610-mm face. The hole extended completely through the 203-mm dimension and was pre-formed with pipe. One of the specimens is shown in Figure 8. Leads from four biaxial rosettes, two within

the holes and two on the 203x610-mm sides, are shown attached to the switch and balance unit. The rosettes on the sides of the specimens furnished data for computations of modulus of elasticity (E) and Poisson's ratio (ν). Placement of gauges in Figure 9 shows the hole enlarged for clarity.

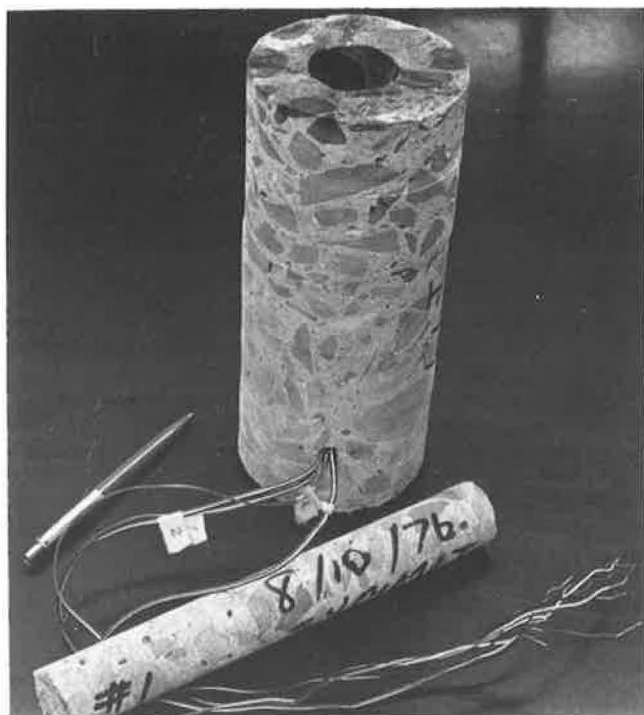
Figure 10. Core and overcore.

A 102-mm (4-in) diameter diamond drill was centered on the corehole and was forced through the pavement. A typical core and overcore are shown in Figure 10. The small hole near the bottom of the overcore was drilled later so the rosettes could be used for measuring material properties.

In order to compute modulus of elasticity and Poisson's ratio, laboratory testing was required. It was decided to use the same biaxial rosettes used in the field tests and still attached to the overcores. The samples had to be capped with sulfur compound, so it was necessary to drill a small hole near one end in order to use the leads, as shown in Figure 10.
