Environmental Constraints on the Vail Pass Project

Austin B. Milhollin, International Engineering Company, Inc., Denver

Environmental constraints to a large degree controlled both design and construction of the 22.5-km (14-mile) long segment of I-70 through Vail Pass in Colorado. An interdisciplinary team composed of engineers, ecologists, aquatic and wildlife biologists, and architectural and landscape consultants evaluated every aspect of the highway with regard to its environmental impact from the determination of the alignment to the color of the concrete structures. A variation of the Design Alternative Rating Evaluation system was used to quantify eight environmental factors, and these factors were then used to rank alternative alignments. After the alignment was selected, measures were taken to mitigate adverse environmental consequences associated with highway construction. In some instances, the amount of terrain disrupted was reduced by substituting a structure for a cut or a fill. In other cases, terrain was restored by landscaping methods. Environmental constraints imposed on the project design made it necessary to adopt innovative design concepts. The principal envir

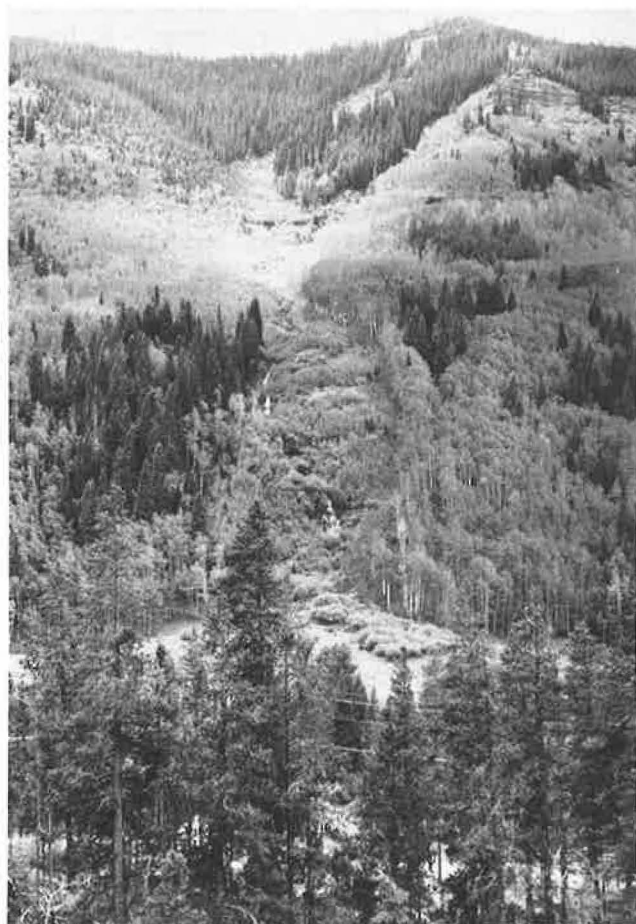
Figure 2. Typical timbered mountain slope.

eastern slope, the location lies within the drainage of West Tenmile Creek. This stream meanders down a relatively flat drainage course bordered by extensive growths of willow trees and alpine meadows in the narrow bottom of the valley, which gives way quickly to steep, timber-covered mountain slopes (see Figure 2). West of the summit, the highway follows the course of Black Gore Creek, which twists and plunges down a steep drainage course at the bottom of a valley bordered on both sides by steep mountain slopes that are broken in places by precipitous cliffs. For the most part, the mountainsides are covered with light to moderate growths of timber.

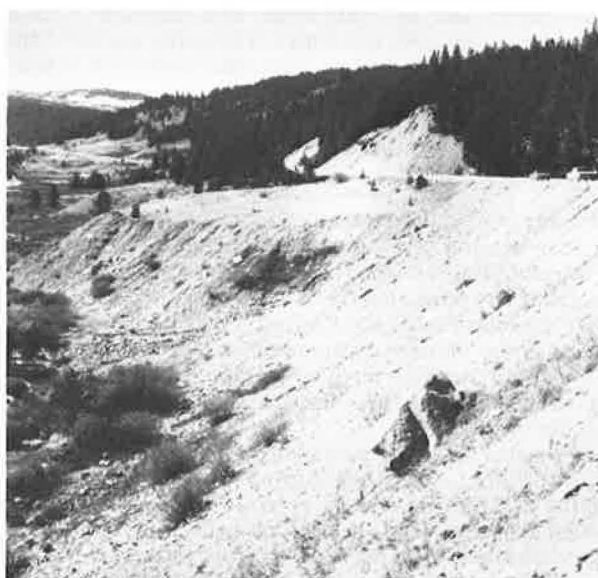
Figure 3. Old construction scar along existing highway.

The overriding problem on the west side of the summit, from a highway engineer's viewpoint, was the character of the geology. It was evident that any major roadway cuts could trigger earth slides and result in huge scars that would remain evident for generations (see Figure 3). Geology was thus a major factor in the environmental considerations.

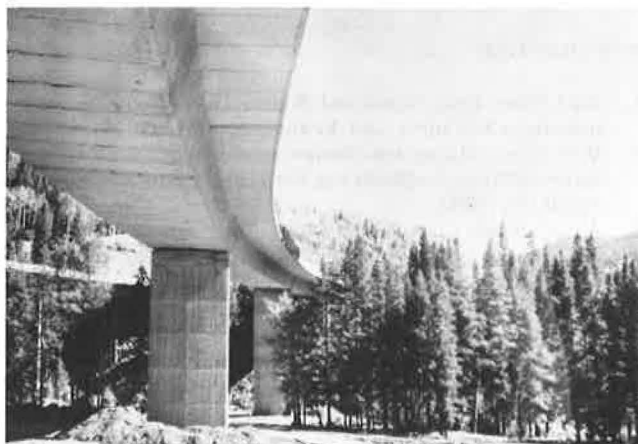
Figure 4. Precast concrete segmental box-girder bridge.

Twenty-one highway bridges in the project were designed so that they could be erected without falsework to minimize construction damage to the terrain. Eight of these were post-tensioned concrete segmental bridges (see Figure 4), 11 were welded steel box-girder bridges (see Figure 5), and 2 were poured-in-place concrete structures.

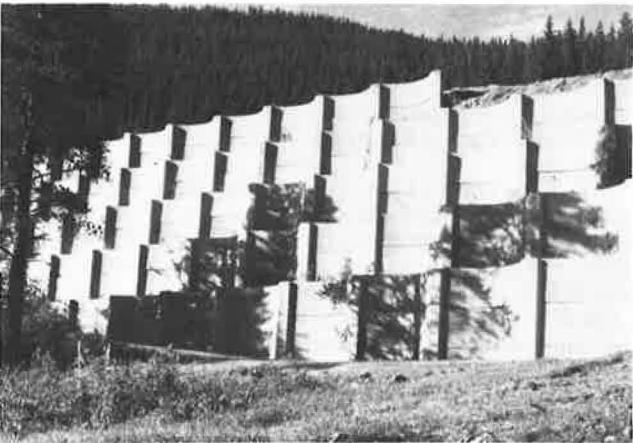
Figure 6. Terraced retaining wall.

In other places, a more economical solution was a retaining wall that would limit the base of the roadway embankment and confine all embankment materials on the hillside above the creek. In many places, the height of the required wall was so great that a concrete cantilever retaining wall would have been uneconomical as well as aesthetically unacceptable. The designers, therefore, set out to create another type of retaining wall that would be economical to construct and architecturally acceptable. The scheme devised consisted of a wall of any height and length composed of two basic precast concrete elements that could be easily fabricated and erected. The two basic elements were a precast concrete L-shaped piece, called a tieback, and a 12.7-cm (5-in) thick curved concrete precast facing panel. Units were assembled in the field to provide a wall of any desired height consisting of a series of tiers, each 2.4 m (8 ft) in height, with each succeeding upper tier set back a minimum of 1.2 m (4 ft) from the lower. Each setback provided a terrace that was topsoiled and planted with vegetation.
