Water-Quality Considerations for Highway Planning and Construction of the Vail Pass Project

William N. Johnson, U.S. Forest Service, South Lake Tahoe, California
R. Scott Fifer, U.S. Forest Service, Glenwood Springs, Colorado

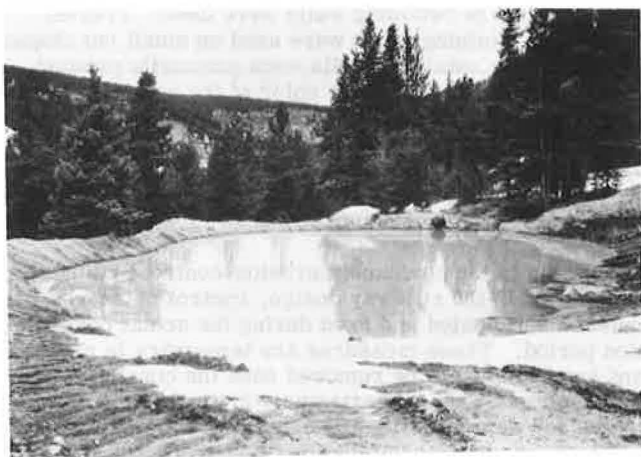
Figure 1. Excavated sediment basin.

Basins constructed by excavating depressions or using natural depressions (see Figure 1) proved superior to ones built with low head dams. Because these basins were located in flatter terrain, access for their con-

struction and maintenance was generally easier. Their simple design did not require the construction and upkeep of a steep dam face. In contrast, the dam-type basins were located in narrow drainages that restricted the movements of construction equipment. Since it was often difficult to achieve adequate compaction, the fill material was allowed to become saturated during the spring runoff and summer rains. Consequently, dam faces would occasionally fail and send large amounts of sediment to downstream areas.

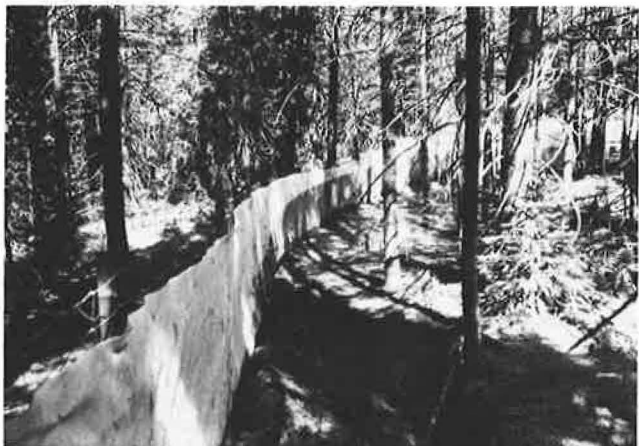
Figure 3. Filter-fence sediment trap.

Another effective and easily transported sediment trap is constructed by using a fabric filter. The fabric is made from filament fibers with randomly distributed pore openings. Water easily passes through the fabric, but soil is trapped. Figure 3 shows how the fabric is attached to a temporary wire fence. The bottom 15.2 cm (6 in) of the fabric is buried in the ground to prevent water from flowing under the structure. Construction runoff water is directed to the filter trap along berms, dikes, plastic-lined ditches, or culverts. For the best results, the water should be dispersed before it en-

counters the filter blanket. Fences in steep, narrow drainage ditches or swales should be avoided. The fabric has little lateral support and cannot withstand a force such as that caused by impounding 0.6-0.9 m (2-3 ft) of water.

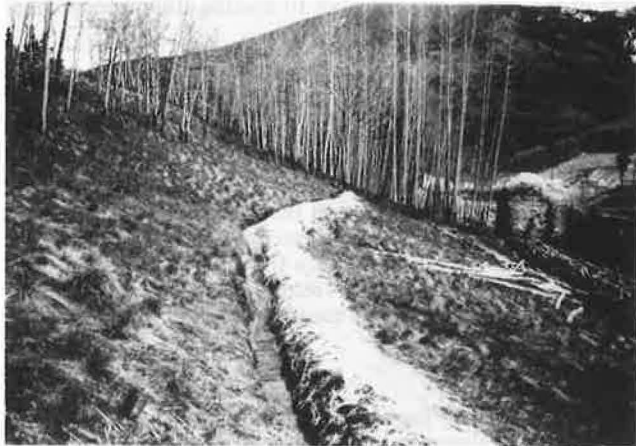
Figure 4. Hand-dug interception ditch above project area.

Hand-dug ditches such as the one shown in Figure 4 proved superior to backhoe trenches. The ditches were usually constructed on side slopes during the early construction season when conditions were wet. Backhoes had a difficult time operating in these conditions, often sliding and rutting the area adjacent to the ditch. It was also difficult to operate them in and around obstacles such as rocks and trees. Hand-dug ditches, on the other hand, had only minimal effects on the terrain and could be constructed through tight places such as forested hillsides.

Once constructed, the ditches held up well. Minor slumping and vegetative overgrowth were evident after one year of use. A jute netting or a similar product was often used to line the ditch at gradients of more than 6 percent to guard against erosion. Drainage was most efficient when gradients ranged from 5 to 8 percent; when gradients were less than that, water ponded and drainage was ineffective. Gradients of more than 10 percent that were not lined with a jute netting caused some scour and minor erosion.

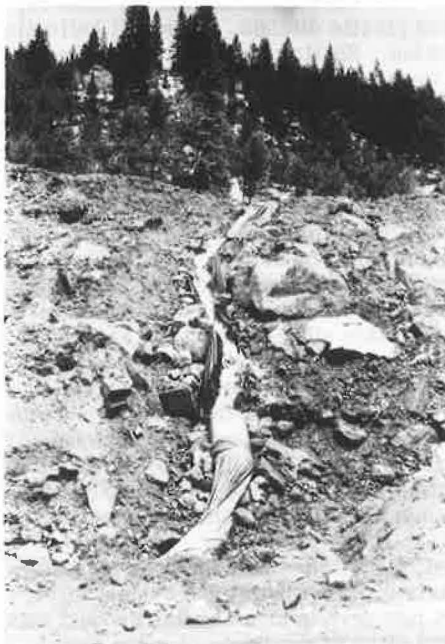
Figure 5. Failure of plastic-lined ditch.

The use of plastic-lined ditches should be limited to diversion projects of short duration. The ditches require constant inspection and maintenance. The plastic is anchored in place by logs, rocks, stakes, or other means. Figure 5 shows how failures occurred at Vail Pass when the plastic slipped beneath its anchor and drainage water spilled on the disturbed soil. The plastic must also be durable so that water flow does not tear it on the irregular channel bottom. The plastic was at least 0.15 mm (6 mils), and preferably 0.35 mm (10 mils), thick.
