*TRANSPORTATION RESEARCH RECORD 717*

**Engineering Solutions  
to Environmental  
Constraints: I-70  
Over Vail Pass**

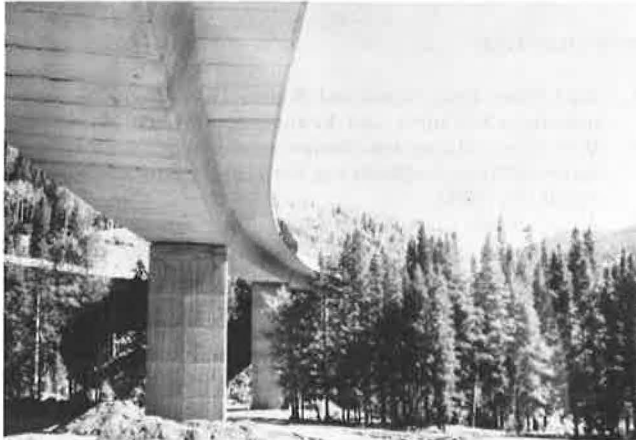
Figure 4. Precast concrete segmental box-girder bridge.

Twenty-one highway bridges in the project were designed so that they could be erected without falsework to minimize construction damage to the terrain. Eight of these were post-tensioned concrete segmental bridges (see Figure 4), 11 were welded steel box-girder bridges (see Figure 5), and 2 were poured-in-place concrete structures.

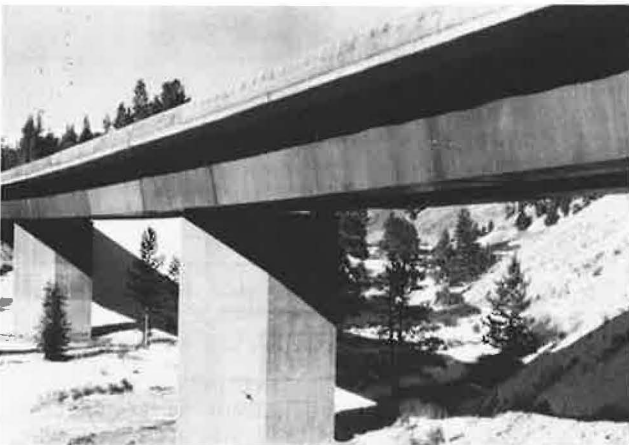
Figure 5. Typical welded box-girder bridge.

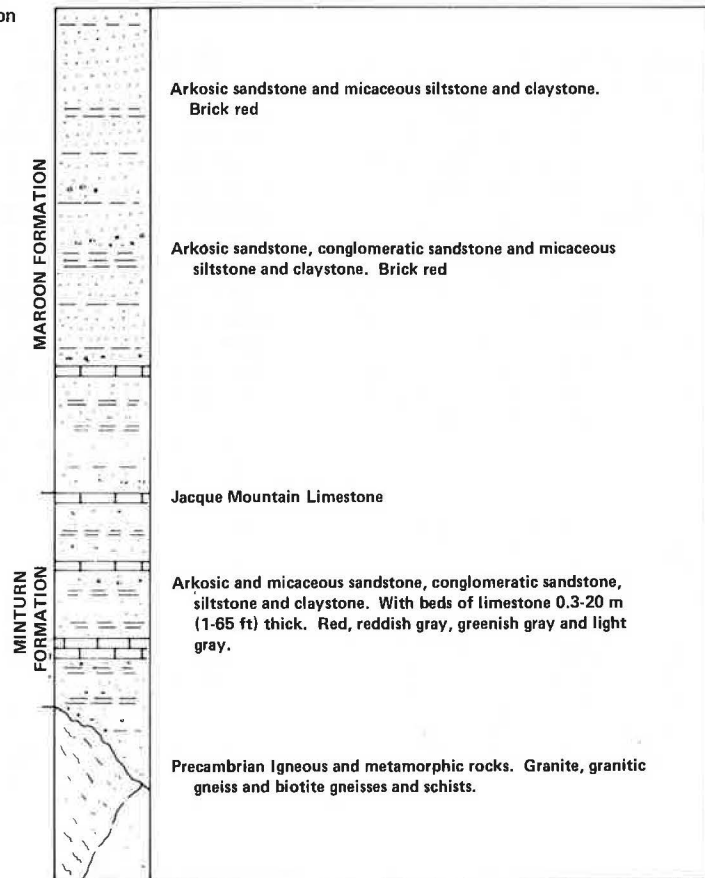
Figure 2. Generalized stratigraphic section of the Vail Pass area.

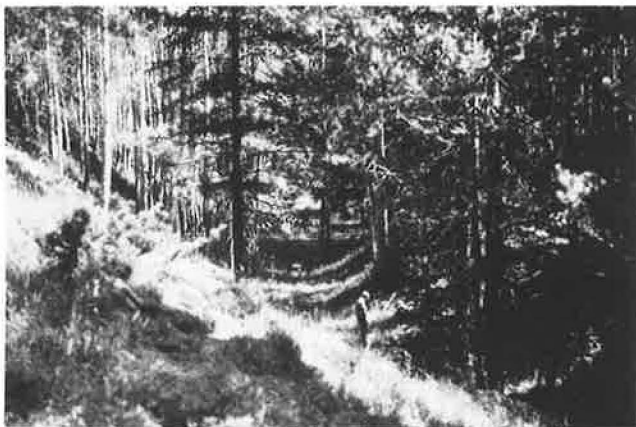
Figure 7. Trees growing in landslide scarp depression.

eter growing within their limits (Figure 7). Other landslides show, as evidence of recent movement, cracks in the sod in the bottom of the depression. Some of these cracks have been probed to depths of more than 5 m (16 ft).

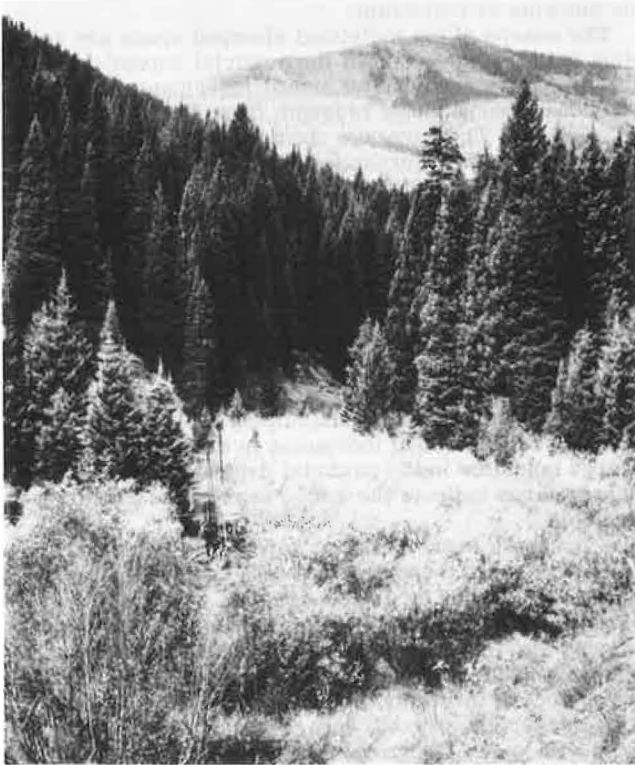
Figure 9. Alluvial deposits as result of damming of stream by landslides.

A landslide in the surficial deposits is the result of the deposition of these deposits on a bedrock slope that was oversteepened by glacial erosion. The deposits were poorly drained at the time of deposition, and many swamps developed. The permeability of the surficial deposits is different in different areas, and numerous springs occur throughout. During much of the year when the surface is not frozen, the deposits are saturated with water. With the spring runoff there is a period of rapid erosion during the time of maximum saturation. This results in minimum stability in a mass of poorly sorted and unconsolidated material on a steep slope, the lower edge of which is at a stream channel. Along Black Gore Creek, downcutting of the creek has not been able to keep up with the movement of the landslides into the valley. The gradient of the creek above the landslides has been lowered and alluvial deposits have formed because the landslides have partially dammed the creek (Figure 9).

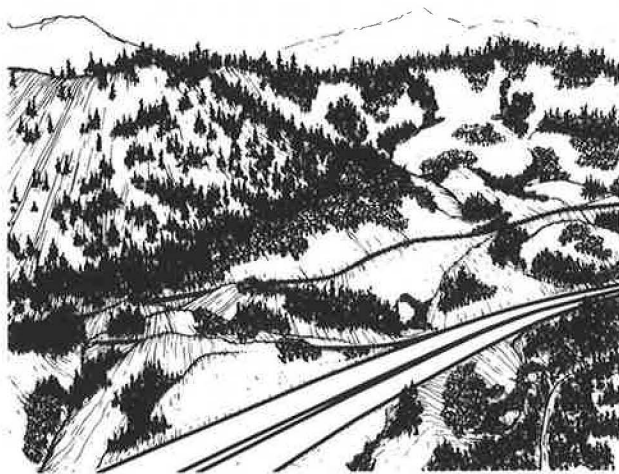
Figure 3. Created landform diversity.

On some large slopes, it was impossible to modify slope characteristics by just laying back draws and accenting ridges. On these slopes, diversity was created by modifying slope ratios and developing false draws and ridges along the slope. Large slopes were rarely left at their 2:1 ratio but were often flattened and rolled to reflect the natural character of the terrain.

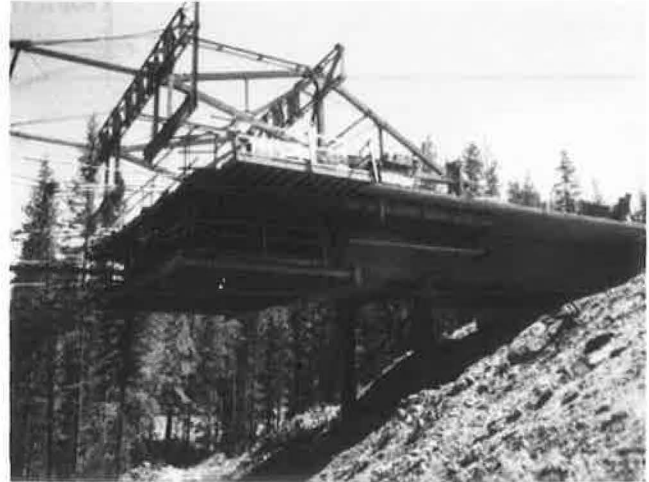
Figure 5. Side-span cantilever construction: bridge AL.

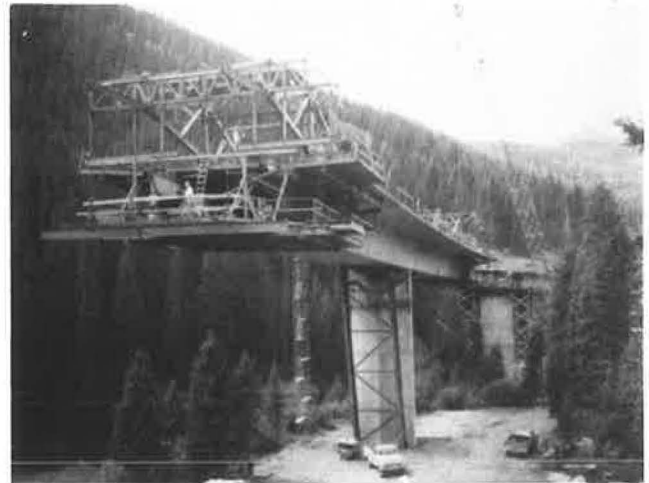
Figure 6. Free cantilevering from center pier: bridge AM.

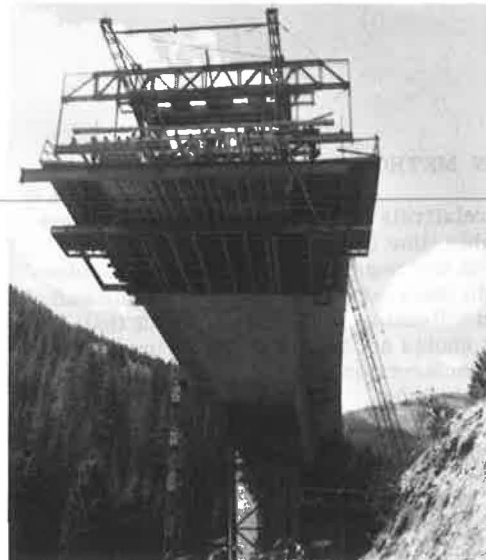
Figure 7. Bottom view of free-cantilevered span: bridge AM.

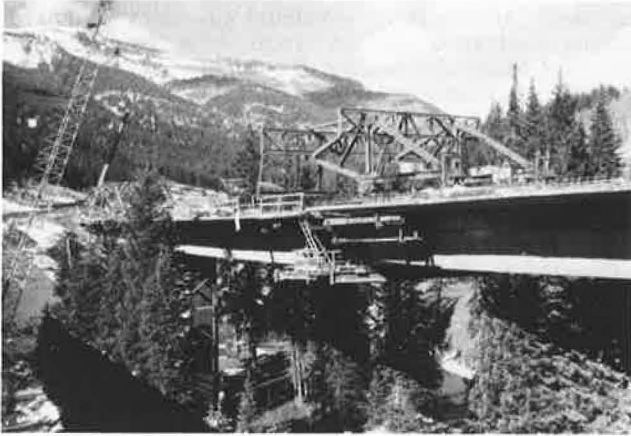
Figure 8. Closure pour after removal of form travelers from other side of bridge: bridge AM.

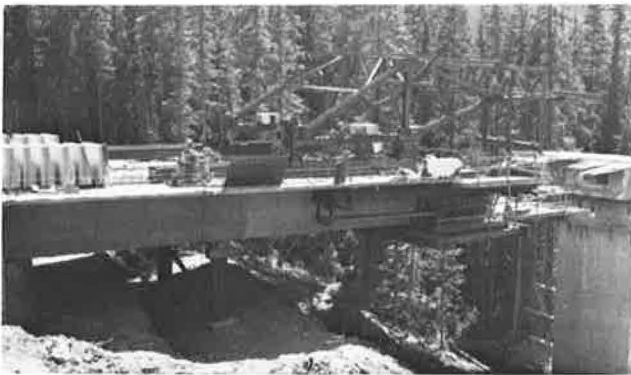
Figure 9. Form traveler.

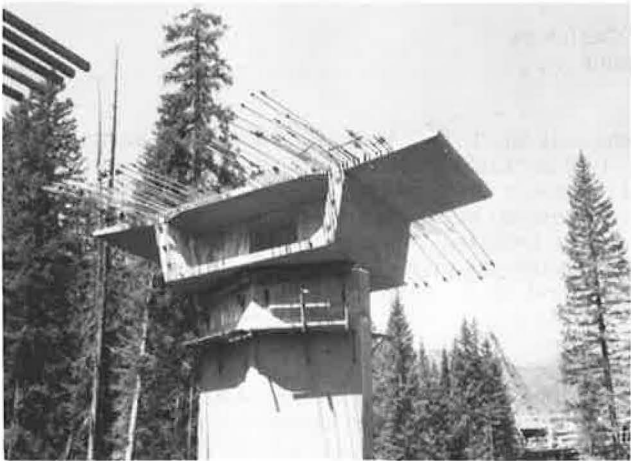
Figure 10. View of pier segment showing typical tendon arrangement: bridge AK.

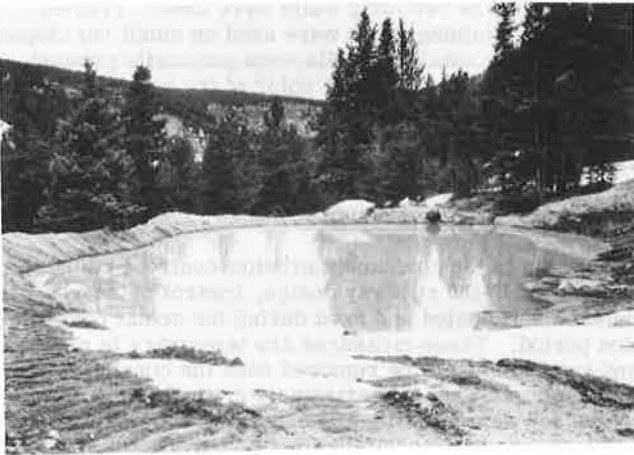
Figure 1. Excavated sediment basin.

struction and maintenance was generally easier. Their simple design did not require the construction and upkeep of a steep dam face. In contrast, the dam-type basins were located in narrow drainages that restricted the movements of construction equipment. Since it was often difficult to achieve adequate compaction, the fill material was allowed to become saturated during the spring runoff and summer rains. Consequently, dam faces would occasionally fail and send large amounts of sediment to downstream areas.

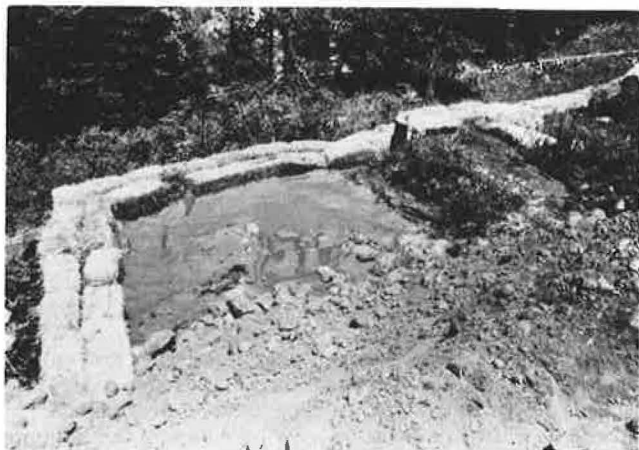
Figure 2. Straw-bale sediment trap.

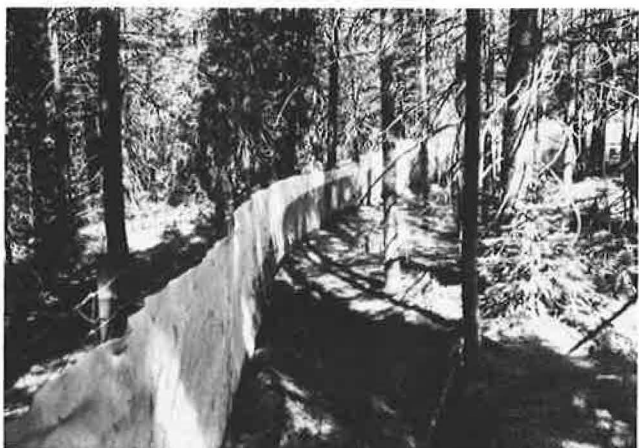
Figure 3. Filter-fence sediment trap.

counters the filter blanket. Fences in steep, narrow drainage ditches or swales should be avoided. The fabric has little lateral support and cannot withstand a force such as that caused by impounding 0.6-0.9 m (2-3 ft) of water.

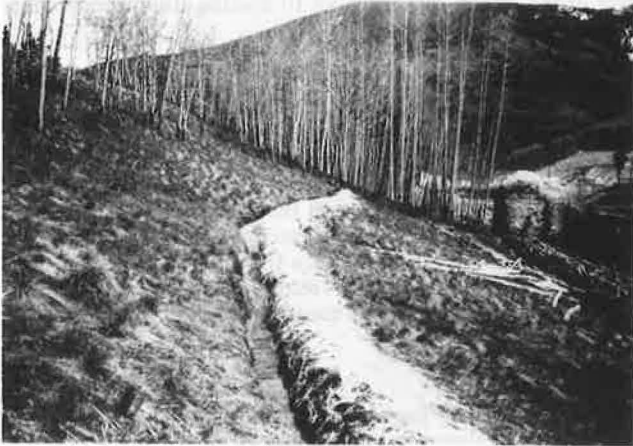
Figure 4. Hand-dug interception ditch above project area.

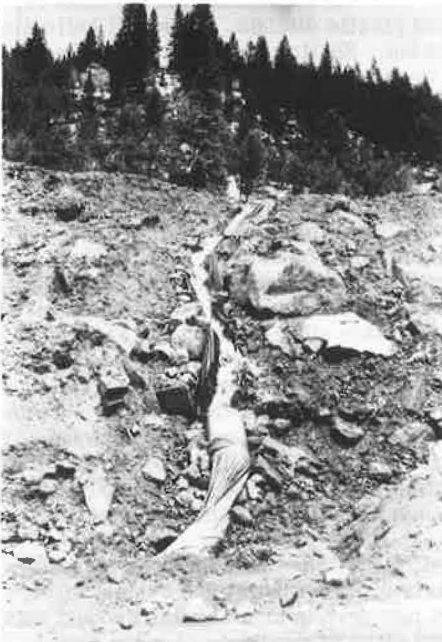
Figure 5. Failure of plastic-lined ditch.

structed by using sandbags at the water source. The impounded water was diverted into an irrigation pipe, a culvert, or flexible plastic down drains and directed through the work area. The water was then discharged into natural drainage courses below the construction site. Collection basins work well if they are inspected and maintained. The inflow pipe must be kept free of debris to prevent overtopping and subsequent erosion. As in the case of other temporary erosion-control structures, a routine maintenance schedule is imperative for collection basins and should be specified in the water-quality plan.
