Comparison of Performance of Wood-Tie Fasteners at FAST

Howard G. Moody

The results of experiments with wood-tie fasteners at the Facility for Accelerated Service Testing are reported. Since the beginning of the use of 91-Mg (100-ton) freight cars, there has been an increasing problem with wood-tie fasteners. The resulting high axle loads have caused an increase in the deterioration of wood ties from spike killing and tie-plate cutting and have taxed the cut-spike fastener to the limit in preventing rail rollover and wide gage. The objective of the wood-tie fastener tests at the Facility for Accelerated Service Testing is to find an alternative to the cut spike that would alleviate some of the problems that have occurred in revenue service. Two test cycles have been completed, and a third is currently being run. In the first test, an excessive amount of rail wear, attributed to high flanging forces and a lack of effective lubrication, resulted in two rail transpositions. The rail was regaged each time, which eventually "spike killed" the ties. In the second test, in the elastic-clip segments, a large number of the hold-down fasteners failed, which resulted in wide gage. This led

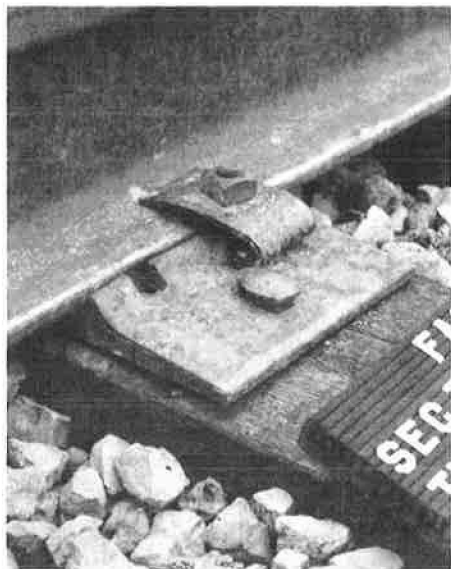
Figure 7. Compression-clip assembly.

The first component test that had to be terminated was associated with segments 2 and 6. The compression-clip bolt (see Figure 7 for installation) loosened, and the clip backed out of the tie plate and came off the rail. Sixteen clips out of 488 were removed by hand on March 9, 1979. In the next two months, several other clips backed out. Since it was difficult to re-apply them, it was decided to terminate the test in segments 2 and 6.

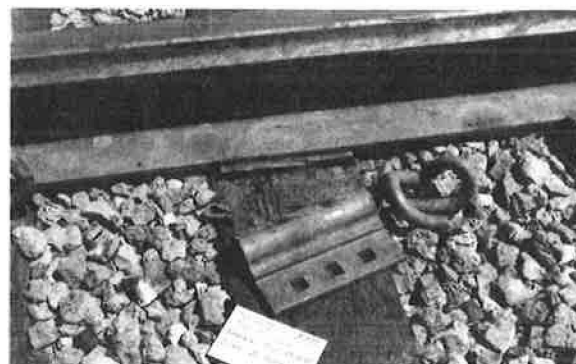
Figure 9. Failure of elastic-clip plate.

Figure 10. Failure of elastic-clip plate in track.

at 141 million Mg (155 million tons)], a few elastic-clip plates began to fail. These bending failures occurred at the lead edge of the plates where the outside of the rail edge contacted the plate (see Figures 9 and 10). As data given in Table 2 show, 65 of these failures occurred out of a sample population of 732 plates. Forty-one of the failures occurred in cut-spike segments 4 and 8. These were the original plates from the first test. By the time the second test was terminated, they had almost 12 million load cycles on them. There were not enough failures to determine a characteristic curve on the plate but, in contrast, over an accumulation of 213 million Mg (235 million tons), 38 AREA tie plates out of a lot of 22 120 failed.

It is not known whether or not these failures have occurred at all in revenue service and, since the choice of the hold-down fastener may have contributed to the failures, it is difficult to say whether or not this would occur outside of FAST. However, the manufacturer has since redesigned the plate to considerably increase the cross-sectional area in which the fractures occurred. These new plates should perform substantially better.

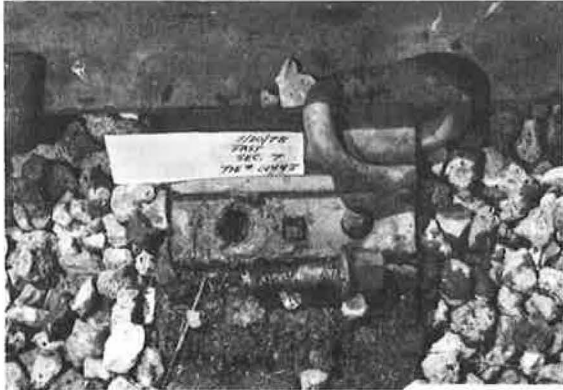
Figure 11. Failed screw spike.

The majority of the fractured screw spikes, drive spikes, and cut spikes failed in bending about 5-7.6 cm (2-3 in) below the head of the spike. When these failures occurred, the stub end of the spike was driven through the tie and a resin tie filler was used to fill the hole as a new spike.

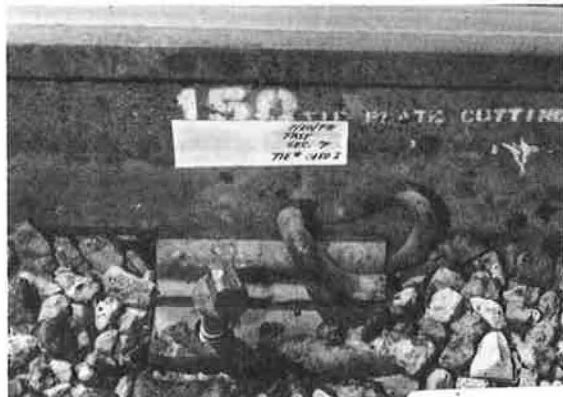
Figure 12. Screw spike out more than 2.5 cm (1 in).

Beginning at 36 million Mg (40 million tons), the hold-down fasteners in elastic-clip segments 3, 4, 5, 7, 8, and 9 began either to work out of the tie or to fail. A complete tabulation of these problems is given in Table 2. These problems were most pronounced in screw-spike segments 3 and 7. In a period of 127 million Mg (140 million tons), 173 of 484 spikes in these segments either failed (see Figure 11) or came out of the tie more than 2.5 cm (1 in) (see Figure 12). A plot of the failure rate is shown in Figure 13. At about 118 million Mg (130 million tons), the failure rate began to escalate, eventually causing the test to be terminated at 128 million Mg (141.1 million tons).
