Construction of a Root-Pile Wall at Monessen, Pennsylvania

Umakant Dash and Pier Luigi Jovino

A case history of the design, analysis, construction, and performance evaluation of a root-pile wall is presented in this paper. The root-pile wall was contracted for construction by the Pennsylvania Department of Transportation to correct a landslide near Monessen. The structure consisted of four hundred and fifty-eight 12.5-cm (5-in) diameter cast-in-place concrete piles placed at different inclinations to both the vertical and the horizontal axes. The piles were connected at the top by a 76.2-cm (30-in) thick by 1.82-m (6-ft) wide cap beam constructed in two 30.48-m (100-ft) sections. The cap beam was constructed first, and the root piles were then installed by extending drill holes through the cap beam to bedrock at predetermined locations and inclinations, inserting a single no. 9 deformed reinforcing steel bar (grade 60) into each drill hole, and grouting the holes. Nine survey targets were marked at the top of the cap beam to measure both horizontal and vertical movements and seven slope inclinometers were installed at various points both upslope and downslope from the structure t

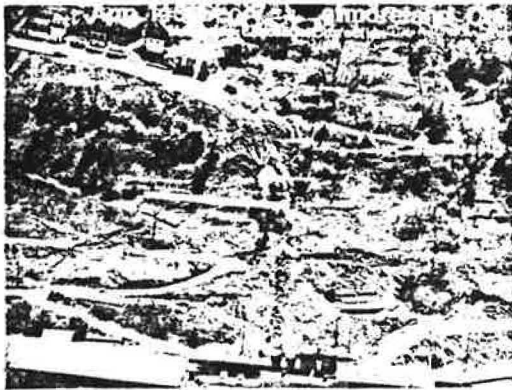
Figure 2. Aerial photograph of site.

Figure 2 is an oblique aerial photograph taken soon after the failure and shows the general site conditions, the scarps, the acid mine-drainage channel, the location of a water pipe, and the location of the root-pile wall. The overburden soils (fill and colluvium) consisted of silty clays and clayey silts (AASHO A-6 and A-7) intermixed with rock fragments, cinders, and building materials.

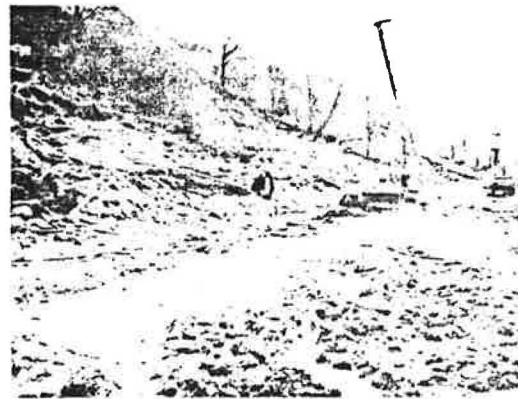
Figure 6. Drilling of holes through cap beam and preparation for grouting.

Figure 7. Drilling operation.

the inclined holes were drilled. Most of the vertical holes were grouted before inclined holes were drilled. Figures 6 and 7 show the drilling operation, and Figures 8 and 9 show the mixing and grouting operations. The construction of the root pile was completed in April 1979.

Immediately after the holes were drilled through the cap beam, they were cleaned by using air pressure and a no. 9 reinforcing steel rod was placed in the drill hole. The grout was then poured into the hole until it was completely filled. No external pressure was applied to the grout during the grouting operation.

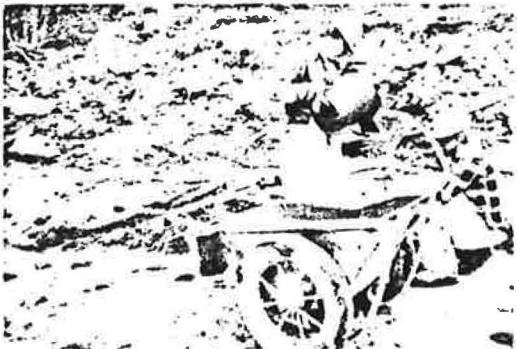
Figure 8. Mixing of grout.

Figure 9. Grouting under gravitational pressure.

The grout mix consisted of 1 bag of cement, 22.7 L (6 gal) of water, and 0.071 m³ (2.5 ft³) of sand.

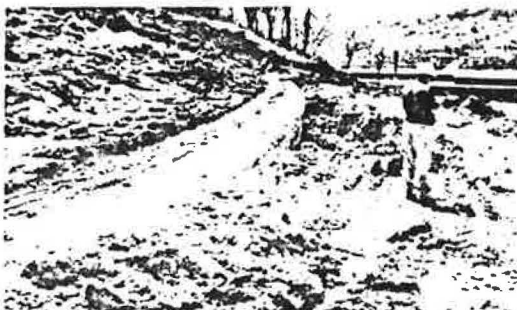
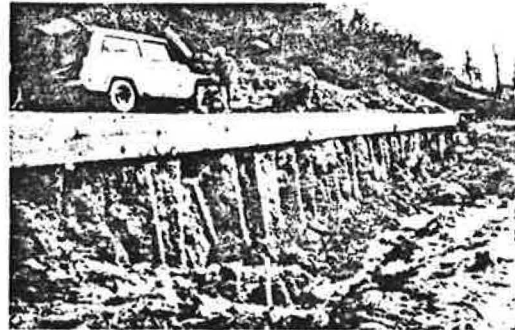
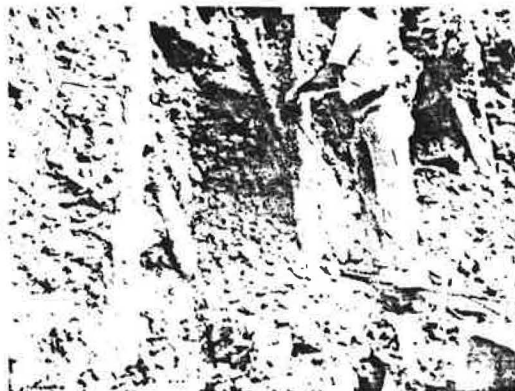
Figure 10. Soil movement during excavation downslope from root-pile wall.

During the excavation for the northbound lanes downslope from the wall, the slope between the wall and the northbound lanes failed. This failure occurred during the second week of April 1979. Figures 10-13 show the

Figure 11. Additional movement that broke slope inclinometer pipes below wall.

Figure 12. Broken root piles.

Figure 13. Testing of piles for soundness.

failed slope, as well as the condition of the root piles after the slope failure.

It was then decided to remove the entire failed slope in front of the root-pile wall and reconstruct the slope at a gradient of 2.5 horizontal to 1 vertical, using a well-compacted fill and a 1-m (3-ft) thick layer of granular material against the root-pile wall.

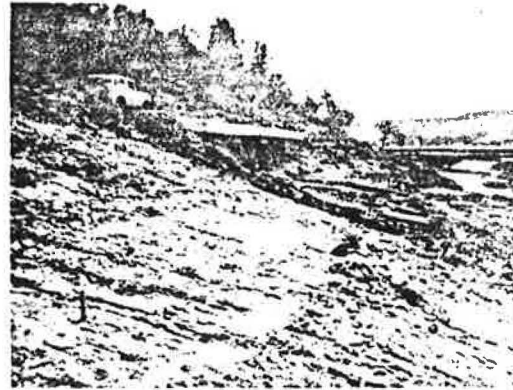
Figure 14. Slide conditions near large water pipe and removal of failed soil.

Figure 15. Root-pile wall after removal of downslope failed soil.

Figure 16. Completion of downslope soil removal.

The drainage ditches were dug at right angles to the wall to drain a significant amount of the water that had ponded at the bottom of the exposed part of the wall and to serve as a permanent drainage system. Figures 14-17 show the general conditions after removal of the soil within the failed slope. Figure 18 shows the drainage ditch filled with stone.

Figure 17. General view before reconstruction.

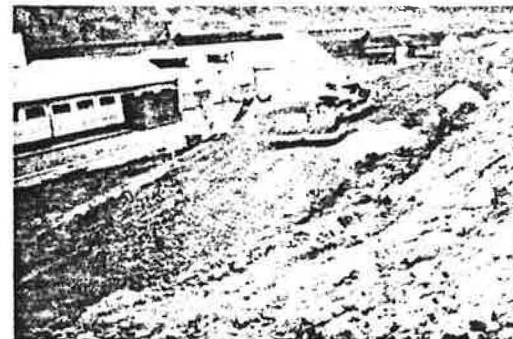
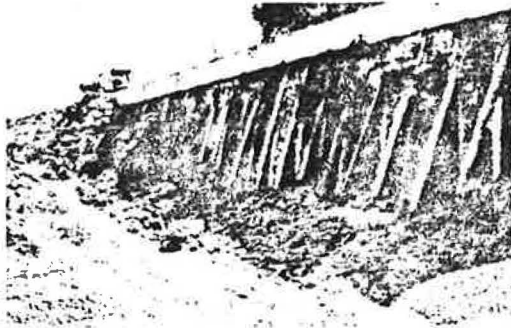
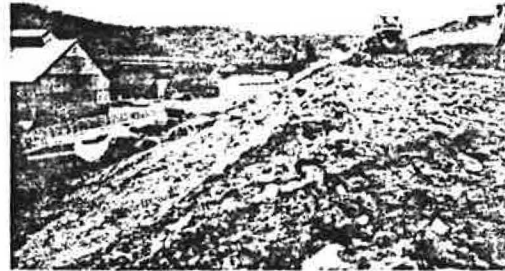
Figure 19. Beginning of reconstruction.

The reconstruction work, particularly the compaction near the root-pile wall, had to be done with special care so as not to damage the piles. Figures 19-22 show the conditions during reconstruction in front of the wall.

Figure 20. Placement of granular material against root-pile wall.

Figure 21. Placement of fill next to root piles.

Figure 22. Reconstructed fill in front of root-pile wall.
