Sealing Joints and Cracks, Thin Resurfacing, and Locating Voids Under Concrete Slabs

TRANSPORTATION RESEARCH BOARD

Transportation Research Record 752

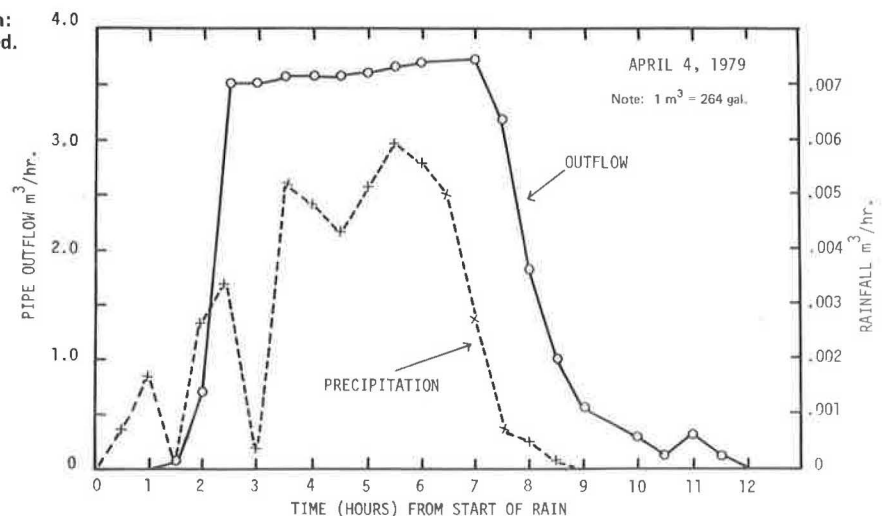
Figure 10. Edge-drain outflow and precipitation: transverse joints sealed, shoulder joints not sealed.

in Figure 10. This graph indicates the capability of the edge-drain system to remove large volumes of water in a relatively short time after the commencement of rainfall. It also points out the need for proper sealing of all joints and cracks to prevent water from infiltrating the area under the pavement in the first place.

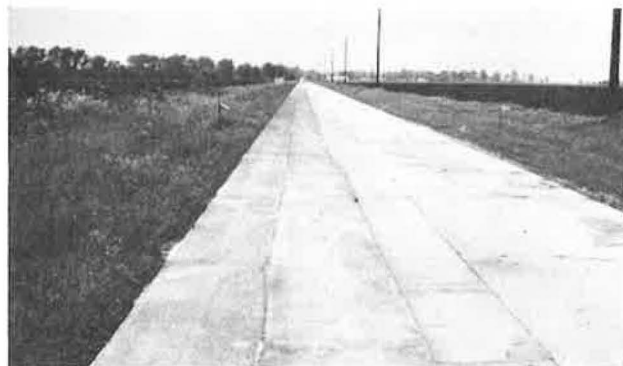
Figure 1. View of test site showing test strips in place on left side of pavement.

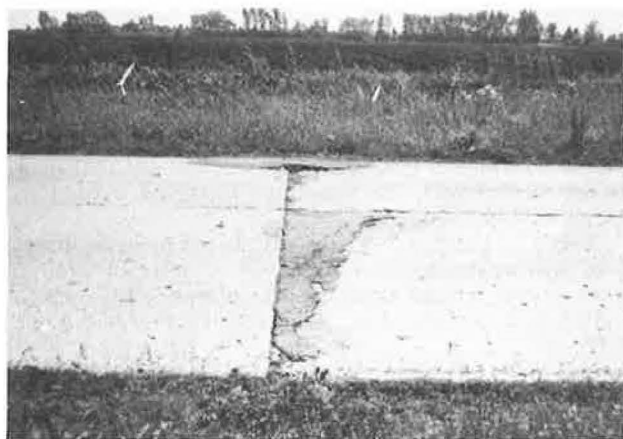
Figure 2. Bituminous patch on existing pavement before overlay.

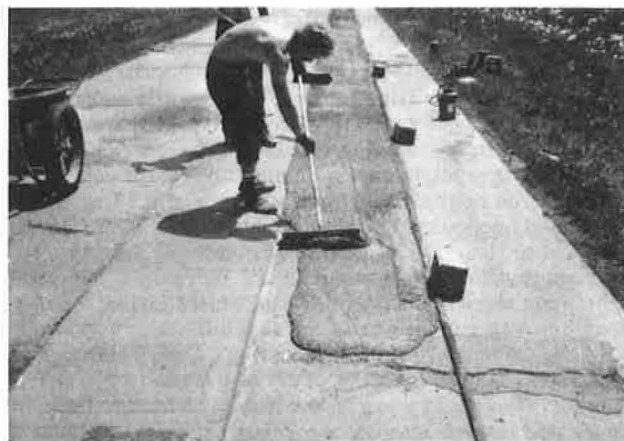
Figure 5. Brooming mortar onto old pavement surface.

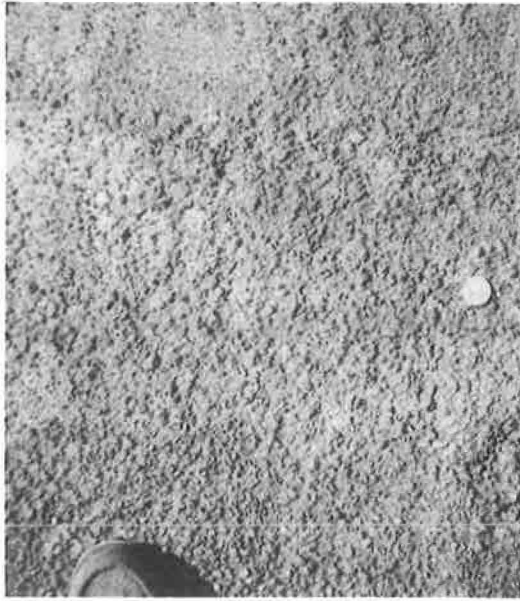
Figure 6. Texture of broomed overlay.

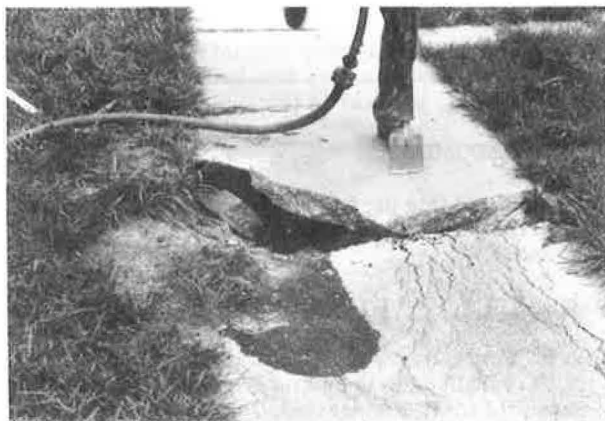
Figure 1. Severe sidewalk undermining.
