Durable Pavement-Marking Materials

HENRY J. GILLIS

Work done by the Minnesota Department of Transportation during the past 10 years to develop and evaluate a durable yet economical road-stripping material is described. The development of equipment capable of applying a two-component epoxy resin is discussed. Epoxy, polyester, and thermoplastic resins and their cost-effectiveness are evaluated. Field evaluation of the various materials consisted of visual observations, photographs, macrophotographs, and measurements of retroreflectivity. The available data suggest that epoxy can be placed on a high-volume bituminous or portland cement concrete roadway, at a thickness of 10 mils, and provide adequate delineation for 12 months or longer while remaining as economical as paint. The polyester material did not adhere well to portland cement concrete and the aggregate in the bituminous pavement. Thermoplastic was found to be generally

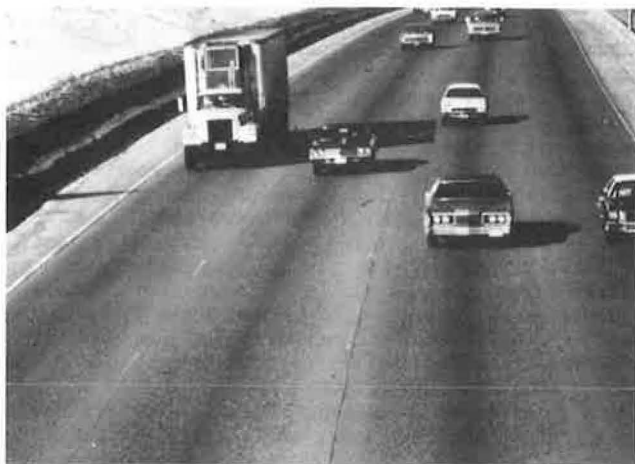
Figure 1. Typical midwinter delineation conditions on high-ADT roadway in Minnesota.

To understand the work done in this study, it is essential to proceed chronologically and to begin with the initial reasons for the use of durable pavement-marking materials in Minnesota. Figure 1 shows the typical condition of high-volume roadways

in Minnesota in late December when conventional traffic paint is used: Very little, if any, delineation is visible. The inability of any material to remain throughout a winter is the main reason the Minnesota Department of Transportation (DOT) became interested in developing a more durable pavement-marking material.

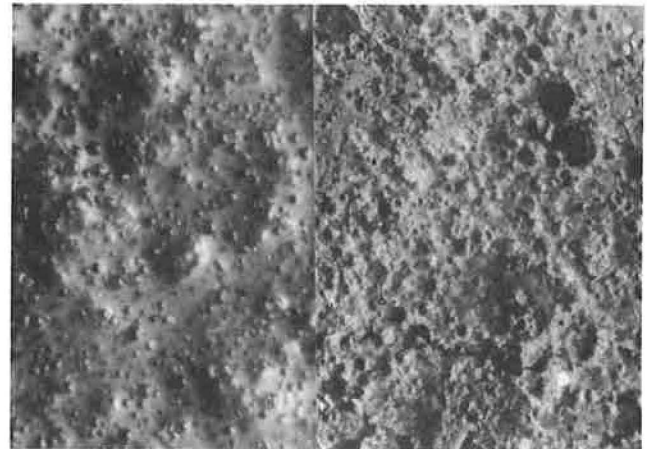
Figure 9. Thermoplastic: new and one year old.

Figures 6-9 are composite macrophotographs (about eight times actual size) of conventional traffic paint and the three durable materials, new and after one or two winters of use. Figure 6 shows a conventional traffic paint. In Figure 7, which shows a polyester resin, sufficient beads remain after two years to produce an acceptable retroreflective value. Unfortunately, the "It doesn't look too good--paint it" philosophy prevailed, and the majority of the material was overstripped after one year. Figure 8 shows an epoxy resin that continued to exhibit acceptable retroreflective value after two years. In Figure 9, which shows thermoplastic, very few glass beads remain after one year, and many pieces of filler crystals have been exposed by snowplowing. The material placed on the high-ADT urban system was 90 percent removed by spring. The retroreflective qualities were virtually nonexistent after one winter's service, and a moratorium was placed on the use of thermoplastic pavement-marking materials in Minnesota.
