TRANSPORTATION RESEARCH RECORD 762

**Corrosion,
Cathodic Protection,
Aggregate Upgrading,
Concrete Density, and
Pavement Markings**

DECISION CRITERIA FOR THE REHABILITATION OF CONCRETE BRIDGE DECKS D. G. Manning and J. Ryell	1
SUCCESSFUL APPLICATION OF CATHODIC PROTECTION TO A CONCRETE BRIDGE DECK H. F. Fromm	9
NEW APPROACH TO CATHODIC PROTECTION OF BRIDGE DECKS AND CONCRETE STRUCTURES J. P. Nicholson	13
CATHODIC PROTECTION FOR CONTINUOUSLY REINFORCED CONCRETE PAVEMENT IN MINNESOTA R. G. Tracy	17
STUDY OF ADHESIVE-BONDED COMPOSITE CONCRETE-METAL DECK SLABS Dana J. McKee and John P. Cook	22
EVALUATION OF THE DURABILITY OF METAL DRAINAGE PIPE Richard W. Kinchen	25
MOTOR-VEHICLE CORROSION FROM DEICING SALT Frank O. Wood	32
DURABLE PAVEMENT-MARKING MATERIALS Henry J. Gillis	36
UPGRADING OF MARGINAL AGGREGATES FOR IMPROVED WATER RESISTANCE OF ASPHALT CONCRETE James G. Chehovits and D. A. Anderson	46
PRELIMINARY STUDY OF COATINGS AND IMPREGNANTS FOR UPGRADING FROST-SENSITIVE AGGREGATES Philip D. Cady, Paul R. Blankenhorn, and Donald E. Kline	53

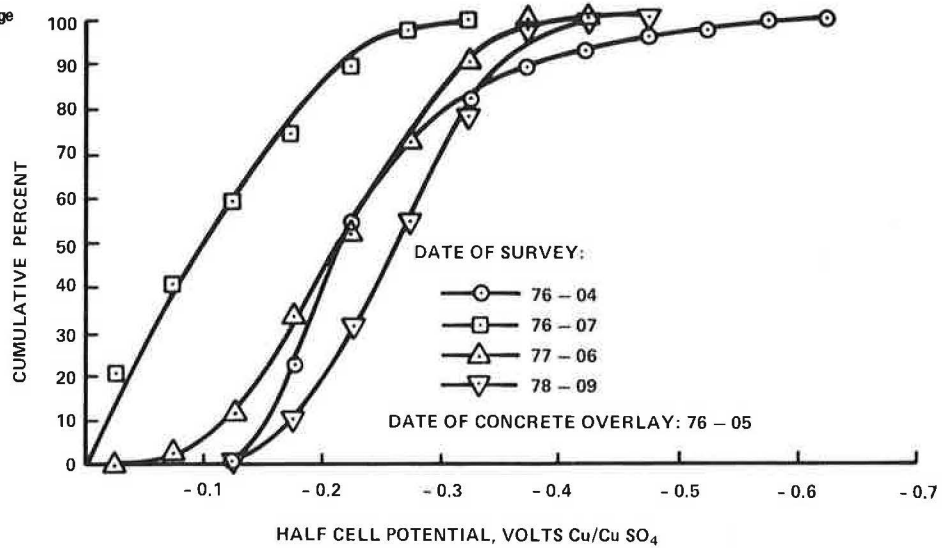
Figure 1. Corrosion potentials at Interchange 4, Ontario 401.

The first low-slump concrete overlay in Ontario was placed in May 1976 and has been monitored regularly. The results of the annual half-cell surveys are shown in Figure 1. The results are presented in the form of cumulative frequency distribution curves, a convenient method of

Although Figure 1 shows the curve for the 1978 survey to be to the right of the curve representing the original deck survey, the area of the deck that exhibits active corrosion (more negative than -0.35

Other decks that have been given either a low-slump or a latex-modified concrete overlay have been monitored and found to exhibit trends similar to those shown in Figures 1 and 2, which can be considered to represent the range of the conditions recorded. Other authorities have reported a similar

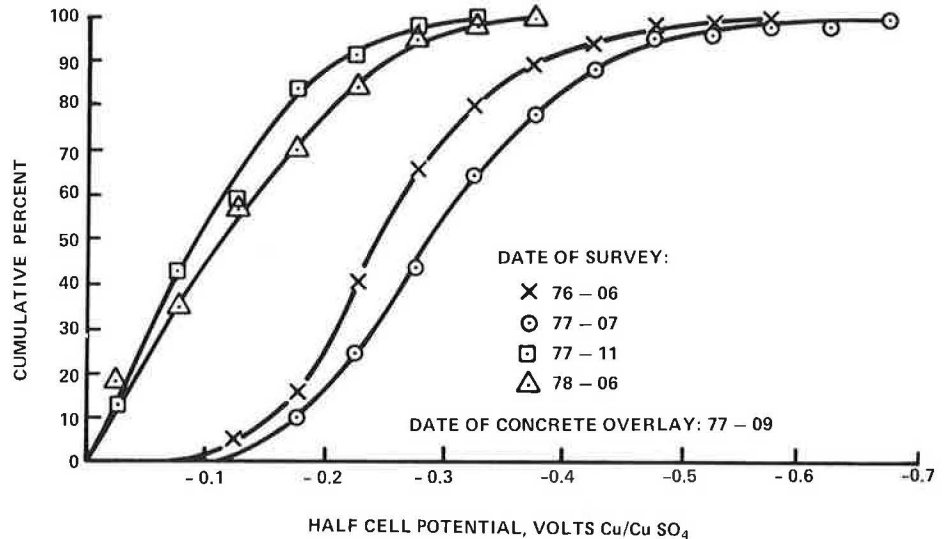
Figure 2. Corrosion potentials at Englehart River Bridge, Ontario 66.

The results of half-cell surveys on a badly deteriorated deck to which a low-slump concrete overlay was applied in 1977 are shown in Figure 2. Two surveys made prior to overlay are shown, and the measurements demonstrate the significant increase in corrosion activity that occurred between 1976 and 1977. Figure 2, like Figure 1, shows a sharp reduction in corrosion activity after construction of the overlay, but in Figure 2 the increase in corrosion in the second year is only slight. Because the deck represented in Figure 2 was considerably more deteriorated than that represented in Figure 1, a greater portion of the reinforcing steel was surrounded by new concrete, and this may account for the slower rate of increase in corrosion activity.

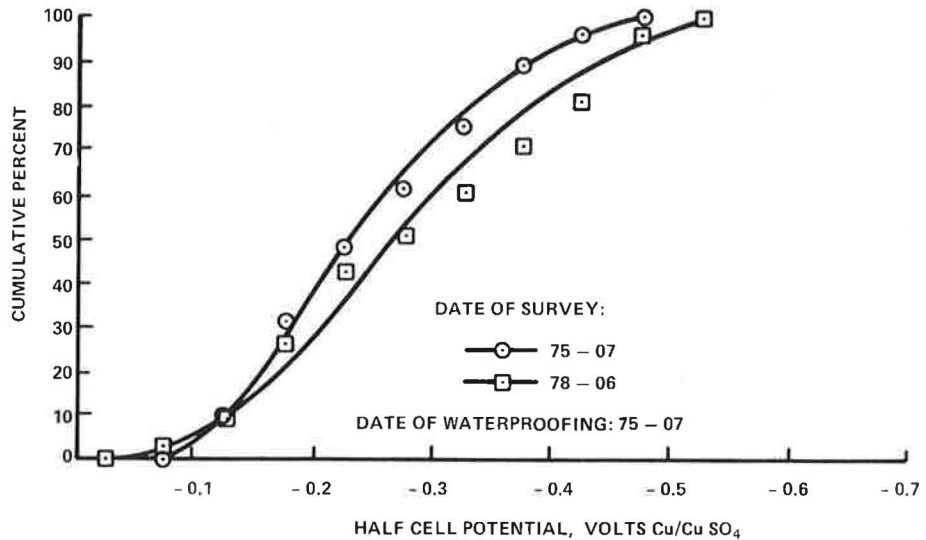
Figure 3. Corrosion potentials at Nith River Bridge, Ontario 401.

When the Nith River bridge (Figure 3) was examined in 1975, extensive areas of delamination were recorded. These were associated with areas of inadequate cover to the reinforcing steel. The cover varied between 20 and 60 mm (0.75 and 2.375 in) and averaged 35 mm (1.38 in). Delaminated concrete was removed, and concrete patches were placed in the spalled and delaminated areas. The deck on the Canadian Pacific Railway (CPR) structure (Figure 4) was in good condition in 1975 and free from delamination. The cover varied between two isolated readings of 25 mm (1 in) and a high of 70 mm (2.75 in) and averaged 55 mm (2.2 in).

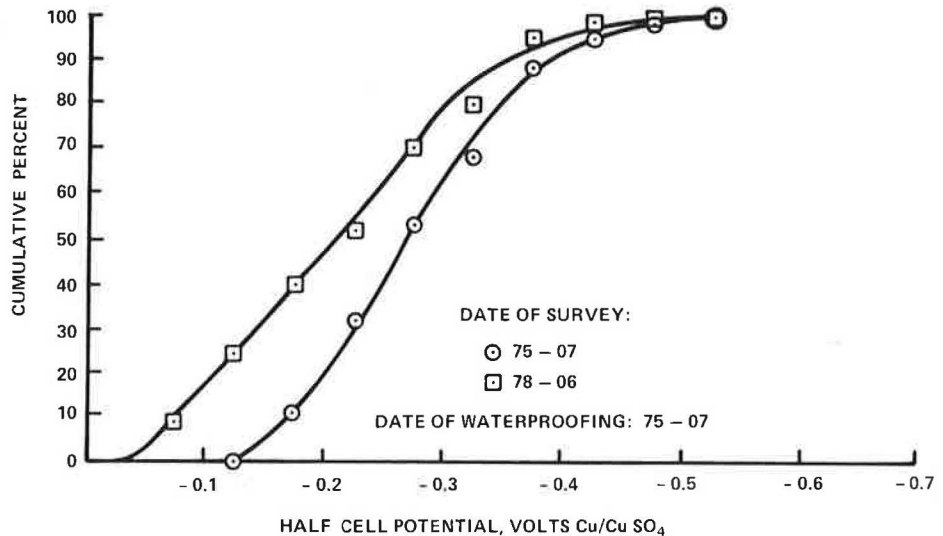
Figure 4. Corrosion potentials at CPR overhead, Ontario 401.

The opposite effect has occurred on the CPR structure, in which there has been a reduction in corrosion activity since the deck was waterproofed.

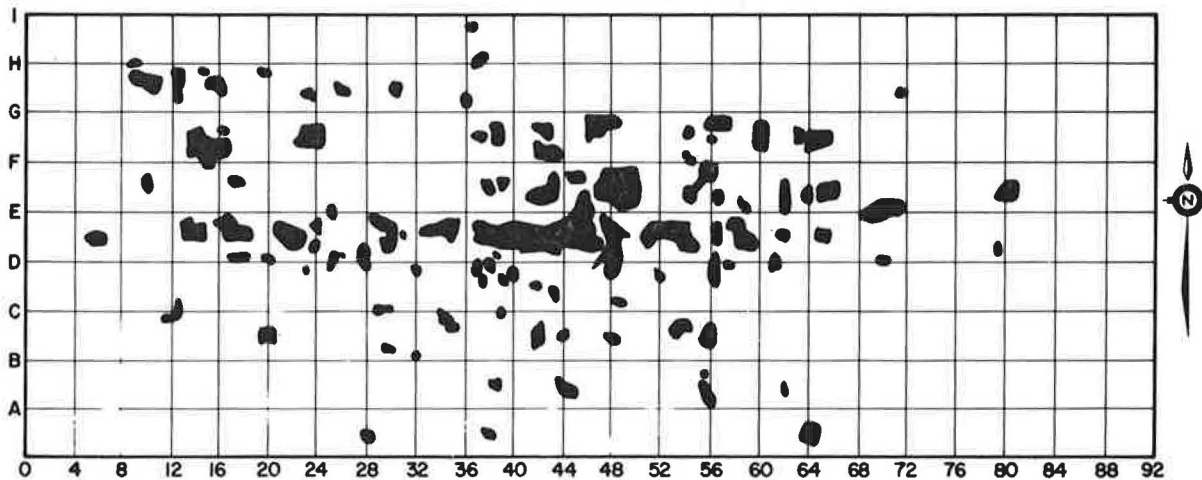
Figure 1. Spalling and delaminations in Duffins Creek bridge deck.

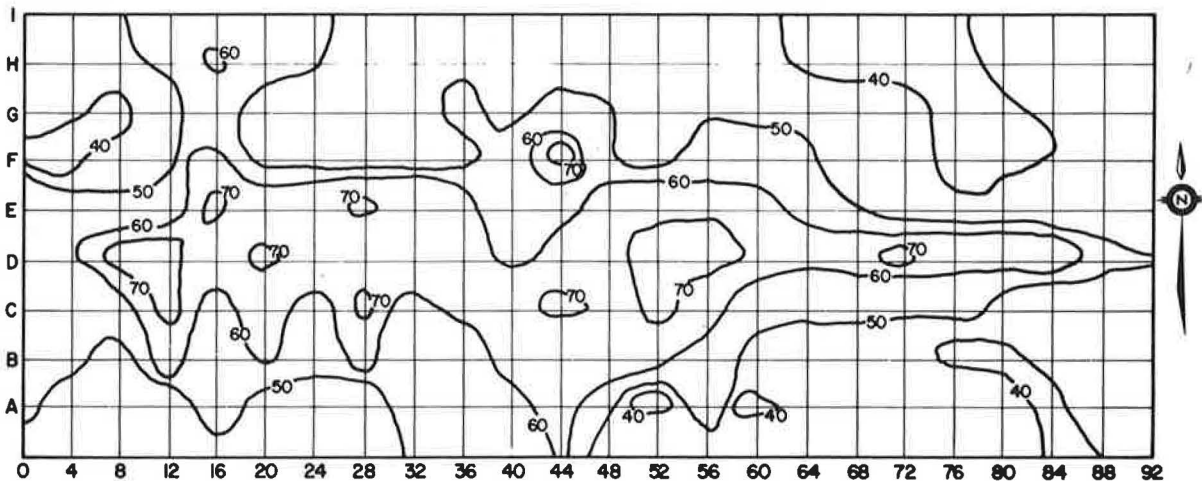
Figure 2. Copper half-cell potentials in Duffins Creek bridge deck.

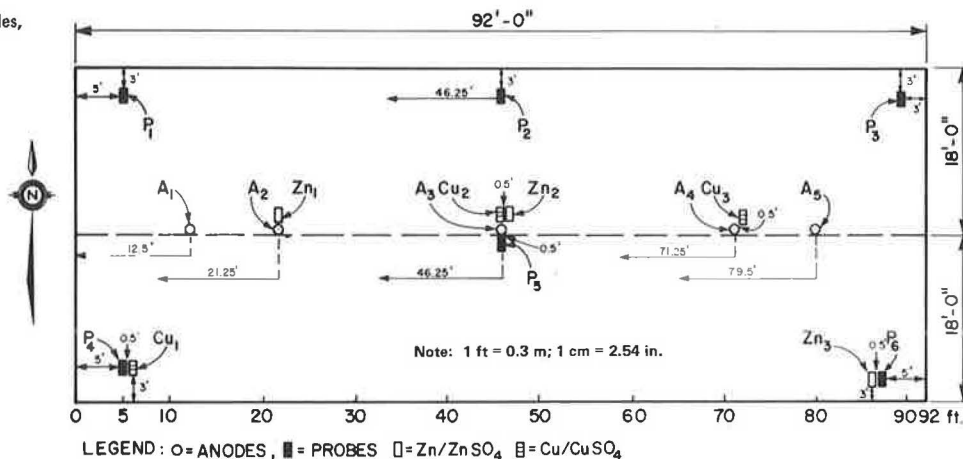
Figure 3. Placement of anodes, probes, and half-cells.

The layout of the anodes, voltage probes, and half-cells is shown in Figure 3. The design called for three anodes down the centerline--anodes 1, 3, and 5 in Figure 3. These are connected in parallel to the main bus, which in turn runs to the power supply. Anodes 2 and 4 are connected to a secondary bus. These were also installed in the event of unforeseen problems. Anodes 2 and 4 can be run separately or in addition to those on the main bus.

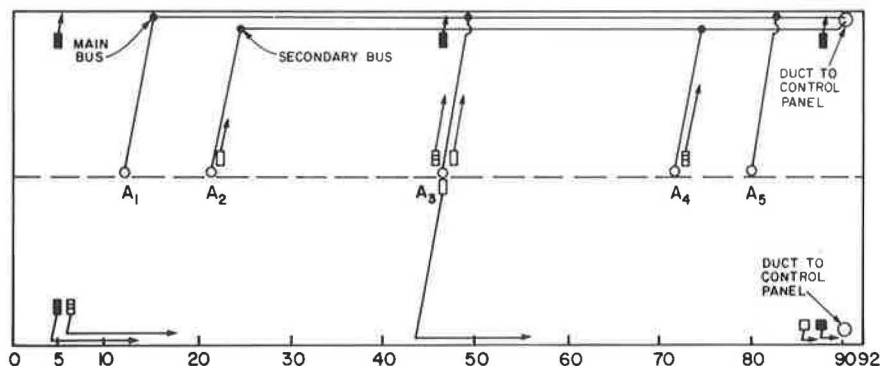
Figure 4. Wiring diagram.

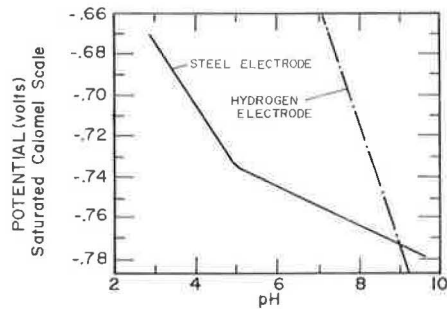
Figure 1. Potential of steel in air-free soils versus soil pH.

ferred to the copper/copper sulfate (Cu/CuSO₄) electrode (see Figure 1). This does not necessarily mean that the criteria in the NACE standard can be used as an indication of satisfactory protection of steel embedded in concrete in the presence of chloride ions.

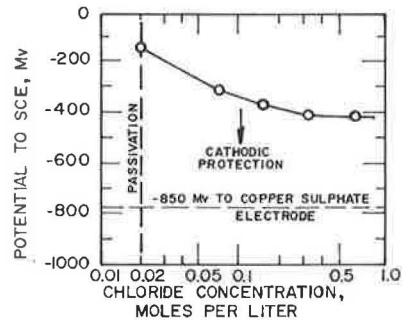
Figure 2. Critical polarization potential for cathodic protection of steel in saturated lime solutions containing sodium chloride.

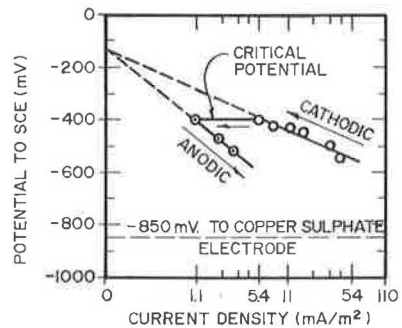
Figure 3. Characteristic change in current during cathodic depolarization of steel in saturated lime solution containing 4.4 percent sodium chloride.

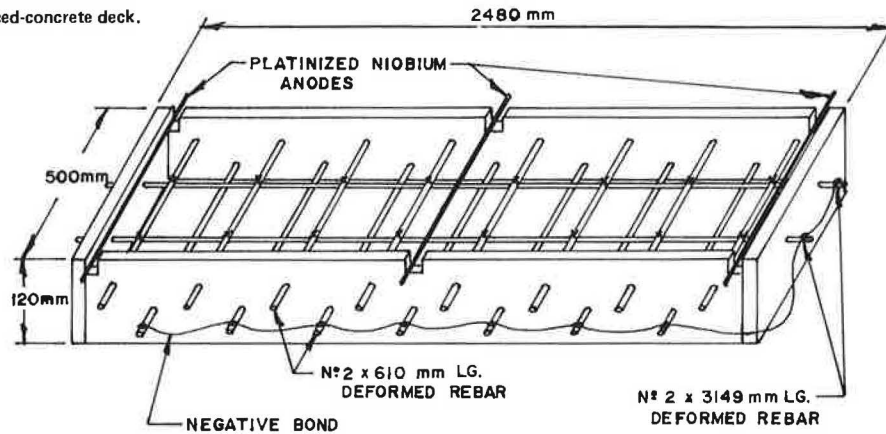
Figure 4. Model reinforced-concrete deck.

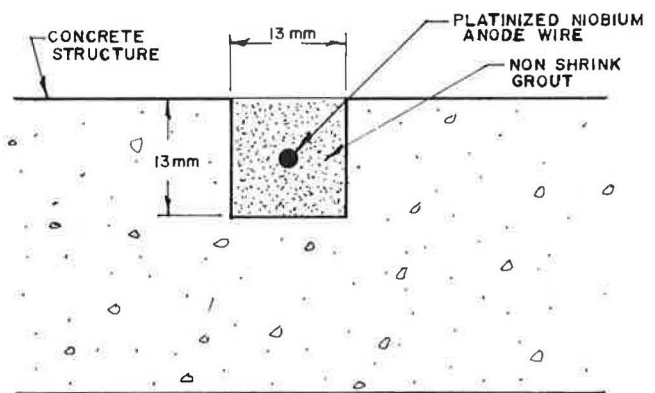
Figure 6. Installation of anode wires in saw slots.

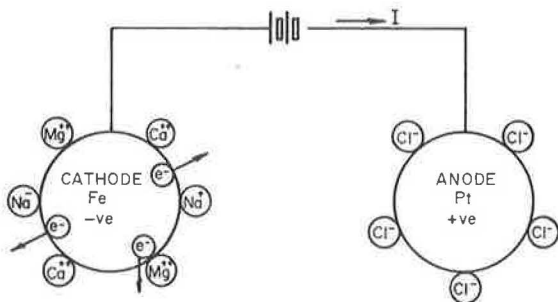
Figure 7. Cathodic protection system operating in presence of chloride ions.

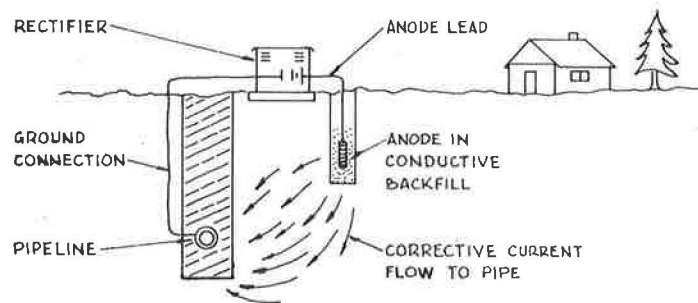
Figure 2. Pipeline cathodic protection system.

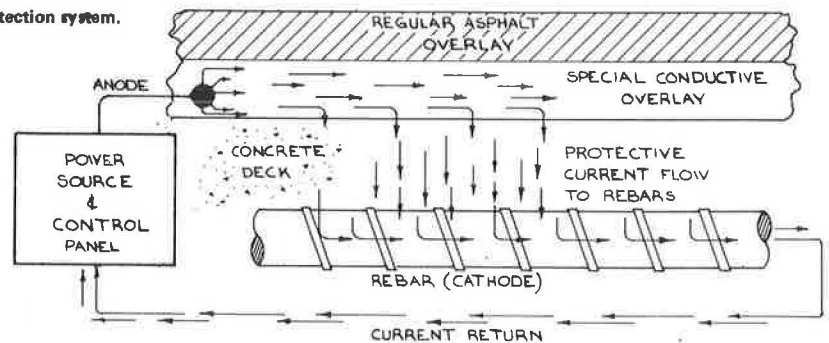
Figure 3. Bridge-deck cathodic protection system.

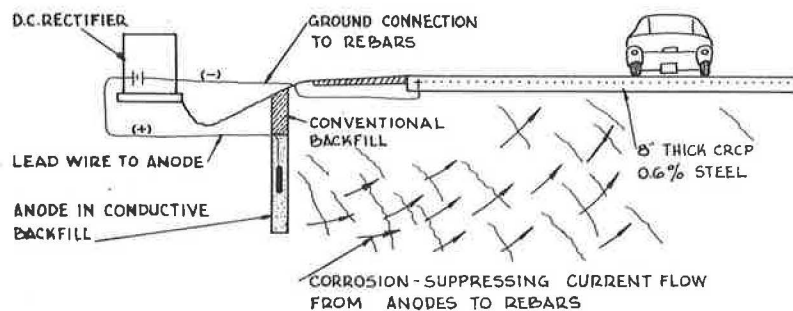
Figure 4. Cathodic protection installation for CRCP.

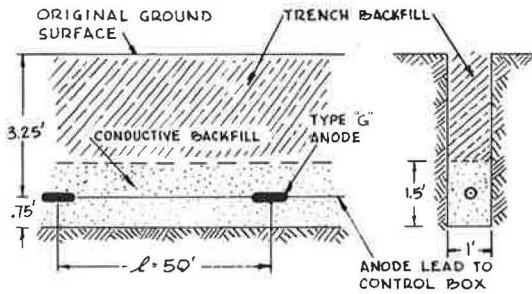
Figure 5. Trench method of cathodic protection for CRCP.

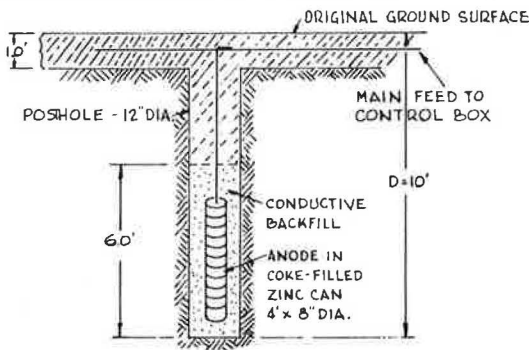
Figure 6. Posthole method of cathodic protection for CRCP.

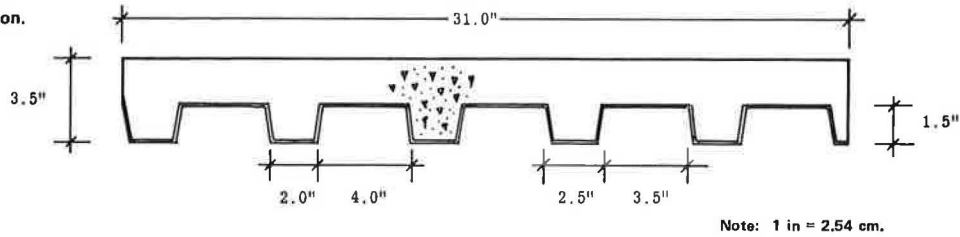
Figure 1. Specimen cross section.

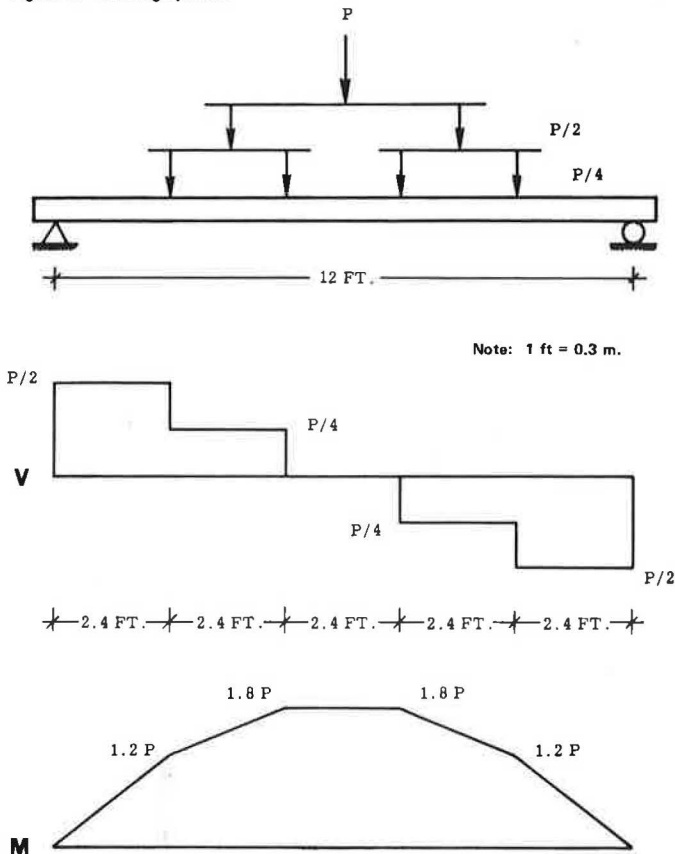
Figure 3. Loading system.

The specimens were loaded as simply supported beams with a span of 3.66 m (12 ft). The loading was applied as four equal line-load concentrations, equally spaced along the span. This loading simulated a uniform load condition and provided a very small shear-free region at midspan.

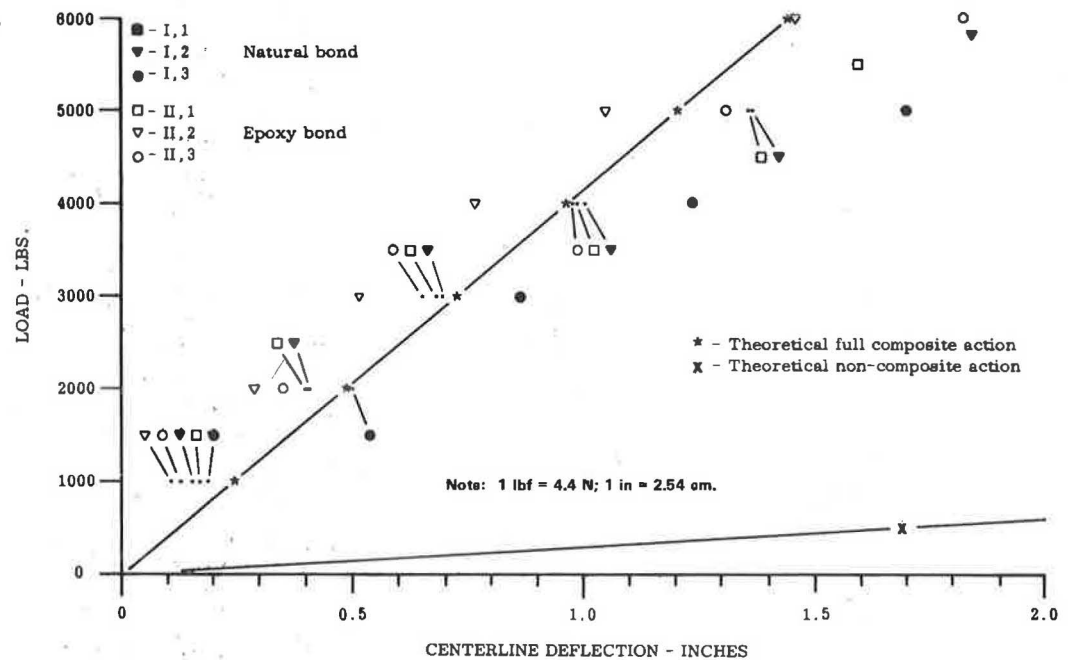
Figure 4. Load-deflection curves.

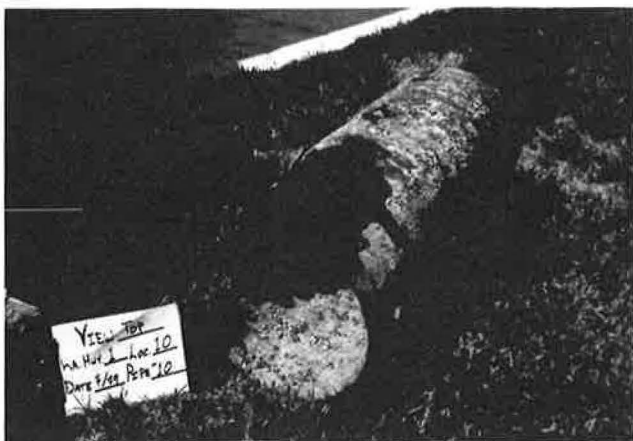
Figure 2. Condition of galvanized-steel culvert in low-electrical-resistivity environment (site 10) after six years.

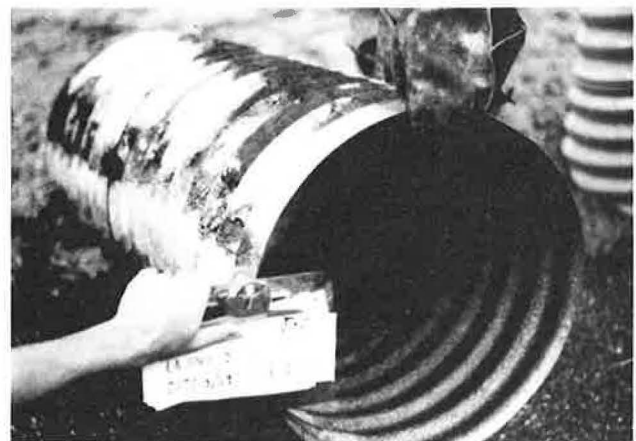
Figure 3. Condition of galvanized-steel culvert in acidic environment (site 4) after six years.

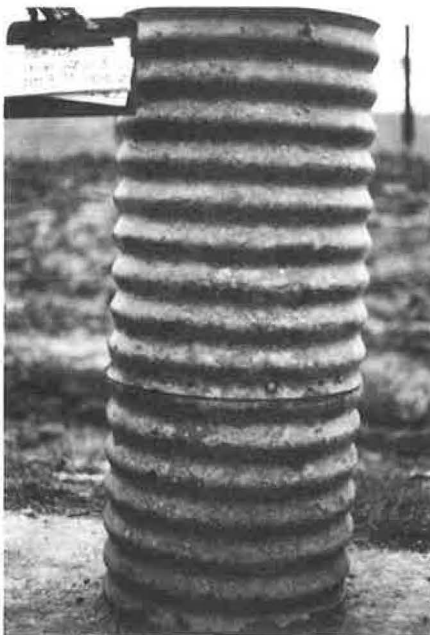
Figure 4. Condition of galvanized-steel culvert in moderate environment (site 5) after six years.

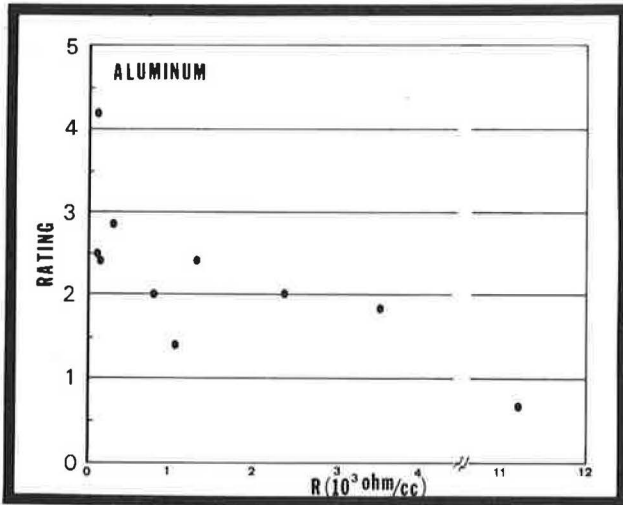
Figure 5. Six-year panel ratings of aluminum-alloy culvert versus electrical resistivity of environment.

If one assumes that electrical resistivity can be isolated as a dominant factor in the corrosion of aluminum alloy, one can develop an interesting plot of six-year panel ratings of this culvert from Table 2 versus critical resistivity values from Table 1 (see Figure 5). The rate of corrosion among the aluminum-alloy test culverts increases as the resistivity of the environment decreases. LADOTD policy states that the aluminum-alloy culvert will be excluded from consideration when the resistivity of the surrounding soil and water is less than 1500 Ω/cm . This minimum level is considered to be conservative but comfortable.

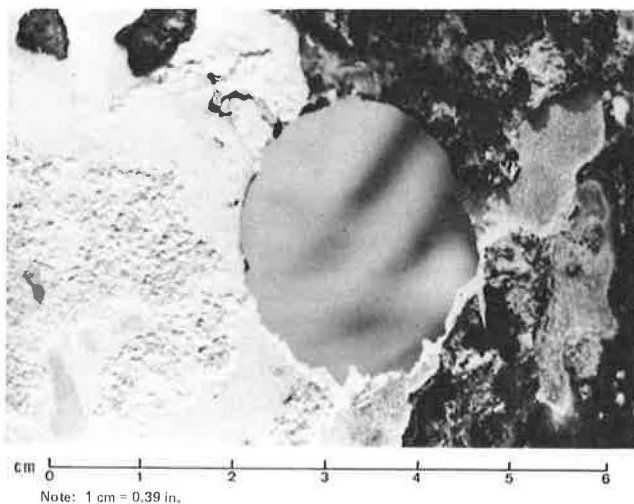
Figure 6. Pitting and thickness loss in aluminum-alloy plate arch after six years in low-resistivity environment (site 10).

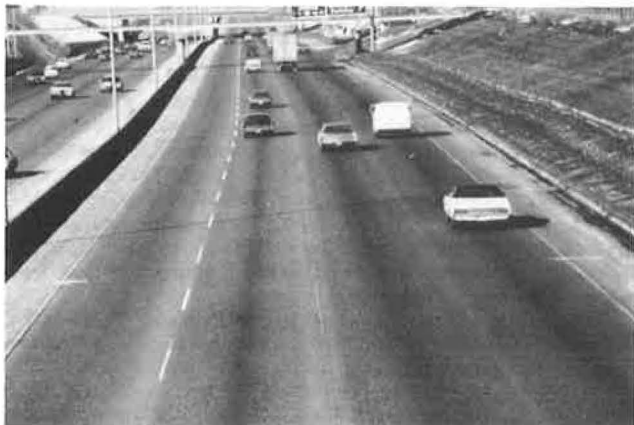
Figure 2. Condition of best-formulation epoxy (HA-1) after three years (left stripe).

winter. Figure 2 shows the HA-1 material in 1979 after six years.

Although some chipping occurred in each individual stripe, this did not reduce delineation because, from a typical sight distance [45.7 m (150 ft)], a stripe can be 20-30 percent removed by chipping and still appear to be a full or complete stripe.

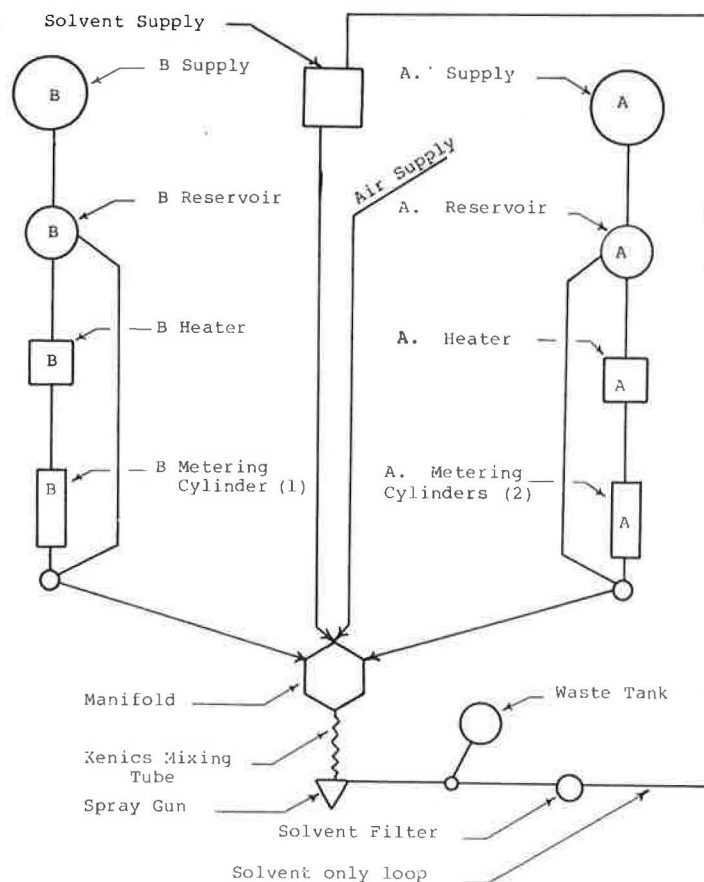
Figure 3. Plumbing of epoxy spray.

through the mixing system, the gun body, and a filter. This is an important part of the system because laminar flow in the system deposits a thin film of cured epoxy that is loosened by the solvent flush and plugs the spray gun. By recirculation through the filter, the system is kept clean.

A Graco model 205-163 material spray gun was modified by placing a Graco 205-163 gun at right angles to facilitate the flushing and cleaning operation.

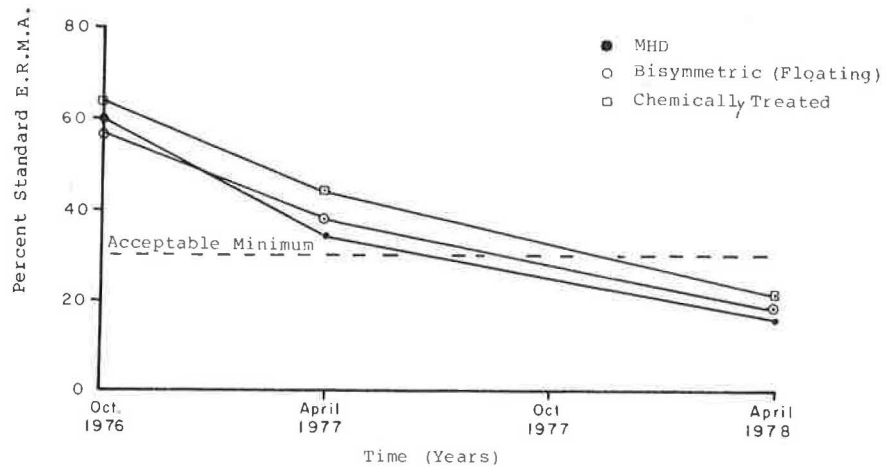
Figure 4. Effect of bead type on reflectivity.

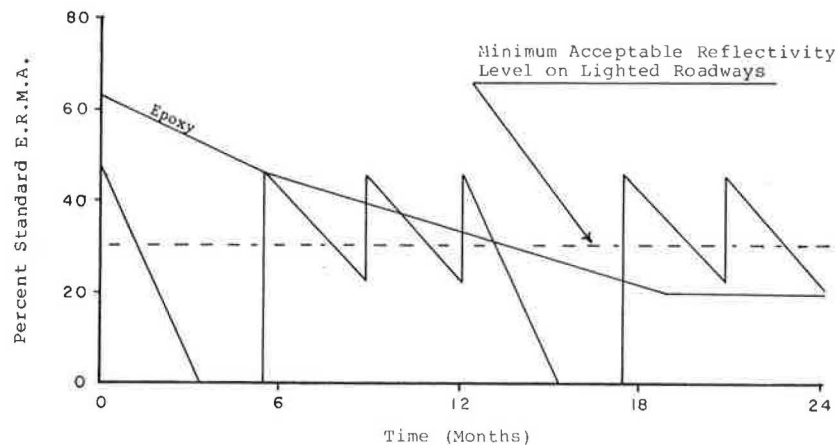
Figure 5. Retroreflective qualities of one epoxy application versus six placements of conventional traffic paint over two-year period.

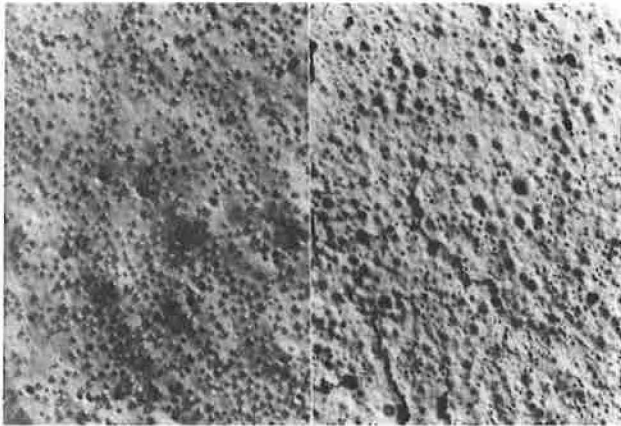
Figure 6. Conventional traffic paint: new and one year old.

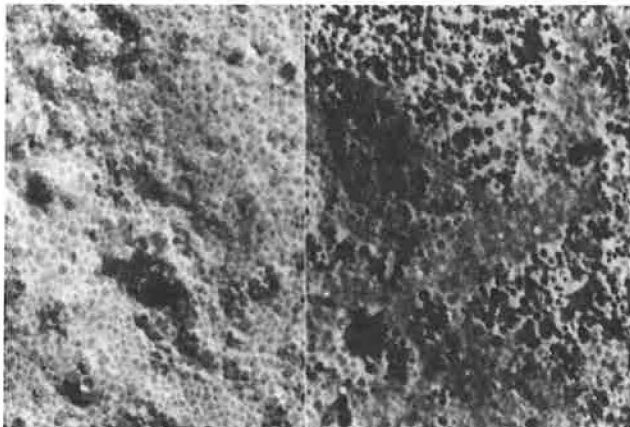
Figure 7. Polyester resin: new and two years old.

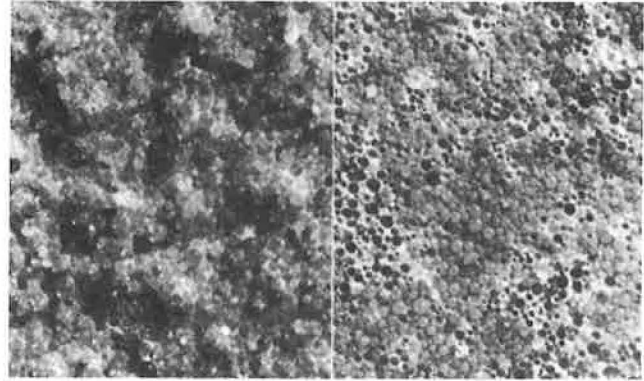
Figure 8. Epoxy: new and two years old.

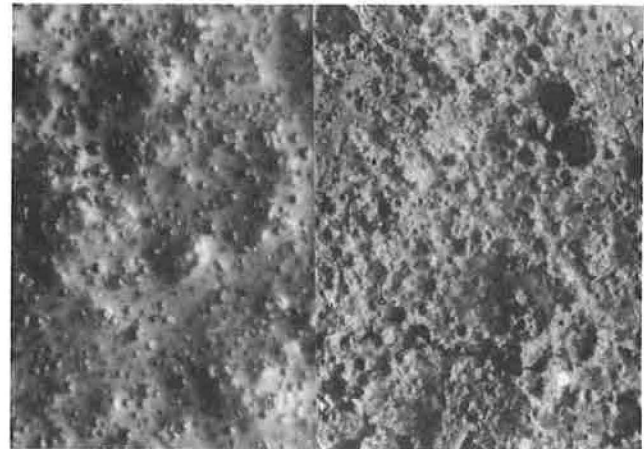
Figure 9. Thermoplastic: new and one year old.

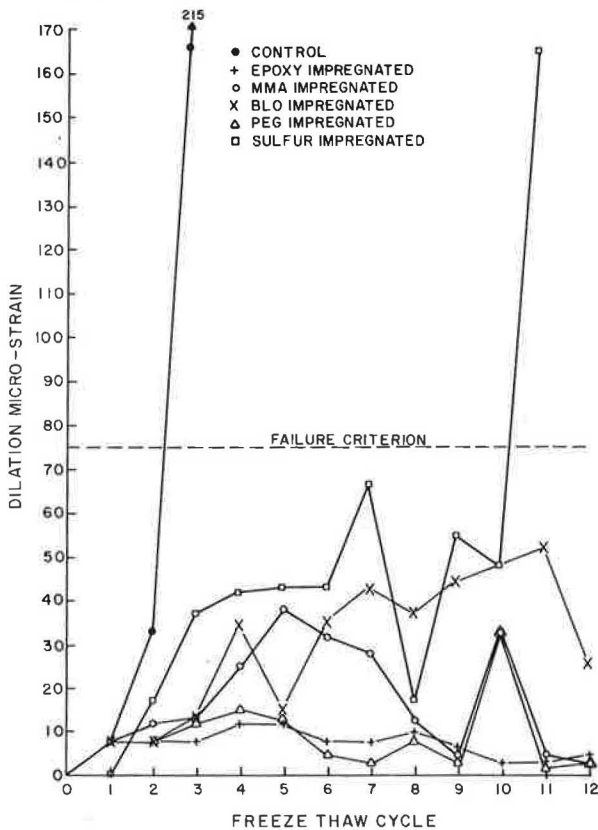
Figure 1. Dilations in freezing and thawing cycles for concrete containing chert aggregate.

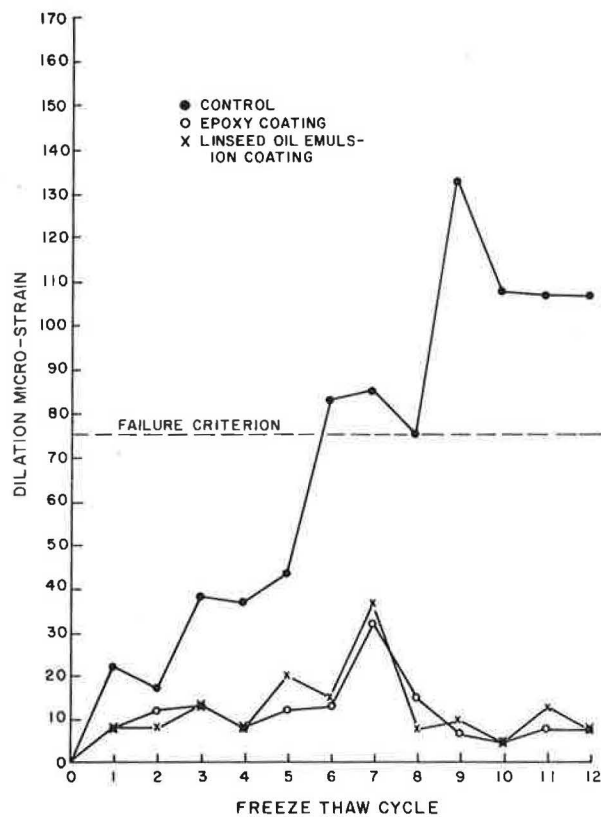
Figure 2. Dilations in freezing and thawing cycles for concrete containing andesite aggregate.

The test results for the andesite aggregate are shown in Figure 2. Again, each curve shown represents the average of three specimens. The tests demonstrate that both coating treatments tested were effective in preventing freezing and thawing damage. The control (untreated) specimen failed in six cycles of freezing and thawing.
