PHOTOLOGGING - A MAINTENANCE MANAGEMENT TOOL

Charles E. Dougan, Louis E. Sugland
Connecticut Department of Transportation

Use of the photolog system as an aid in the decisionmaking process involving the management of Connecticut highway-maintenance operations is outlined. Areas where the photolog system is highly useful, moderately useful and of limited use are denoted. Annual savings in man-hours and fuel consumption as a result of photolog usage are presented. Second generation photolog equipment and its capabilities are discussed.

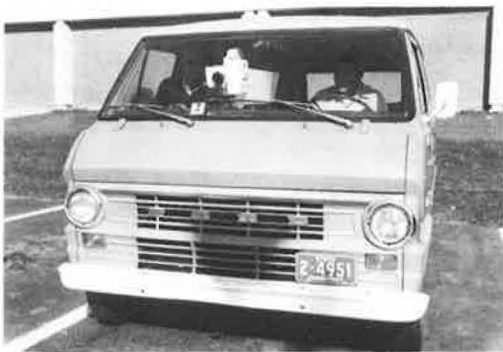
Fig. 1A Photolog Van with Camera mounted in filming position.

Our system is composed of a 35-mm Flight Research Model 4C camera and control unit installed

in a 1973 Ford Econoline Van. We normally operate the system at a rate of one frame every .0161 Km (1/100-mile) traveled, but vary this increment for special purposes. The camera is oriented at 5° to the right and 6° down for two-lane roads, and at 2° right, 3° down for multiple-lane roadways /1/.

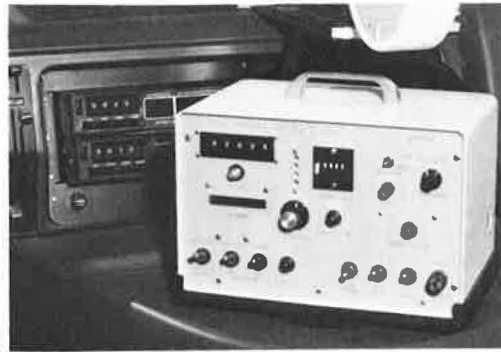
Fig. 1D Distance Measuring Instrument (DMI) and Distance Event Marker (DEM) mounted in dash.

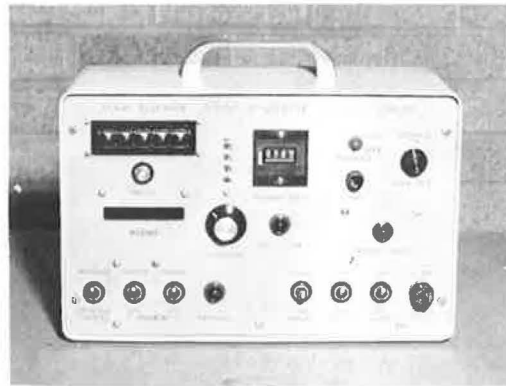
Fig. 1E Front view of control console.

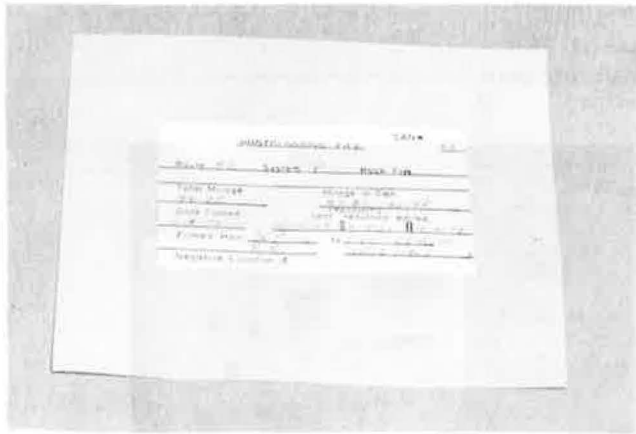
Fig. 1G Reference card for route file.

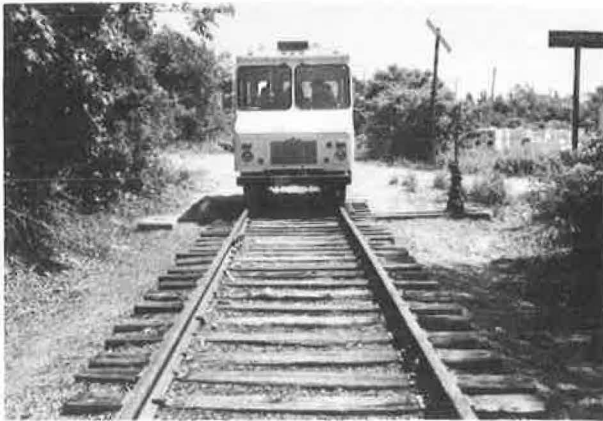
Fig. 2A Front view of rail photolog van, Chevrolet Chassis, High-rail equipped.

Connecticut's present photolog system will be augmented shortly through the acquisition of a new dual purpose photolog vehicle from Techwest Research. This vehicle, in addition to possessing a sophisticated second-generation data-gathering system, is "high-rail" equipped, thereby affording the capability of monitoring both rail and highway systems. Along with the pictorial aspect, this second generation system will digitally present on the film and magnetic tape the following data: grade; curvature; cross slope; side friction; and, roughness. The acquisition of these quantitative data in the past was generally a time-consuming and potentially hazardous task. Photos of this system are shown in Appendix 2.

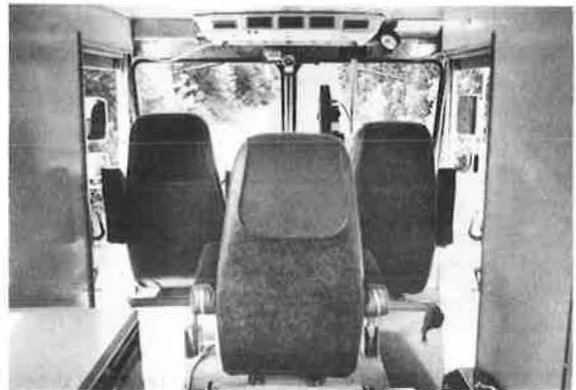
Fig. 2C Track viewed from inside of van. Camera is mounted immediately to left of passenger's seat.

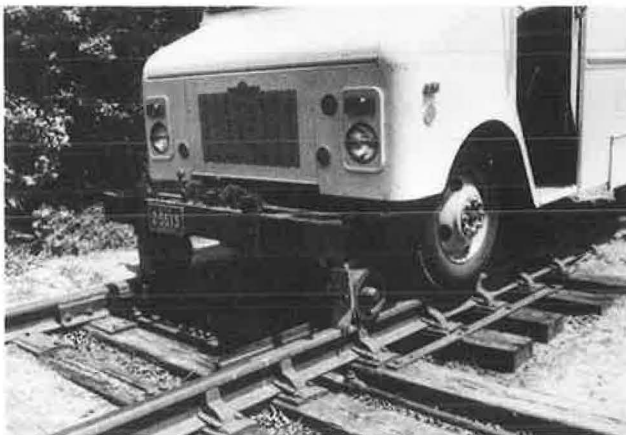
Fig. 2B Close-up of high-rail assembly engaged on track.
