TRANSPORTATION RESEARCH RECORD 783

**Rock Classifications
and
Horizontal Drilling
and Drainage**

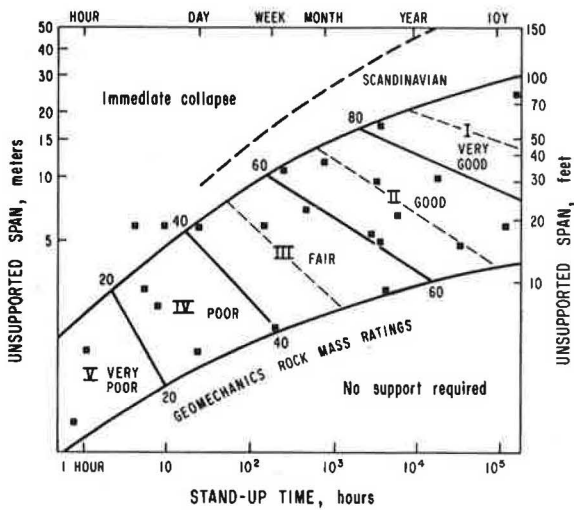
Figure 2. Relationships between stand-up time and unsupported span for various rock-mass classes.

The relationships between stand-up time and span length as well as the support guidelines have been developed on the basis of case histories. The geomechanics classification was based on 49 case histories, whereas the Q-system involved 200. Different rock conditions and tunneling practices have clearly affected the selection of stand-up time and length of unsupported spans. As depicted in Figure 2, Scandinavian practice would allow longer unsupported spans than those recommended by the geomechanics classification (29).

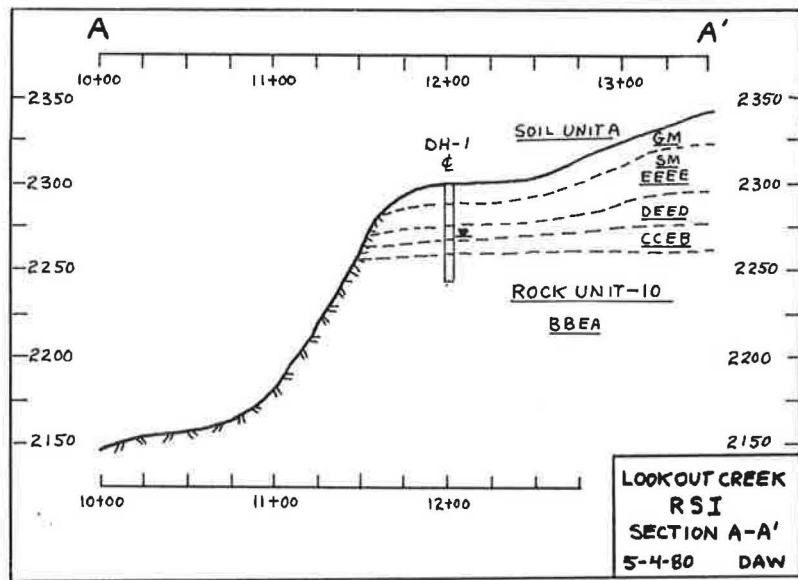
Figure 3. Typical section that shows use of URCS.

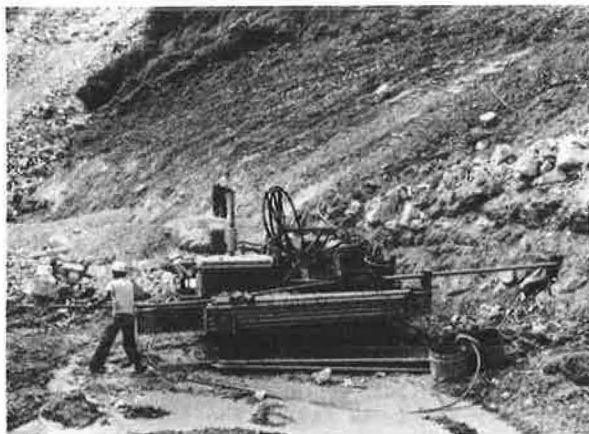
Figure 4. Horizontal drilling rig.

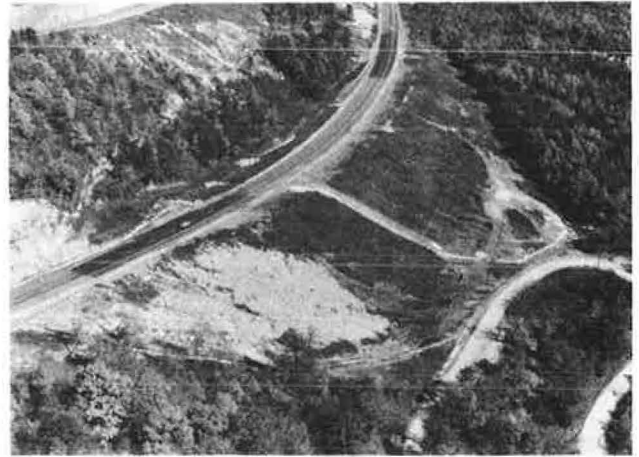
Figure 3. Typical section of embankment at time of failure.

well below 1. The actual effective groundwater table was probably between these two limits, equivalent to a calculated safety factor of approximately 0.9 (Figure 3).

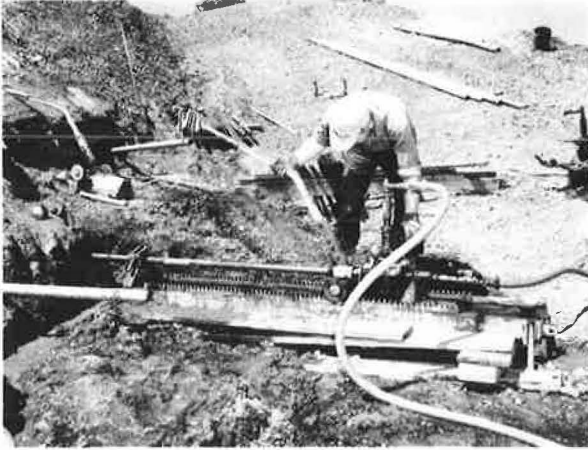
Figure 1. Hydrauger, first used in 1939 to install horizontal drains by CDH.

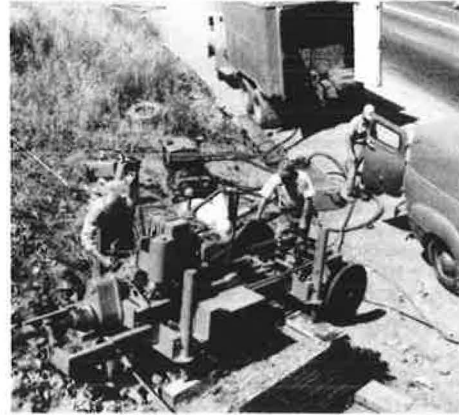
Figure 4. California horizontal drill rig, June 1954.

traverse fairly rough terrain and carry sufficient drill rod and accessory equipment to do the job. These requirements gave birth to our present drill equipment, which is track-mounted and powered by a diesel engine.

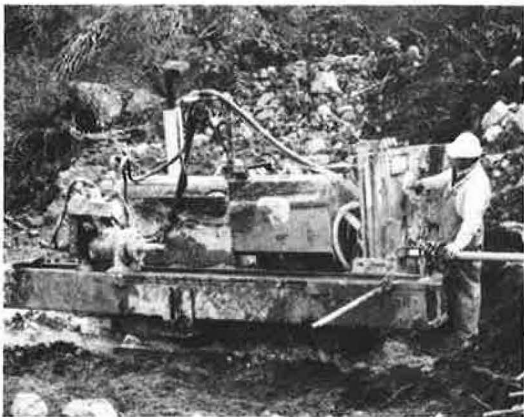
Figure 5. Jensen drill, January 1980.

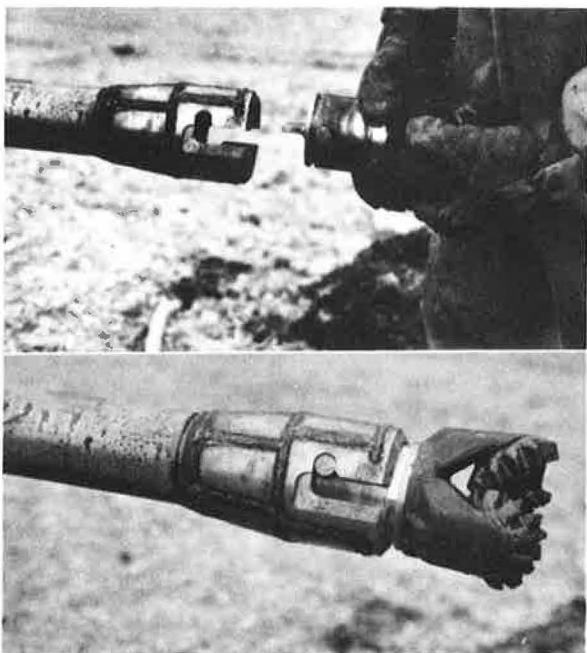
Figure 6. J-slot bit adaptor (top) and dropoff bit (bottom).

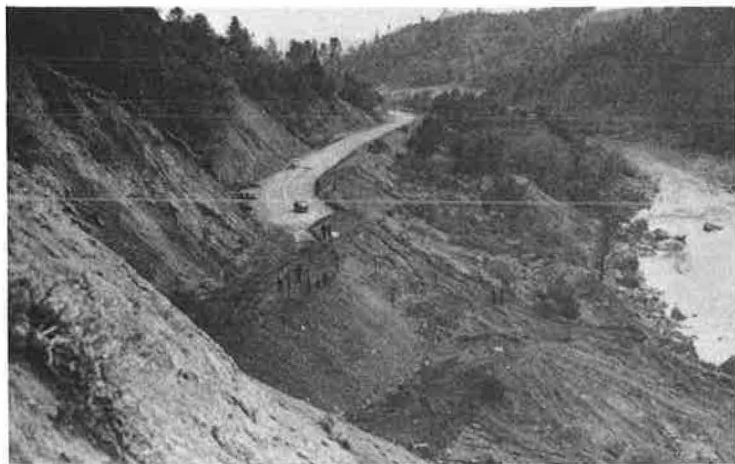
Figure 7. Cloverdale landslide and slipout, December 1941.

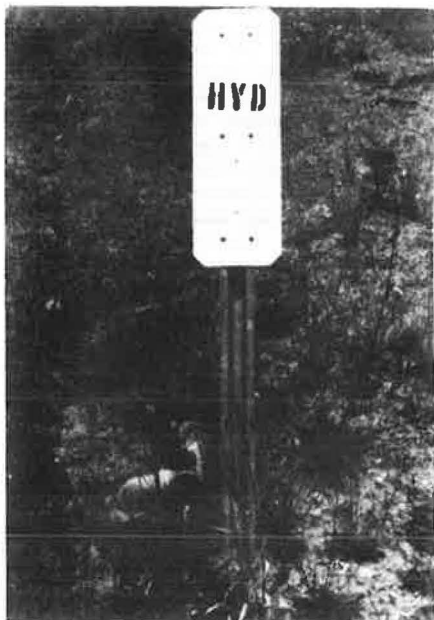
Figure 10. Paddle marker used to locate drain.
