Strengthening of Bridge Beams and Similar Structures by Means of Epoxy-Resin-Bonded External Reinforcement

IAN J. DUSSEK

This paper describes the technique of increasing beam strength by means of externally applied reinforcing steel plates, bonded by means of epoxy-resin adhesive. Test methods, application data, and some indication of preferred resin formulation are given. Steel plates are bonded to the beams by means of epoxy-resin paste adhesive. During curing of the resin the plates are held in place by clamps and/or bolts. This provides an inexpensive method of restoring or upgrading the strength of damaged or substrength concrete bridge and similar beams. To date, results have proved entirely satisfactory, but possible dangers of corrosion on the steel-concrete interface are being investigated. Further work is foreseen that will employ new materials and methods of application and enlarge the scope of the process.

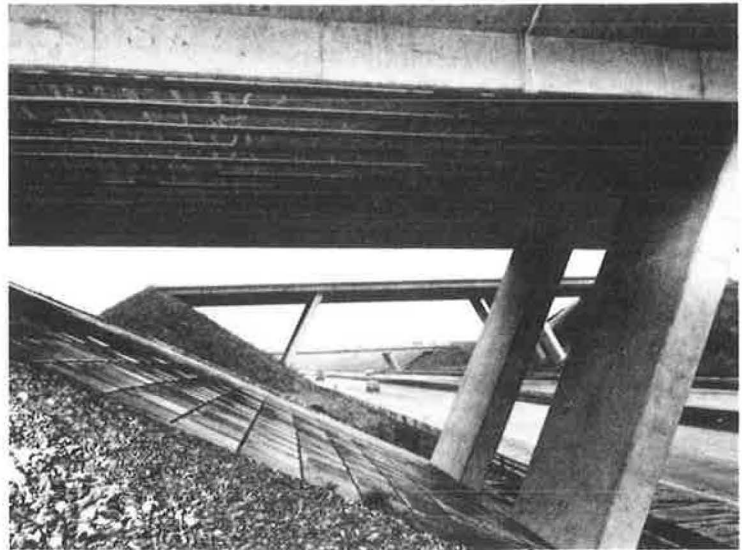
Figure 1. Plates bonded to the underside of the side-span beams of a bridge at Swanley, Kent.

In 1975, four bridges on the M5 Motorway at Quinton Interchange, Worcestershire, England, were repaired by plating, and in 1977 two bridges on the M25-M20 Motorway Interchange at Swanley, Kent, were also treated successfully (see Figure 1).

A similar technique was employed on the M25-M20 Interchange in 1977, following discovery of cracks in the soffit of one side span immediately after the interchange had been opened to traffic (7). In this instance, approximately 450 plates 19.5 ft long, 9.5 in wide, and 0.25 in thick, each weighing 1650 lb, were placed in one month. A trowel-grade adhesive Ciba-Geigy XD800 two-part epoxy resin that had a pot life of 45 min at 60°F was used. Plates were applied on both the top surface and the underside of the beams. For the soffit work a running falsework on which the plate could be placed and then wedged against the soffit was used. For the top surface, the plates were weighted down in place with sandbags.
