Crash Tests of Light-Post Thrie-Beam Traffic Barriers

JAMES E. BRYDEN AND KENNETH C. HAHN

Thrie-beam corrugated steel rail (a W-beam that has a third corrugation) was tested as a single-rail upgrading for discontinuous bridge-rail panels and on S3x5.7 posts as a guiderail and double-faced median barrier. Tests were performed to determine rail deflection characteristics, structural adequacy, vehicle decelerations, and vehicle damage. Ten-gage Thrie beam was used for all tests. As a bridge-rail upgrading, the Thrie beam is suitable for 60-mph, 25° impacts by 4500-lb vehicles. As a guiderail or median barrier on S3x5.7 posts, it appears suitable as a longitudinal barrier, based on tests with 2250-lb and 3500-lb vehicles. Proposed design deflections for Thrie-beam guiderails and median barriers are close to those for box-beam guiderails and median barriers. Further testing of these guiderail and median-barrier designs would yield better definition of impact and redirection characteristics and would better indicate what actions could be taken to reduce the impact between the vehicle's wheel and the posts.

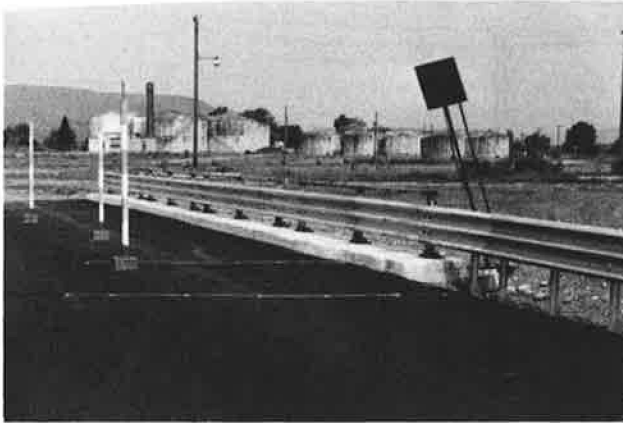
Figure 1. Bridge-rail upgrading (tests 22 and 23).

The first Thrie-beam application tested was an upgrading of discontinuous-panel bridge railings. Such railings, designed to meet the 1957 American Association of State Highway Officials (AASHO) specifications (6), were installed in New York State through the mid-1960s. A three-post railing panel 34 in high, which is common on New York bridges, was chosen for testing.

Thrie beam that was 10-gage rather than 12-gage was used because the added stiffness would help distribute impact loads over more bridge-rail posts, which reduced the chance of pocketing at panel ends and helped in the transition from guiderail to bridge rail. The first design (Figures 1 and 2) was tested by impacting on the bridge and on the approach guiderail. It consisted of spliced sections of 10-gage Thrie beam mounted directly onto the bridge rail; the rail top was 33 in above the pavement. The rail was held in place at each bridge-rail post by four 3/4-in bolts--two in each corrugation valley--around the post and through the 5/8-in backup plates. The approach rail was W-beam 33 in high that transitioned to the Thrie beam 53 ft

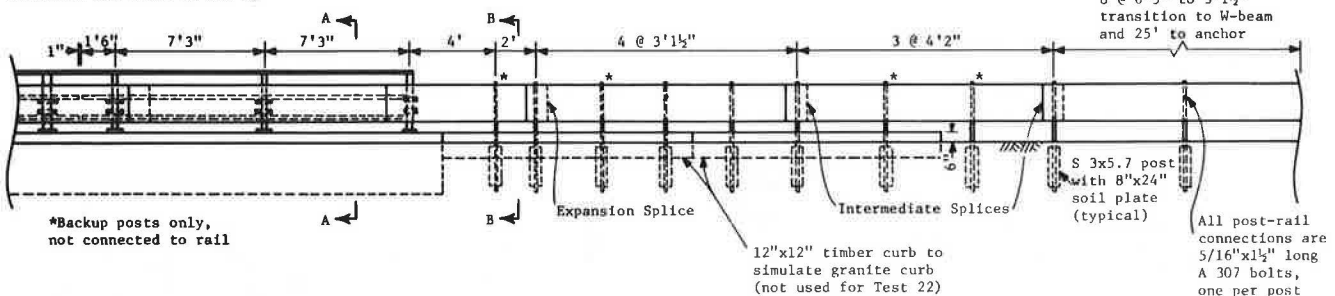
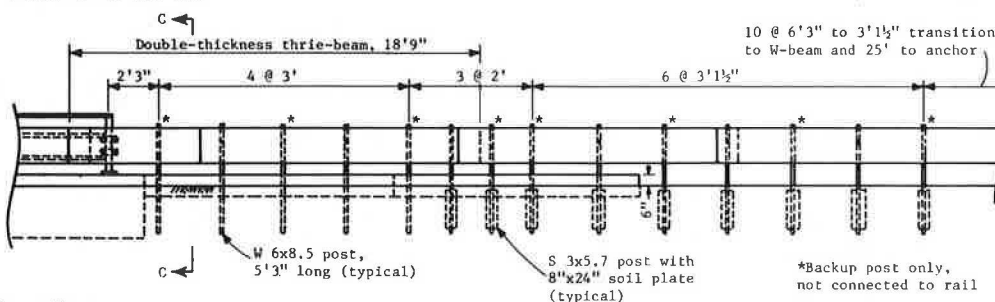
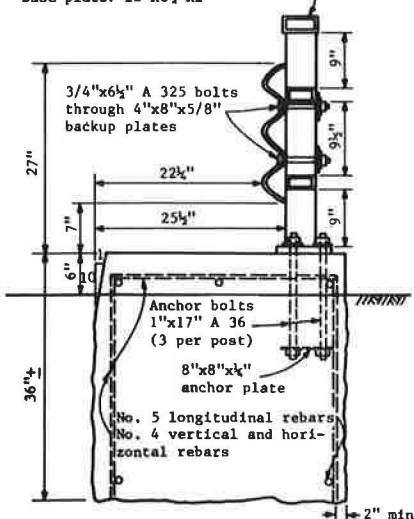
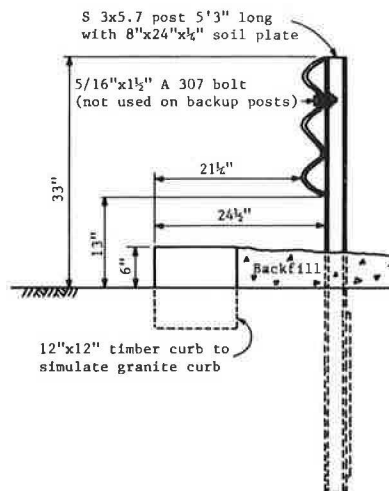
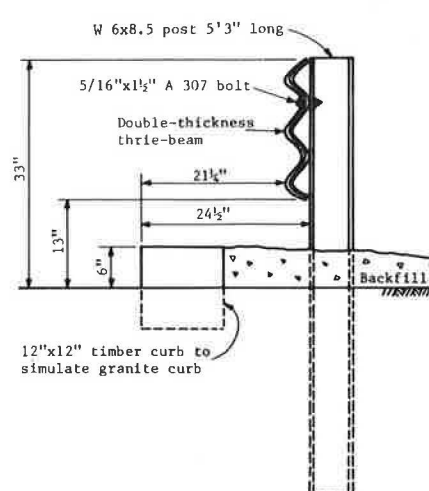
Figure 2. Details of bridge-rail upgrading (tests 22, 23, and 23A).

ELEVATION FOR TESTS 22 AND 23

ELEVATION FOR TEST 23A

Top rail: 5"x2"x0.156" tube
Post: 4"x4"x0.156" tube
Lower rails: 4"x1 1/2"x0.180" tubes
Base plate: 12"x8 1/2"x1"

SECTION A-A (Test 22)

SECTION B-B (Test 23)

SECTION C-C (Test 23A)

After unsatisfactory performance in the second test, the transition was redesigned for the third (Figures 2 and 3). Five W6x8.5 posts on 3-ft centers were added just upstream of the bridge, and an S3x5.7 post pattern similar to that used in the previous two tests was installed upstream of the W6x8.5 posts. The transition was further strengthened by doubling the rail element for one and one-half rail lengths. The double rail extended 3 ft onto the bridge and 16 ft back onto the guiderail. The second rail element was simply placed over the first, and the splice bolt holes were adjusted as necessary to provide bolt clearance. The Thrie-beam approach rail was not tested at the change from light to heavy posts. Unlike the box beam, the wide bearing area of the Thrie beam does not cut into the vehicle sheet metal and thus keeps the vehicle's wheels relatively far from the heavy posts.

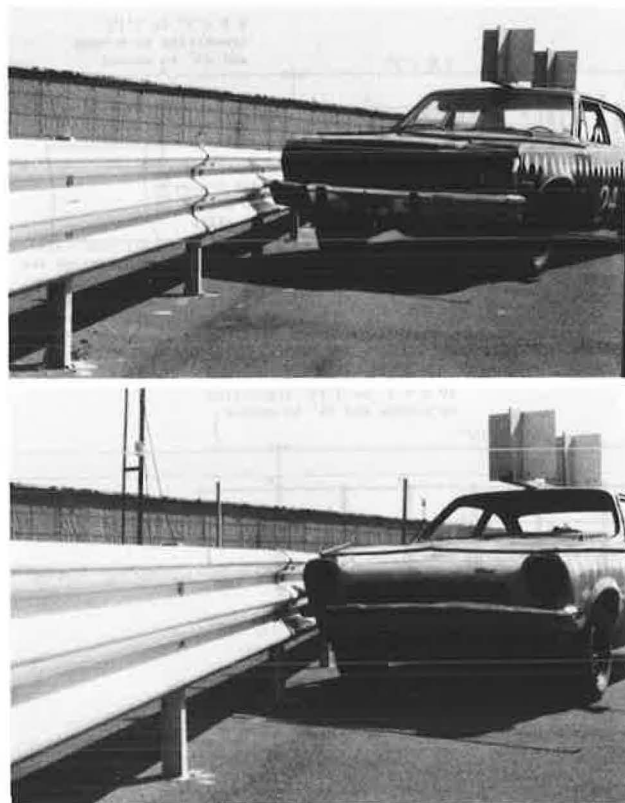
Figure 4. Guiderrail with large car (test 24, top) and small car (test 25, bottom).

Bridge-railing upgrading tests were followed by two tests of guiderails (Figures 4 and 5). Ten-gage Thrie-beam rail mounted 33 in high on S3x5.7 posts at 6-ft 3-in centers was impacted by intermediate and compact cars.

In test 24, a 3600-lb sedan impacted at 56.0 mph and 26°. Before impact, the car snagged momentarily on the guidance-system release post; the result was a +5° vehicle pitch at impact. Initial vehicle-rail contact was on the right end of the front bumper and right front fender. As the rail deflected, the bottom twisted under slightly, and a maximum dynamic deflection of 3.6 ft was observed. The right front

For test 25, a 2300-lb sedan impacted the barrier at 60.9 mph and 25°. Initial redirection was smooth; the maximum dynamic deflection was 2.1 ft. Again, the right front wheel impacted the exposed posts and was driven back into the wheel well. After about 15 ft of contact, the car rolled -3°, pitched +15°, and then spun out, but the right front corner remained in contact with the rail. After sliding along the rail about 35 ft further, the car exited at an angle of 6° but yawed -90°. Maximum 50-ms average decelerations were quite low for the high speed and angle impact--3.8 g longitudinal and 5.2 g lateral. Containment and redirection were generally quite acceptable, in spite of the impact of the wheel on the exposed posts. Vehicle damage included both front fenders crushed, the hood sprung and driven back to the windshield, the right side dented, and the right front wheel broken from its suspension and driven back under the chassis. Barrier damage was limited to two bent Thrie-beam sections and four damaged S3x5.7 posts. The first was deflected back, but the other three were bent nearly to the ground by the wheel impact. Permanent rail deflection was 0.8 ft.

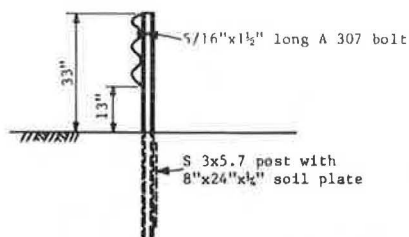
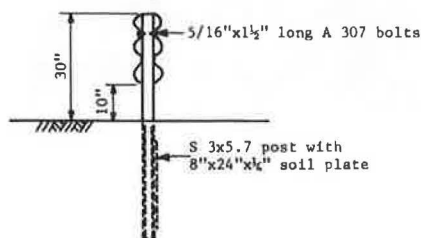
Figure 5. Details of guiderail (tests 24 and 25, top) and median barrier (tests 26, 27, and 26A, bottom).

Three tests of a median barrier were performed (Figures 5 and 6). Back-to-back 10-gage Thrie beam was bolted directly to S3x5.7 posts by using one 5/16-in bolt per rail at each post. Because of a possible wheel-snag problem detected in the two guiderail tests, rail height was reduced to 30 in. A post spacing of 6 ft 3 in was tested by using both an intermediate and a compact car, and a post spacing of 12 ft 6 in was tested with an intermediate-weight vehicle.

GUIDERAIL (Tests 24 and 25)

MEDIAN BARRIER (Tests 26, 27, and 26A)

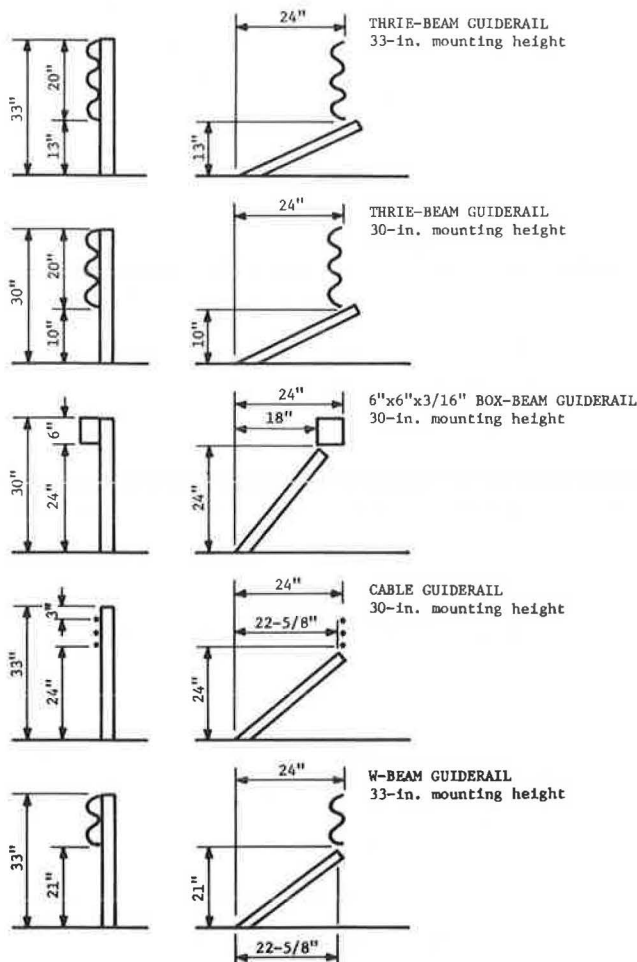
Figure 7. Attitudes of several light-post barriers before and after impact.

Although this contact between wheel and posts did not appear to result in unacceptable performance, it is desirable to eliminate such damage if possible. Examination of the barriers after impact and close examination of the test films revealed two factors that contributed to the wheel-post impact problem. First, these barriers were all installed on an asphalt pavement; the posts were driven through several inches of asphalt. Combined with the 8x24-in soil-support plates, this resulted in posts that bent at the pavement surface on impact and did not push through the asphalt. This installation condition is typical in New York State, where guiderail and median barrier are frequently installed on asphalt shoulders or medians that are paved over compacted gravel subbases. This very stiff restraint may have increased the severity of the wheel-post impact somewhat. The second contributing factor is the relatively high stiffness of the barriers tested and the greater depth of the Thrie-beam section. As the rail deflected on impact, the rail mounting bolt was snapped, but the posts were bent back by the rail. However, the small amount of post exposed prevented contact of the post with the vehicle bumper or sheet metal. Instead, the main force on the post was imparted by the wheel, which resulted in the suspension damage experienced. For W-beam, cable, or box beam installed on light posts, the shallow rail depth would permit more vehicle sheet-metal contact on the post, which would partly bend it down before it was struck by the wheel. For W-beam and cable, greater deflections would also help eliminate this problem. The relation of several light-post barriers before and after impact is shown in Figure 7, and it can be seen that the Thrie beam is the most critical case for wheel-post impact.

The first effort to reduce contact between wheel and posts was to lower the rail height from 33 to 30 in. However, as seen in Figure 7, this cannot be expected to have much effect, because contact occurs after the rail and post have separated and the post has been bent laterally by the deflecting rail. The second effort, which was successful, was to increase post spacing from 6 ft 3 in to 12 ft 6 in as in the last test (test 26A). By increasing the spacing, greater deflection was permitted, which helped to move the wheel behind many of the posts and to permit the bumper and sheet metal to contact and bend the posts longitudinally. Increasing post spacing also results in fewer posts to contact. Depending on impact conditions, it is much more likely that the vehicle can be redirected without a severe wheel-post impact. Damage to the right front
