*TRANSPORTATION RESEARCH RECORD* 800

# Bridge and Pavement Maintenance

**DETERIORATION OF NEW YORK STATE HIGHWAY STRUCTURES**  
Michael W. Fitzpatrick, David A. Law, and William C. Dixon ..... 1

# Deterioration of New York State Highway Structures

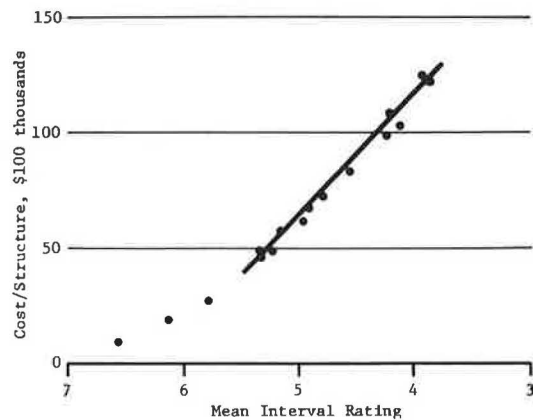
Figure 6. Cost per structure versus mean rating of intervals.

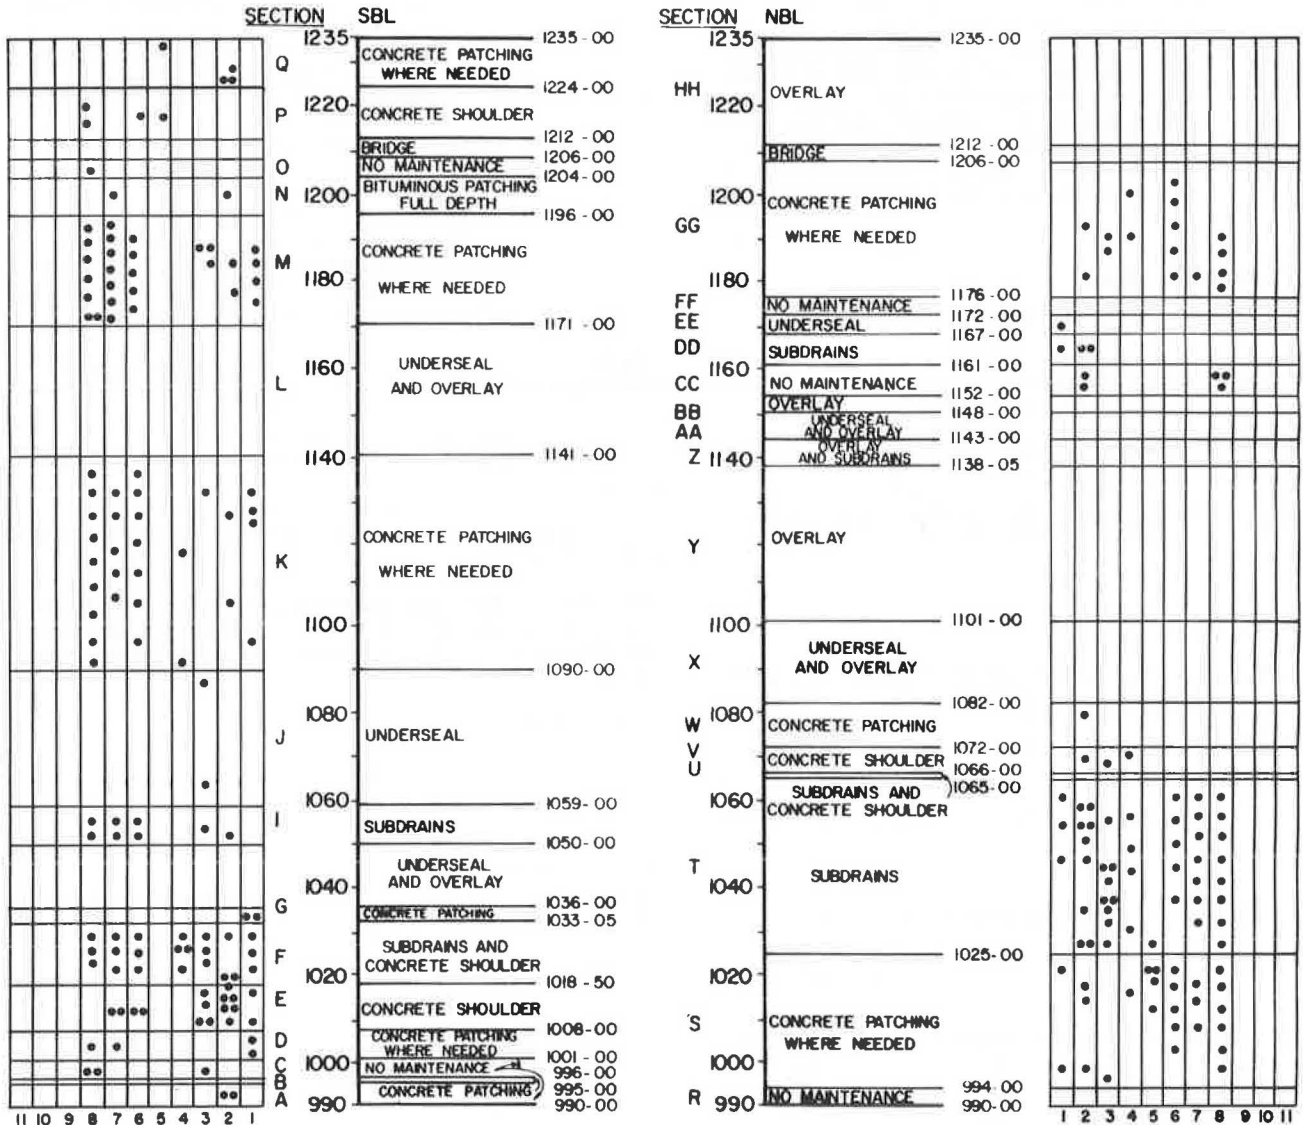
Figure 4. Failure as a function of location and time.

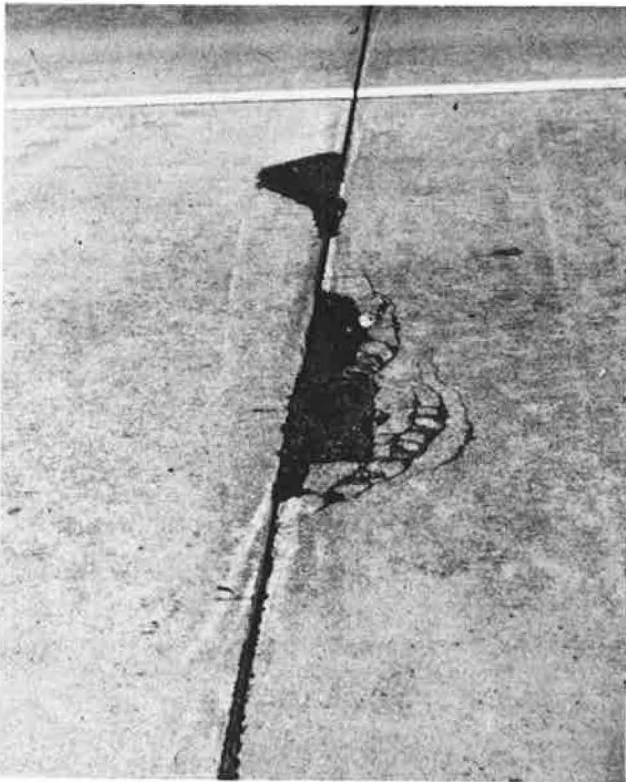
Figure 1. Semicircular spall caused by corrosion of insert.

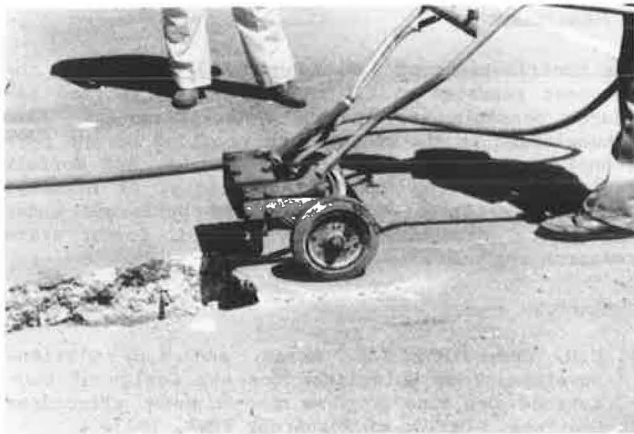
Figure 2. Crack chaser in operation.

A test was developed to simulate the crack formed in the concrete pavement by using a crack chaser. A crack chaser is a wheel-mounted piston-driven bit for following cracks in concrete and opening them up uniformly for remedial work. The crack chaser has a special tungsten-carbide-tipped, four-point cross face and side-cutting bits that have a standard diameter of 7/8 in. The standard bit drills holes about 2 in deep and 1 in wide. Figure 2 shows the crack chaser.

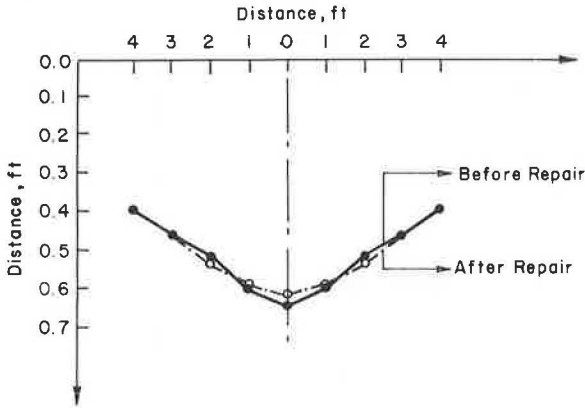
Figure 8. Deflection between cracks for a sound pavement.

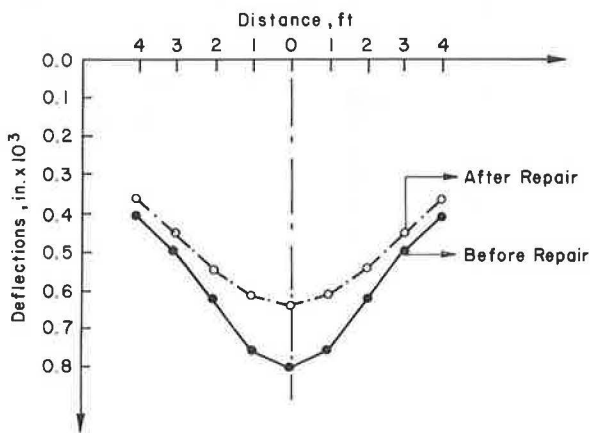
Figure 9. Deflections at upstream edge of repair no. 10.

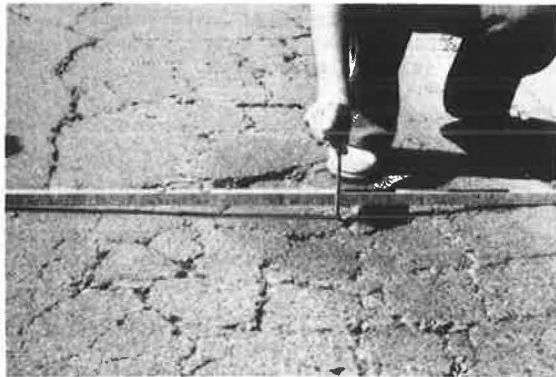
<b>Description:</b>	Cracks form a network of multi-sided (polygon) blocks resembling the skin of an alligator. The block size can range from 5 to 10 cm to about 50 cm. The alligatored area may or may not be accompanied by distortion in the form of depression, and may occur anywhere on the pavement surface.	
<b>Possible causes:</b>	1. Insufficient pavement strength. 2. Poor base drainage and stiff or brittle asphalt mix at cold temperature.	
<b>Severity:</b>	<b>Class.</b>	<b>Guidelines</b> (Base on appearance and surface distortion)
	<i>Slight</i>	Alligator pattern established with corners of polygon blocks fracturing
	<i>Moderate</i>	Alligator pattern established with spalling of polygon blocks
	<i>Severe</i>	Polygon blocks begin to lift; may or may not involve potholes.
<b>Density:</b>	<i>Local:</i>	Less than 30% of pavement surface affected; distress spotted over localized areas only.
	<i>General:</i>	More than 30% of pavement surface affected; distress spotted evenly over entire length of pavement section.

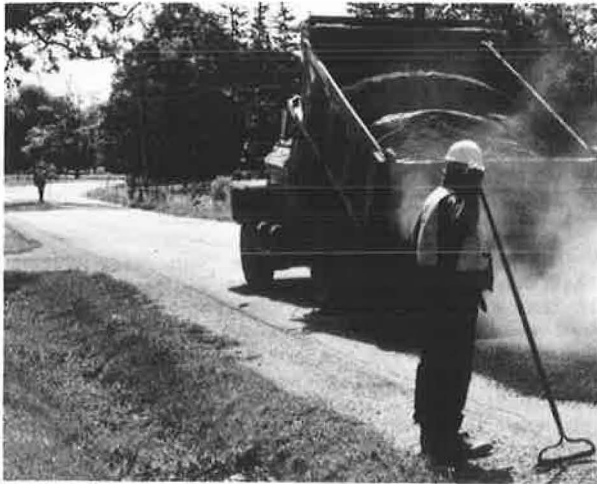
Procedures for Placing and Spreading Hot or Cold Mix Asphalt (Machine Patching)
