Pavement Management Study: Illinois Tollway Pavement Overlays

BOB H. WELCH, MATTHEW W. WITCZAK, DONALD C. ZIMMER, AND DANIEL G. HACKER

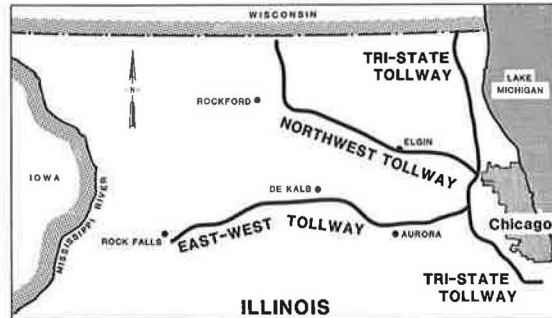
Figure 1. Illinois Tollway.

The Illinois Tollway consists of three toll highways--the Tri-State, East-West, and Northwest Tollways, as illustrated in Figure 1. Together they total approximately 243 centerline miles, of which 104 miles have three traffic lanes in each direction. In addition to the main-line mileage, the Illinois Tollway consists of several access ramps, interchanges, and toll-collection facilities. The Illinois Tollway is a high-level system that serves motorists in the metropolitan Chicago area as well as throughout the state of Illinois. Segments of the tollway system serve more than 100 000 vehicles daily, which includes Interstate transport and localized commuter travel.

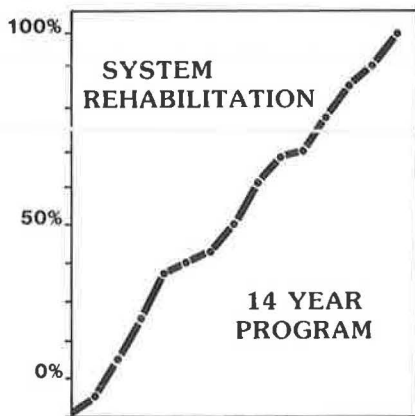
The resulting schedule is a 14-year cycle (Figure 8) in which major rehabilitation for all mileage will be performed. The average number of projects to be rehabilitated each year is between five and six; the average length is 6.56 miles. The cumulative percentage of system rehabilitation to be

Figure 8. Tollway rehabilitation schedule.
