Work Zone
Safety, Maintenance
Management and
Equipment, and
Transportation of
Hazardous Materials

TRANSPORTATION RESEARCH BOARD

Transportation Research Record 833
Price \$5.60
Edited for TRB by Susan Singer-Bart

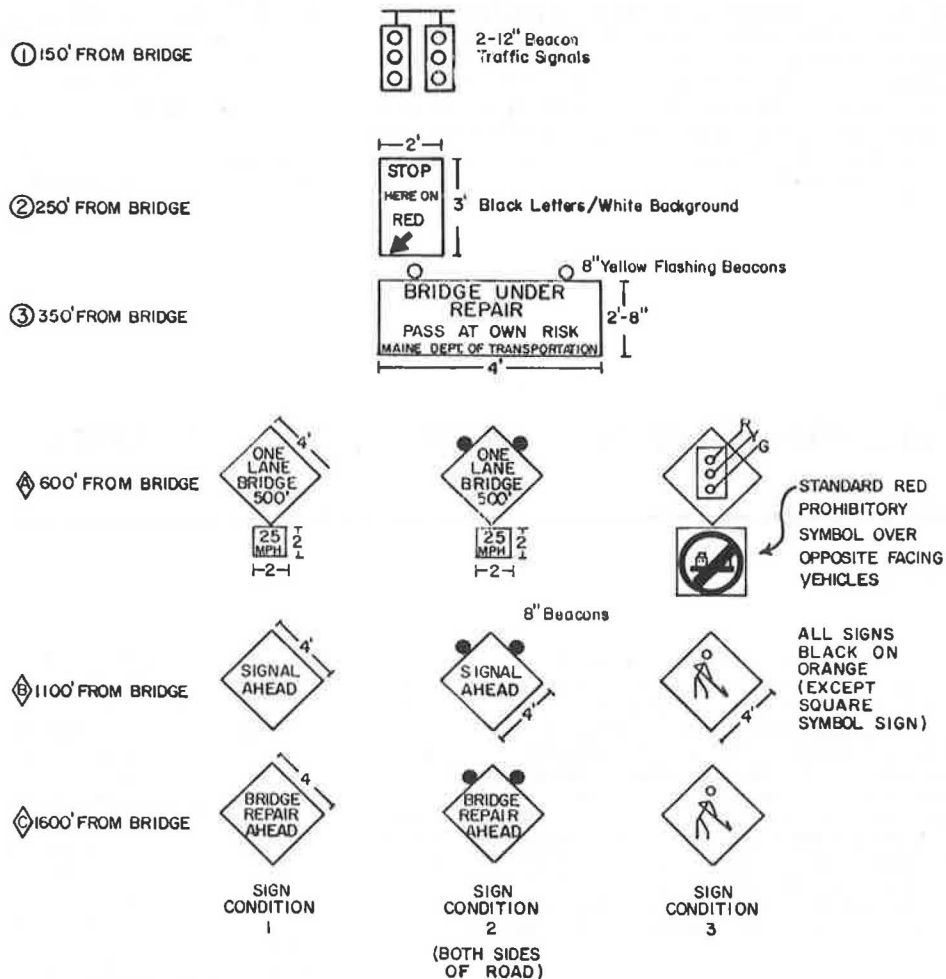
Figure 1. Sign sequences in long zone. SIGN POSITION

NOTES: SQUARE SYMBOL SIGN: WHITE BACKGROUND WITH RED CIRCLE AND DIAGONAL.
8" BEACONS ON SIGNS ARE AMBER AND CONTINUOUSLY FLASHING
SIGNS 1, 2, AND 3 ALWAYS PRESENT (MAINE DOT REQUIREMENT) ALTHOUGH THEY DO NOT CONFORM WITH THE "MANUAL ON UNIFORM TRAFFIC CONTROL DEVICES" NOR WITH THE UNIFORM VEHICLE CODE

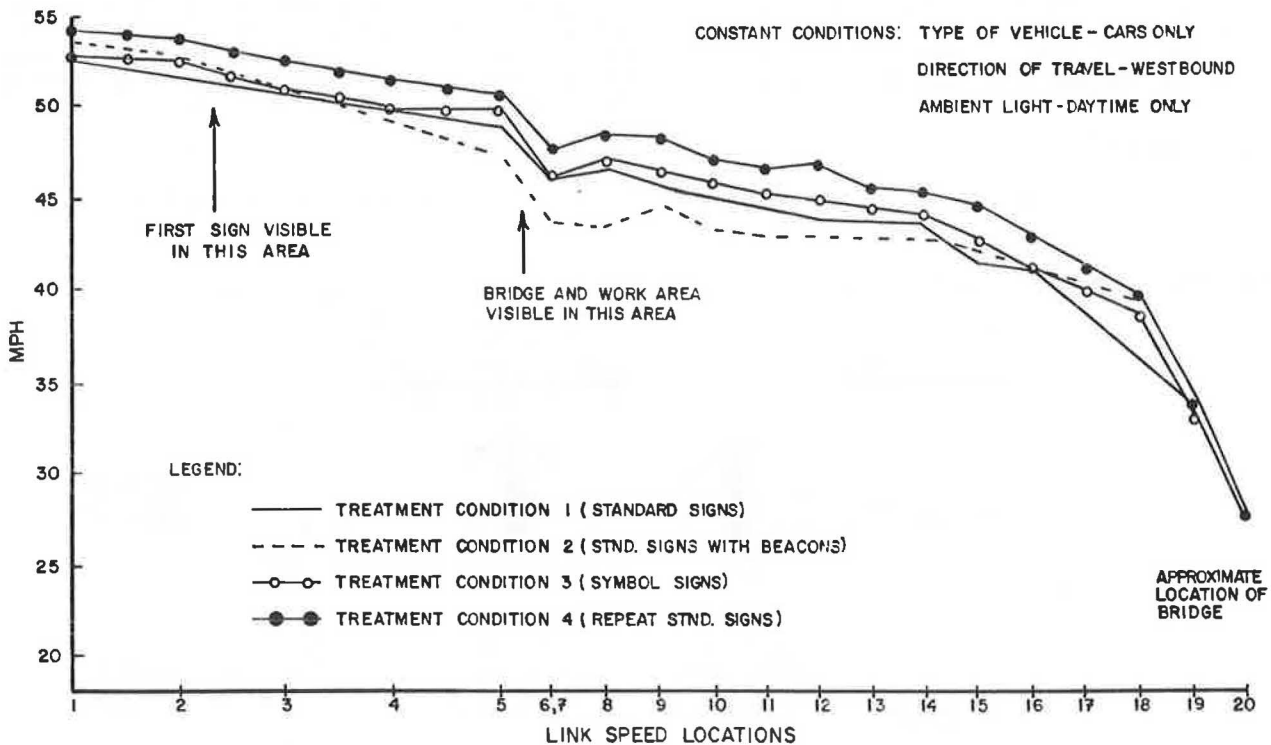
Figure 4. Mean speed profile in long zone.

As an example of some of the results, Figure 4 shows

the mean speed profile for the westbound approach for the motorists who were exposed to different sign sequences (note that the first sequence, standard signing, was repeated as a base). These results illustrate the basic superiority of the lighted signs (insofar as lower speeds are concerned) over part of the approach. Similar data (not shown) indicated that the lighted signs were even more effective at night and over a longer distance. By way of a brief summary, the experiment in the long zone dealt with an explicit situation where approaching motorists saw both warning signs and a traffic signal on a rural, two-lane road. Within that context, the following conclusions are offered:

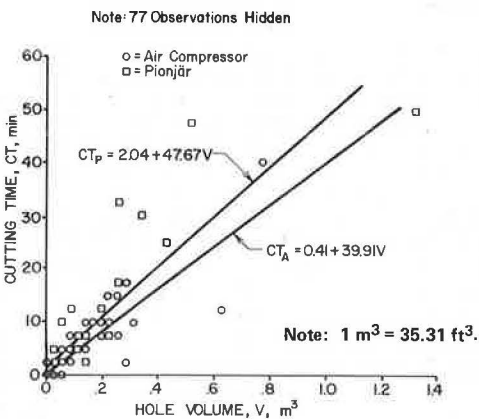
Figure 2. Plot of cutting time versus hole volume.

The numerical comparison of cutting performance is very important to the manager because the rate at which holes are cut and prepared establishes the production rate of the crew. Figure 2 shows the

plot of cutting time versus hole volume and the anticipated difference in mean cutting times for the air compressor and the Pionjär. The difficulty in using these values as the basis for comparison is that the distribution of hole volumes is definitely skewed toward smaller-sized holes. Furthermore, approximately 14 percent of the hole volumes are very large [i.e., exceed 0.23 m³ (7.99 ft³)]. Since the cutting time differential widens significantly as the hole size increases, concerns should be raised about use of the approach shown in Figure 2 as a predictor of relative performance. Note also that the holes prepared by the Pionjär tended to be larger than those cut by the compressor. This information is summarized below (note 1 m³ = 35.3/ft³).

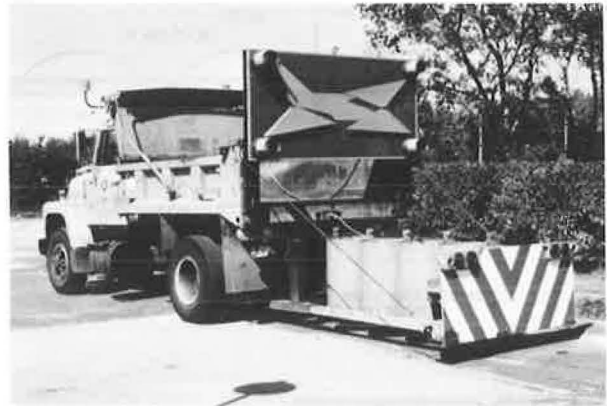
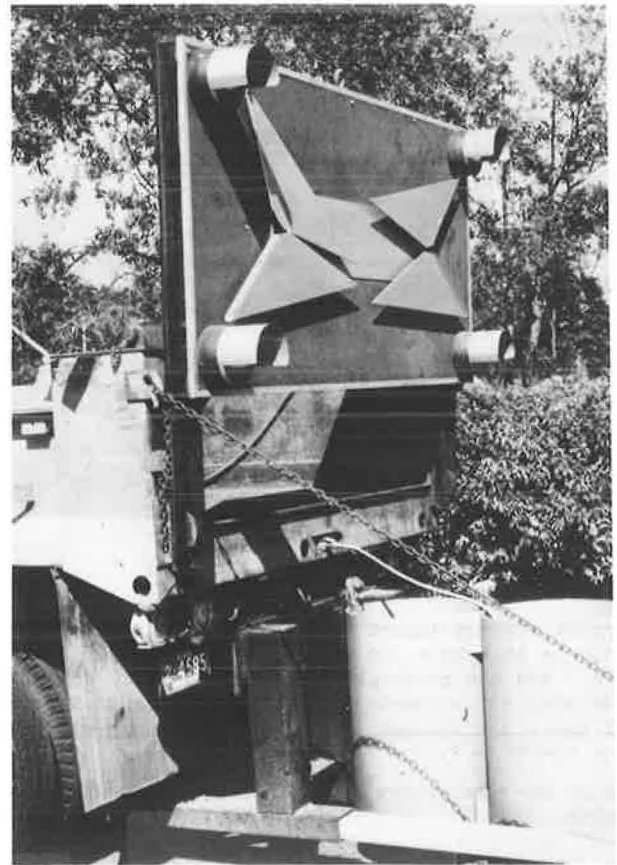
Figure 6. Connecticut portable energy-absorbing system.

1. It absorbs most of the energy dissipated in a high-speed collision between an automobile and the highway service vehicle, and it absorbs this energy in such a way that the accelerations and acceleration rates to which the automobile and service vehicle are subjected are within the guidelines specified by FHWA.

2. It is inexpensive to build; the total assembly can be constructed at an approximate cost of \$2000. This figure compares favorably with the cost of existing competitive units.

3. It is inexpensive to repair; under most crash conditions, all that is required is to insert new 2-ft diameter pipes into the system. These pipes are bolted together and cost about \$100 each. The aluminum impacting plate and the steel frame under the dump truck body will not usually require repairs. In the case of a collision at low speed, the steel pipes can be jacked back to their original shape and reused.
