# Performance Observations on Open-Graded Bituminous Concrete Overlays in Connecticut

CHARLES E. DOUGAN

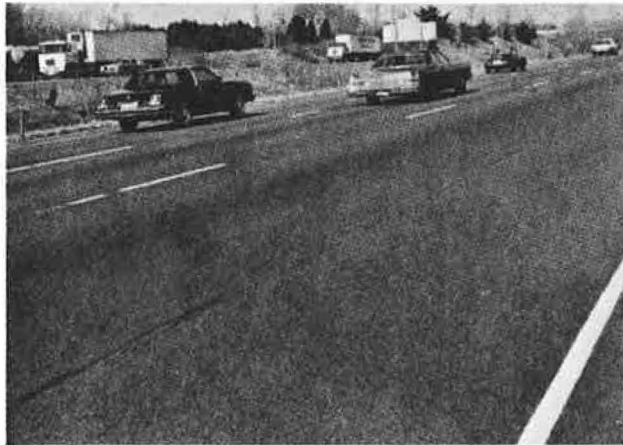
Figure 2. Propagation of longitudinal cracking beyond previously sealed portions (northbound, control section).

2. The open-graded mat has failed to arrest longitudinal reflective cracking (Figure 2). Transverse reflective cracks have also appeared (Figure 13) where the crack-relief joints have been misaligned or the underlying transverse joints have opened to unusual widths. Spalling is virtually absent or minimal at reflective cracks to date. Of the 20 consecutive unsawed joints in the control section on I-91, 95 percent have reflected through

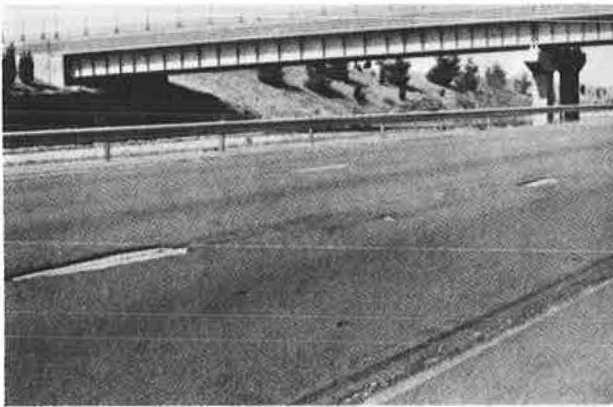
Figure 9. Overview of portion of test section 3N.

1. OGFC overlays have for the most part performed well, not only in standard pavements (OGFC over 2 in of dense-graded material) but also in two of the three test sections placed on I-91. The test section with the thinnest overlay (0.75 in of open-graded material on concrete) failed in adhesion and lifted off in several large areas. Several smaller areas in the standard sections have also lifted off; one possible explanation for this failure is the inadequacy or poor application of the sand-asphalt scratch coat. Figures 2-13 show typical views of the experimental and control sections on I-91.
