## Pavement Drainage in Seasonal Frost Area, Ontario

J.B. MACMASTER, G.A. WRONG, AND W.A. PHANG

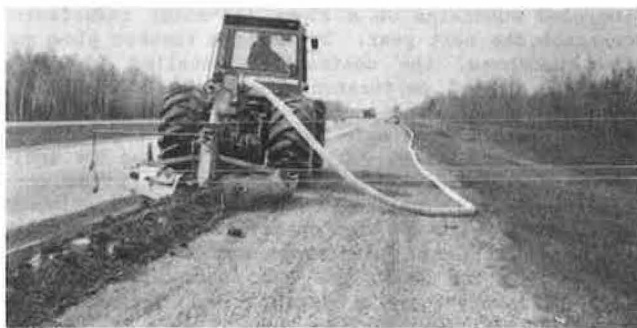
Figure 8. Trenchless plow mounted on rubber-tired tractor.

On recent projects, tracked plows have been replaced by rubber-tired units (Figure 8). This move has increased average daily production from 16 to 23 km (10-14 miles). In addition to providing operator comfort, the new method is advantageous because the pavement surface is no longer marred by the steel tracks. Tubing is now supplied in 1200-m (4000-ft) rolls, thus reducing the handling required.
