Symposium on  
Aspects of Subsurface  
Drainage Related to  
Pavement Design and  
Performance

Transportation Research Record 849  
Price \$6.00  
Edited for TRB by Naomi Kassabian

LABORATORY AND FIELD STUDIES OF CHANNELING AND PUMPING Barry J. Dempsey . . . . .	1
SUBBASE PERMEABILITY AND PAVEMENT PERFORMANCE Gary L. Hoffman . . . . .	12
PAVEMENT DRAINAGE IN SEASONAL FROST AREA, ONTARIO J.B. MacMaster, G.A. Wrong, and W.A. Phang . . . . .	18
SIMULATING PAVEMENT PERFORMANCE UNDER VARIOUS MOISTURE CONDITIONS Michael J. Markow . . . . .	24
PUMPING MECHANISMS OF FOUNDATION SOILS UNDER RIGID PAVEMENTS Lutfi Raad . . . . .	29

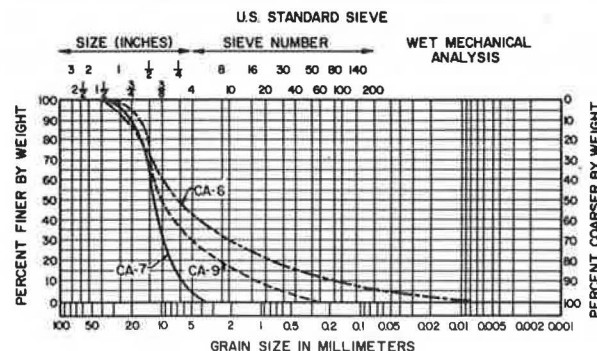
Figure 3. Gradation curves for base courses used in model tests.

The CA-6 base-course test provided different results than the CA-7 base course, and pore-pressure changes in excess of 20.7 kPa (3 psi) were observed during loading. Table 2 and Figure 3 show CA-6 to be a dense-graded aggregate with a low permeability. The variations in pore pressure were extremely erratic with position in the base course and no pattern could be discerned. However, separate and distinct flow paths were seen in this base-course material, as shown in Figure 5. It appeared that small air bubbles trapped between the particles during saturation would rise to the surface during loading and create a path that water, carrying soil particles, would follow. Large amounts of fine-grained material, most of which passed the 75- $\mu$ m (No. 200) sieve, were pumped along the sides of the slab (joint between tank wall and slab) and through the joint between the slab and the shoulder to the surface of the slab.

The pore-water pressure results from the test by using the CA-9 base-course material were similar to those from using the CA-6 material and peaked at about 20.7 kPa. As seen in Table 2 and Figure 3, CA-9 has an intermediate gradation between the CA-7 and CA-6 material. CA-9 is not considered to be a highly permeable material, as has been shown above. Figure 6 shows some of the fine material from CA-9 being moved toward the bottom of the joint between the concrete slab and asphalt-concrete shoulder. As found with the CA-7 base course, load durations of 0.1 or 1.0 s had little effect on the excess pore pressures in the CA-6 and CA-9 base courses.

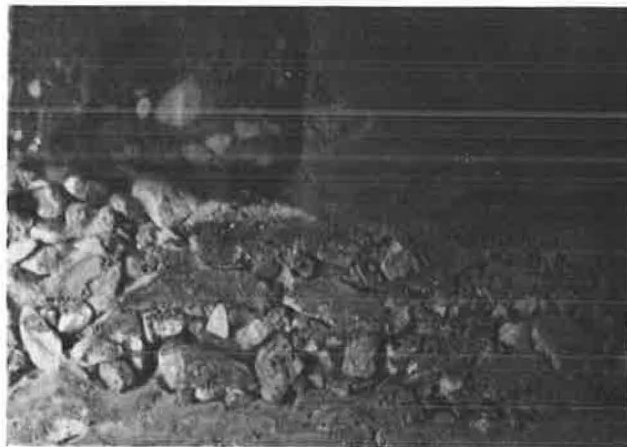
Figure 6. Fine material moving toward concrete slab and asphalt concrete shoulder joint in CA-9 base course.

Figure 8 (top) shows more clearly the influence of number of load applications at various stress levels on pore-water pressures in CA-6 and CA-9 base courses. The top diagram in Figure 8 shows a general trend for the pore pressure to increase as the number of loads increases; the bottom diagram shows more erratic pore-water pressure changes with load applications on the CA-6 and CA-9 materials. The fact that the pore-water pressures vary considerably with position in the base may indicate that channels are created that allow passage of water and the transfer of fine materials as noted in Figures 5 and 6.

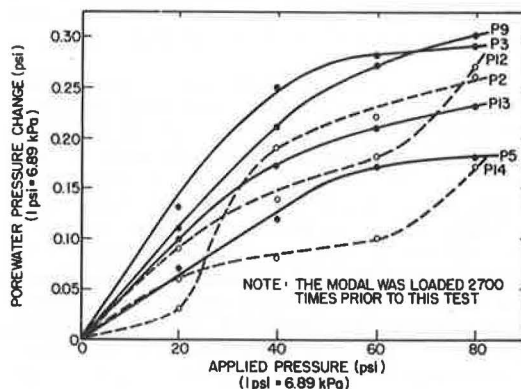
Figure 7 shows the excess pore-water pressure at several positions in the CA-6 base course as the load is increased from 0 to 551.5 kPa (0-80 psi) (see Figure 2 for piezometer locations). The general trend was an increase in pore pressure as the load increased and a diminishing rate of increase as the load became larger. The highest pore pressure occurred directly below the loading plate. The somewhat erratic changes in pore pressure recorded at P2, P12, and P14 may be caused by instrumentation error or by changes in the base-course material during the loading sequence. It was found during testing that the pore pressures would increase uniformly with load as long as the local aggregate structure remained unchanged.

Figure 7. Influence of applied load on excess pore-water pressure in CA-6 base course.

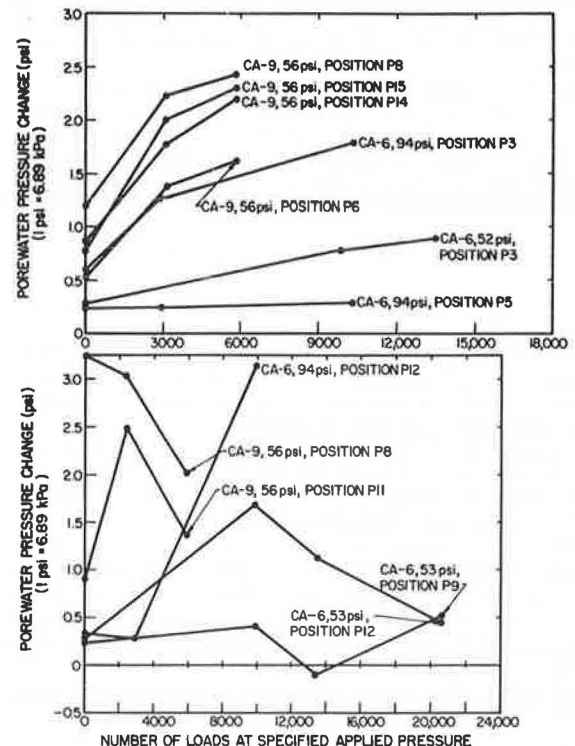
Figure 8. Influence of number of load applications on excess pore-water pressure.

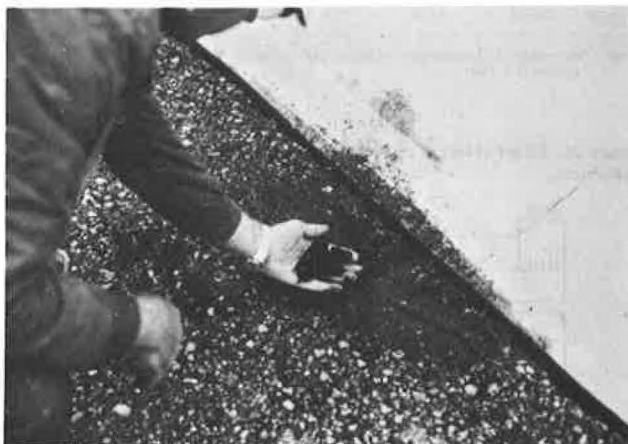
Figure 21. BAM pumped from beneath continuously reinforced concrete pavement.

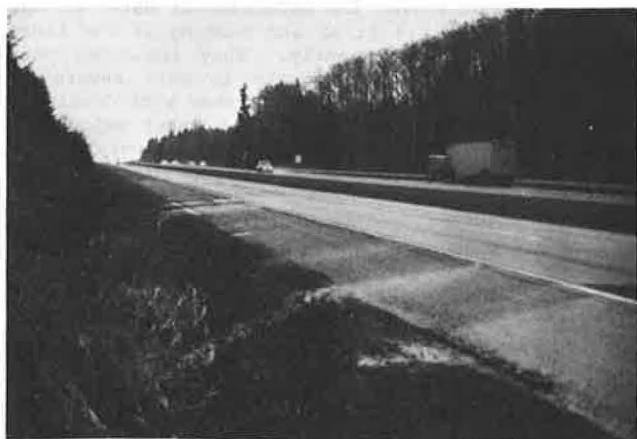
It was found that pavements located on long gradients in rolling topography were often most vulnerable to pumping and bleeding of water and fines from the support materials. Figure 19 shows water and fine material flowing out from beneath a jointed concrete pavement system located on a long gradient. It is probable that water channeling also exists in this pavement system. In some areas with rolling topography, pavement cuts through the top of a hill will often intercept groundwater sources, which will cause water flow along the pavement profile. This condition is easily recognized by the growth of cattails or other water plants in the ditches at the crest of the hill.

Figure 19. Water and fine material flowing out from beneath jointed concrete pavement on long gradient.

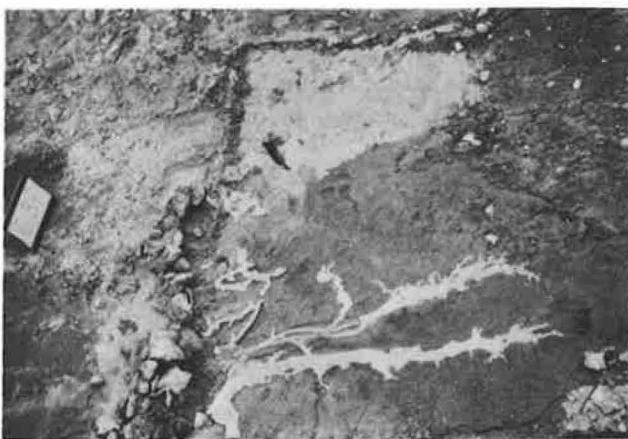
Figure 22. Channeling marks at interface between concrete slab and cement-treated base.

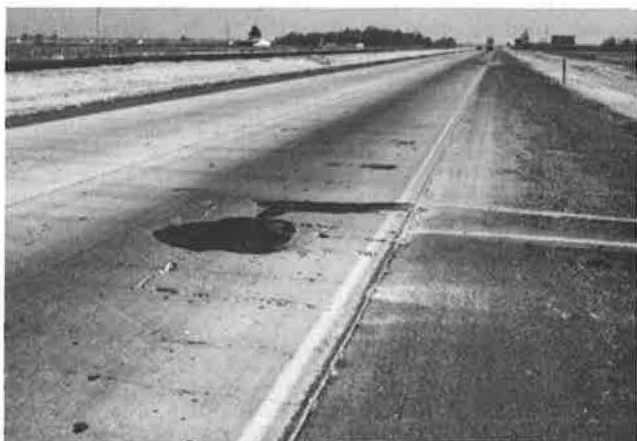
Figure 20. Pumping associated with continuously reinforced concrete pavement.

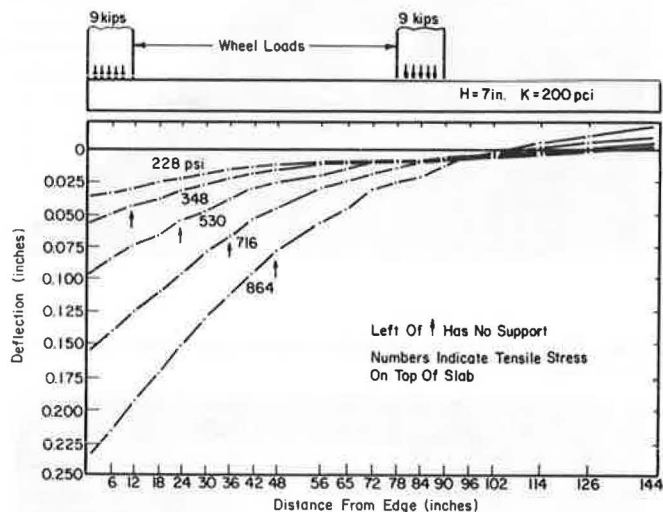
Figure 24. Effect of loss of pavement edge support on critical stresses and deflections.

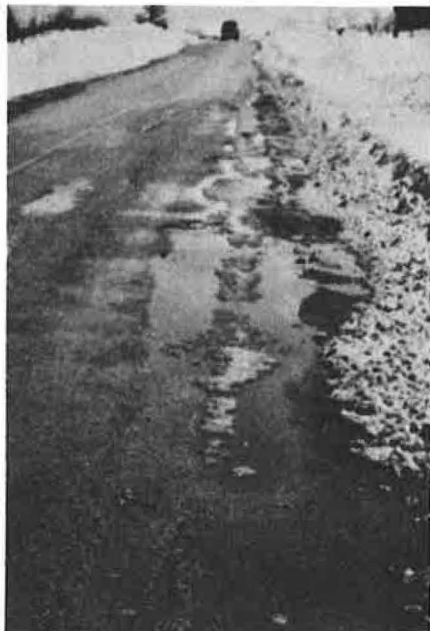
Figure 1. Snowmelt trapped by plowed snowbanks.

During the winter, most precipitation remains frozen above ground in the form of ice and snow. Snowbanks created by winter plowing operations tend to restrict the movement of water produced from salting operations or direct sunlight (Figure 1). This melt water remains on the granular shoulders long enough to infiltrate the base and subbase layers and enter through cracks in the pavement. During warm winter days the granular shoulder adjacent to the pavement may thaw slightly, due to the heat-absorbing qualities of the asphalt. The standing water can then penetrate and further saturate the base. While the granular base beneath the pavement thaws, the remainder of the shoulder, insulated by the snowbanks, remains frozen. The result is a trough or bathtub effect in which water is trapped beneath the surface. During the night, this moisture freezes and causes the pavement to heave. Repeated freeze-thaw cycles in late winter and early spring overstress the asphalt and cause longitudinal cracking to develop at the pavement edge. In time, these cracks progress inward toward the wheel-track area and when pavement courses are thin [less than

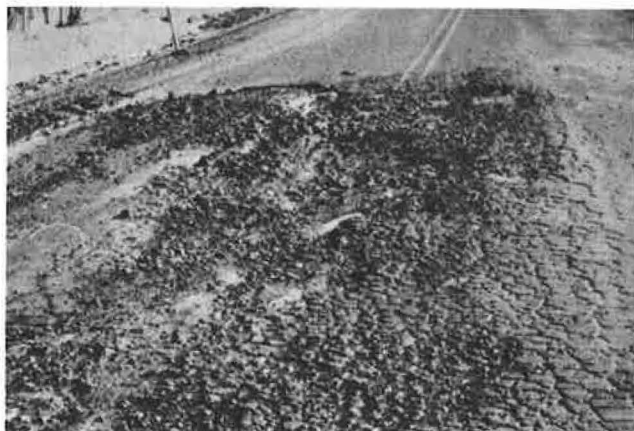
Figure 2. Spring breakup due to poor subsurface drainage.

40 mm (1.5 in)] eventually cause pavement breakup. Frozen drainage ditches can also aggravate the bathtub effect and result in pavement breakup such as that in Figure 2.

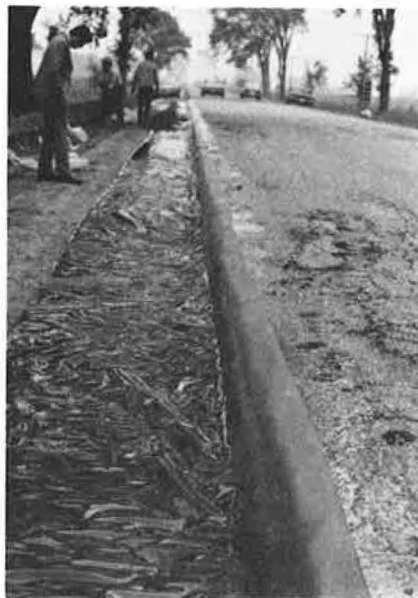
Figure 3. Plastic edge skirts in gravel shoulder.

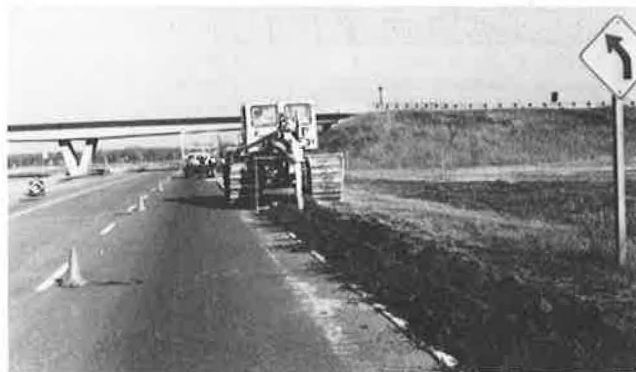
Figure 5. Installing plastic pipe subdrains by using trenchless plow.

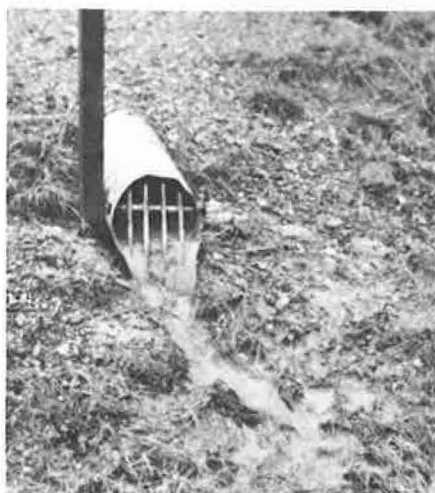
Figure 6. Discharge from pavement edge subdrain.

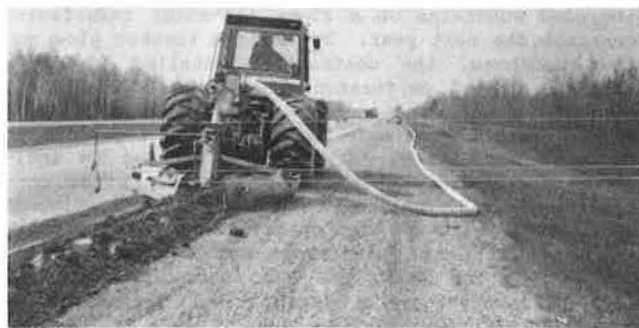
Figure 8. Trenchless plow mounted on rubber-tired tractor.

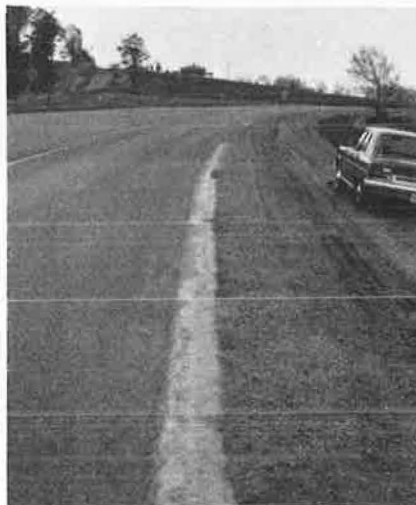
Figure 11. Primed gravel shoulder three years after application.
