Effects of Concrete Deterioration on Bridge Response

DAVID B. BEAL AND WILLIAM P. CHAMBERLIN

Two reinforced-concrete T-beam bridges, constructed in 1931 with similar cross-section dimensions and properties, now show major differences in the appearance of their concrete. As a result, inspectors have rated one as having "serious deterioration and not functioning as originally designed" and the other as being in "new condition". Bridge engineers are responsible for translating these subjective evaluations into predictions of the structures' load-carrying capacity, but little information is available to permit quantification of the consequences of concrete deterioration on bridge response. The two bridges were instrumented to determine tension reinforcement stress under an equivalent HS-20 truck positioned on the bridge deck. The results showed no difference in behavior attributable to concrete deterioration. Theoretical justification for this result was established by showing the variation in reinforcement stress expected as a function of compressive concrete loss and reduction in concrete strength. In both cases, the magnitude of the resulting stress change was shown to be small an

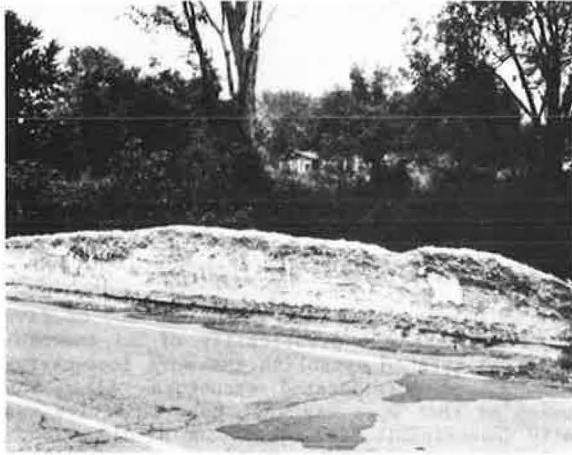
Figure 2. Bridge 1.

The overall appearance of the concrete in bridge 1 was one of advanced deterioration. Curbs and parapets were badly eroded due to paste damage (Figure 2), and large areas of concrete had spalled from the underside of T-beam stems and fascia beams (Figure 3), exposing rusted steel reinforcement. The vertical faces of all beams exhibited extensive cracking, which generally paralleled their axes. Efflorescence was common. Measurements of sonic pulse velocity through the stems of three girders yielded values in the 1700- to 4400-ft/s range, which indicates concrete with generally low strength and elastic properties.

Both bridges were rated visually by state forces as part of a routine biennial inspection (3). On a scale of 1 (potentially hazardous) to 7 (new condition), the primary members of bridge 1 were rated 3 (serious deterioration or not functioning as originally designed) because of severe concrete deterioration (see Figures 2 and 3), particularly in T-beam stems and in the lower extremity of the fascia beams. By contrast, the primary members of bridge 2 were assigned a condition rating of 7 because of their generally sound appearance (see Figures 4 and 5).

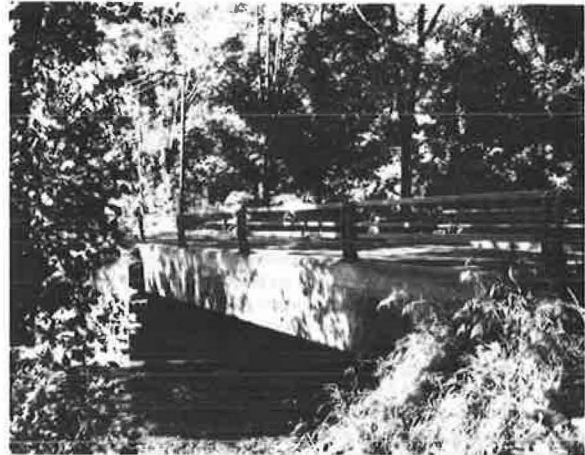
Figure 4. Bridge 2.

By contrast, the concrete in bridge 2 was in excellent condition (Figures 4 and 5). No scaling or spalling was evident on structural elements or on the underside of the deck, and both were free of cracking. Pulse-velocity measurements through the stems of two girders were in the 12 400- to 14 200-ft/s range, which indicates concrete of at least moderate quality.

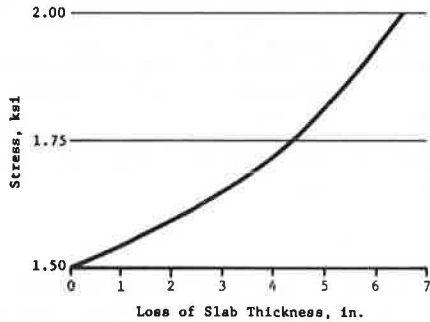
Figure 7. Variation in steel stress with slab thickness.

The consequences of loss of compression area can be evaluated by considering a specific T-beam section representative of the bridges tested. The section is subjected to a constant moment, and the variation in steel stress with decrease in slab thickness is evaluated. It can be seen in Figure 7 that steel stresses increase at an increasing rate. Although the variation in stress over the range of thicknesses shown is great, it should be realized that losses greater than about 3 in would weaken the ability of the slab to perform its primary function of resisting wheel loads.

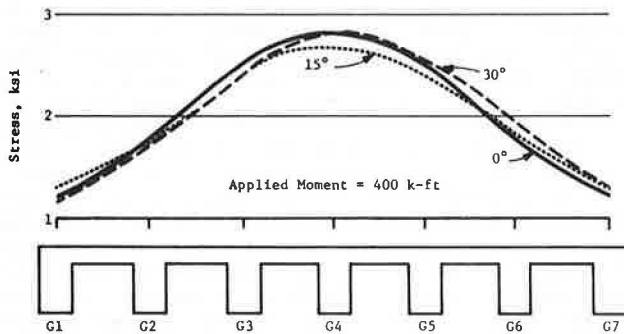
Figure 8. Effect of support skew on transverse influence line.

Because of structural differences in the bridges, direct comparison of measured values is not possible. However, differences in response due to span length and support skew angle can be eliminated by normalizing the result to a constant level of mid-span bending moment. Although support skew causes a marked change in the bending moment resisted by individual girders, there is an accompanying change in the total bending moment. Because of these changes, the variation in transverse distribution of bending moment is small for skew angles less than 30° (see Figure 8).
