*TRANSPORTATION RESEARCH RECORD* 853

# Concrete Analysis and Deterioration

*TRANSPORTATION RESEARCH BOARD*

# D-Cracking: Pavement Design and Construction Variables

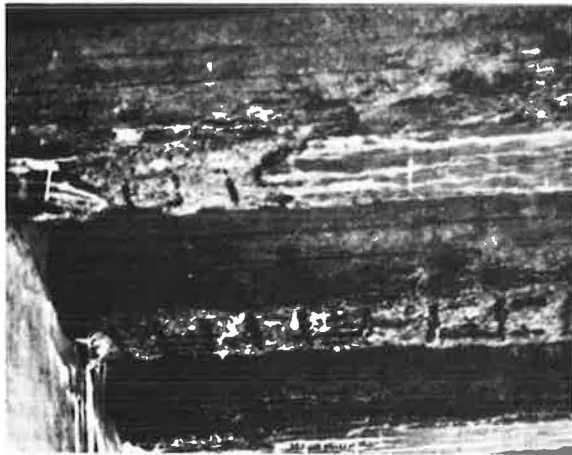
Figure 3. Deterioration of T-beams in bridge 1.

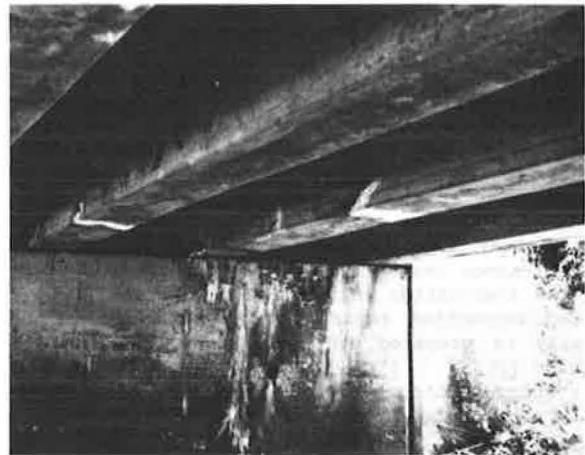
Figure 5. Condition of T-beams in bridge 2.

have been rated 4 (minimum adequacy to tolerate present traffic, immediate rehabilitation necessary to keep open).
