## Evaluation of Platinized Niobium Wire Anodes for Cathodic Protection of Bridge Support Structures

H.J. FROMM AND F. PIANCA

An investigation was conducted to determine whether platinized niobium wire could be used as anode material to provide cathodic protection without neces-

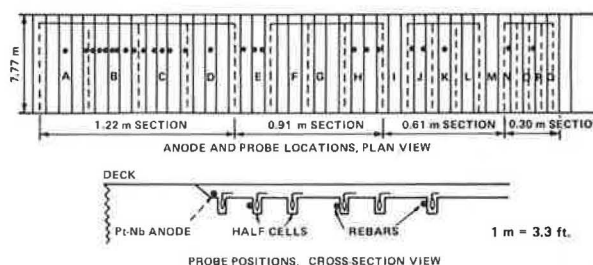
Figure 1. Anode and probe locations.

In order to determine the applied and polarized potentials on the rebars, a series of small copper and copper sulfate half-cells were set in holes drilled into the deck. The positions of these half-cells and the anodes with reference to the rebars are shown in Figure 1. Each half-cell was connected by its own wire to a jack on the control panel (Figure 2). The applied or "instant-off" voltage could then be read at the panel by a high-impedance voltmeter.

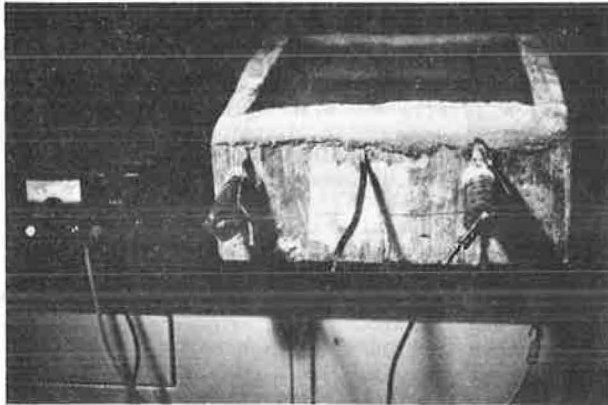
Figure 4. Laboratory test specimen.

anodes and their effect on the concrete. A concrete specimen 400 mm by 300 mm by 120 mm (16 in x 12 in x 5 in) was made. This experimental specimen contained two prerusted rebars. These were set 200 mm (8 in) apart and positioned 25 mm (1 in) below the surface. The concrete used contained 2 percent salt (NaCl) by weight of the cement. Therefore, a corrosive condition existed and, at the same time, an excess of free chloride ions was present. After the specimen had been cured, three grooves were cut in its surface to a depth of 6 mm (0.25 in). Two of these grooves were directly over the rebars; the third was midway between these rebars. Platinized anode wires were placed in these grooves and covered with grout. A dyke was formed on the surface around the entire specimen. Water was ponded on the surface and cathodic protection was applied to the specimen by using a wire anode directly over one rebar. In order to get a polarized potential of 1 V on the other rebar, 7 V were required for this protection. The experimental slab and connections are shown in Figure 4.

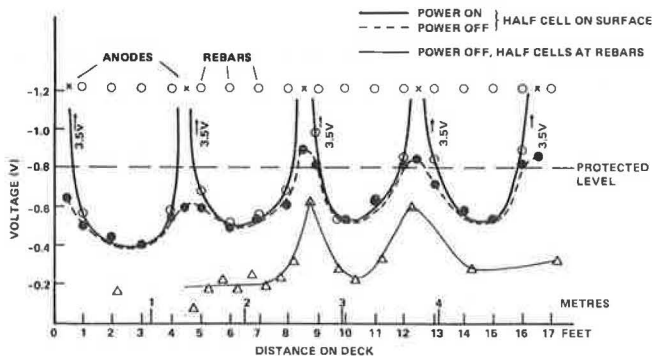
Figure 5. Voltage versus distance, 1.22-m section, applied voltage 6.0 V.

The voltage readings on the surface over the anodes were higher than those obtained at rebar level, the reason being that the anode wires were closer to the surface than to the imbedded half-cells. Samples of the series of readings taken are shown in Figures 5, 6, and 7. The on-instant-off readings are shown for those taken on the surface and only the instant-off readings for the subsurface half-cells. The on readings for these were very close to the off readings.

Figures 5 and 6 show that readings taken near the anodes were high but dropped off rapidly as the distance from the anode increased. In the 1.22-m (4-ft) section (Figure 5), the potential midway between two anodes was approximately 20 percent of the value obtained over the anode. This midpoint potential was not sufficient to protect the rebars. A minimum value of -0.8 V is required. To achieve

The deck readings shown in Figures 5, 6, and 7 were taken just after the deck surface had dried after a rainstorm. It seemed to make no difference when the readings were taken. Just after a rainstorm and dry, dry after several days, or summer or winter, the readings were all very similar.

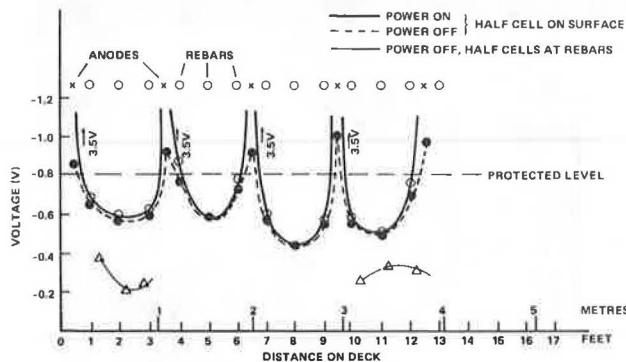
Figure 6. Voltage versus distance, 0.91-m sections, applied voltage 6.0 V.

proper protection, the rectifier would have to operate at a higher potential than the 6 V used here. Such a high potential could cause disbonding of the concrete from the rebars in areas close to the anodes (5). Sufficient potential for protection was not achieved in either the 0.9-m (3-ft) or the 0.61-m (2-ft) section, as is shown in Figures 6 and 7.

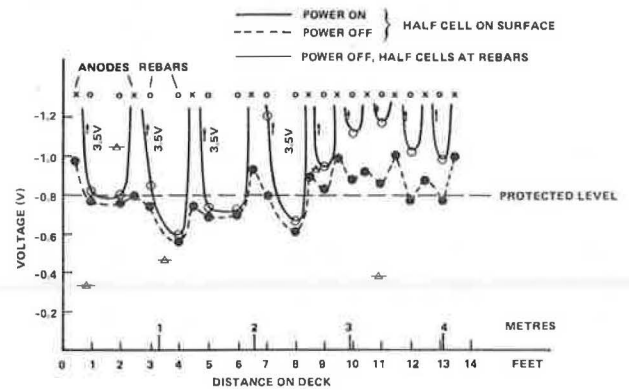
Figure 7. Voltage versus distance, 0.61-m and 0.3-m sections, applied voltage 6.0 V.

The instant-off voltage was higher and more acceptable only in the 0.3-m (1-ft) spacing section

(Figure 7). However, this spacing was not acceptable since it would greatly add to both the material and construction costs of the installation and would be too labor-intensive for most applications.

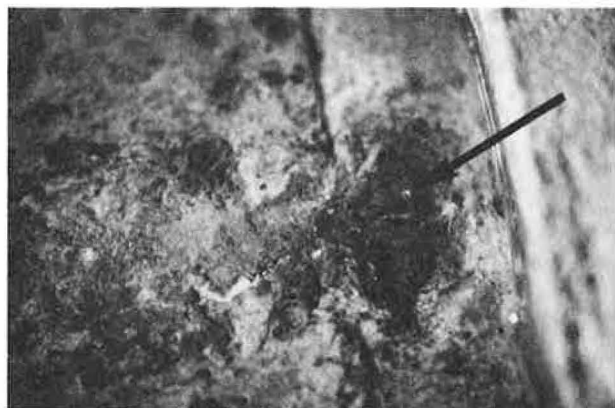
Figure 8. Acid attack over anode on laboratory specimen.

The laboratory slab sample, which was described previously, showed some damage. The grout used to cement the wire anodes in the grooves had been attacked in three places and the bare wire exposed. Each of the three anode wires was used in turn as the powered anode, and a green stain of copper chloride formed over the concrete. The acid action also caused a build-up of yellow-green foam at the center of attack. This was caused by escaping carbon dioxide. This gas was formed as the acid attacked the carbonates in the concrete. One of the attack sites and the exposed wire are shown in Figure 8.

Water was ponded on the surface of the laboratory experimental specimen. Cathodic protection (7 V) was applied to the specimen by means of an anode directly over a rebar. Three days later, a cavity 6 mm long developed directly over the current-carrying anode. The other anodes were used to apply power to the specimen, and cavities appeared over these anodes. This also is discussed in the following section.

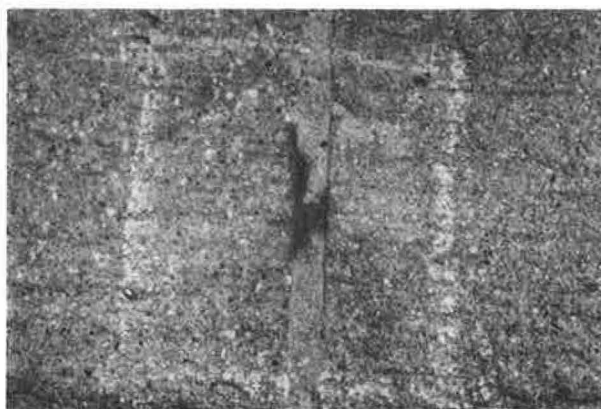
Figure 11. Developing center of acid attack.

On the bridge, after six months of application of cathodic protection, several active centers developed. Figure 9 shows an area in which five active centers developed close together, and the Pt-Nb wire was exposed. Figure 10 shows one center in which the wire was exposed, and Figure 11 shows a de-

veloping center. This bridge is under heavy ramp traffic and no water or moisture would remain on the surface for any length of time; the traffic would remove it and hence no stains of copper chloride were visible.

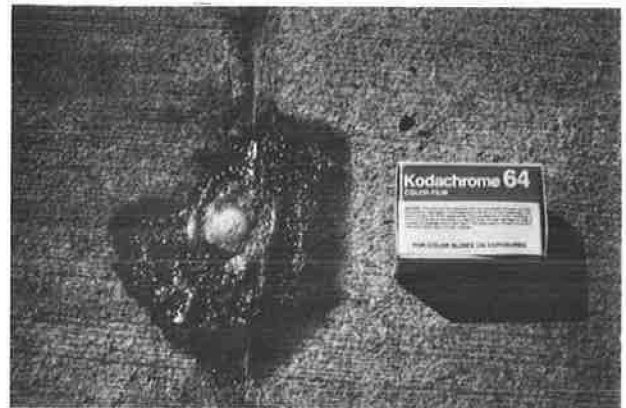
Figure 14. Municipal bridge: acid attack center.

One bridge, belonging to the City of Toronto, had an experimental system of platinized wire installed on it more than two years ago. The road surface was covered with asphaltic concrete, thus concealing the anode grooves. There were two lines of grouted-in anode wire visible down the length of each sidewalk. There were many locations along each of the anode lines and the dark areas where attack was taking place (Figure 12). The concrete in some of these areas was soft and could be dug out with a knife blade. Figure 13 is a close-up of a center in which active attack on the concrete was taking place and a cavity had formed. The froth over the center was caused by escaping  $\text{CO}_2$  gas. The moisture in the cavity was tested with pH paper. The paper stained a deep red, showing a pH of 1 or less, indicative of a high acid concentration. The wire was exposed in the bottom of the hole and the platinum color was showing; all of the copper coating had been eaten by the acid. Several such active centers were observed on the deck. Another is shown in Figure 14.

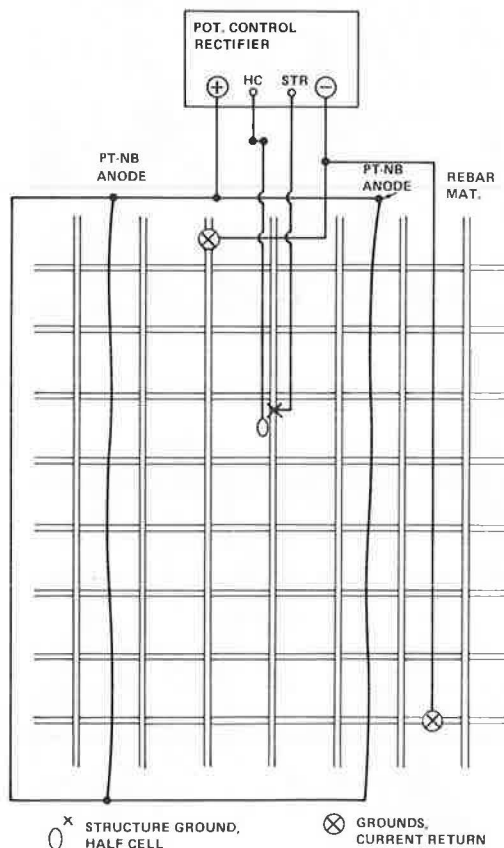
Figure 15. Circuit diagram for cathodic protection with Pt-Nb wire.

It has been shown by Scott (6) and Vrable (5) that the application of larger amounts of current, more than is needed for effective cathodic protection, can cause a weakening of the bond between the rebar and the surrounding concrete. In the normal cathodic protection system, the current is distributed evenly over the deck by a conductive asphaltic concrete layer from which it flows to the rebars. In the wire system, there are points at which the current is concentrated and others at which the flow is considerably smaller. This can be seen by an examination of Figure 15. Here the Pt-Nb wires were

stretched and grouted in grooves 19 mm (0.75 in) deep midway between the transverse rebars. They were thus 152 mm (6 in) from each transverse bar. Where they crossed the longitudinal bars, however, they were only about 55 mm (2 in) above them. There would be, then, three times the current density flowing at each longitudinal rebar crossing as was flowing to each point on the transverse rebars. This concentrated current could weaken the bond between the rebar and the concrete after a period of time. This loss of strength might not be too serious in a slab bridge deck where the deck is supported on beams. It could, however, be a serious matter if the system were applied to, say, a parking garage floor in which there are no supporting beams between the pillars or to a support system under a bridge deck.
