*TRANSPORTATION RESEARCH RECORD* 860

# Snow Control, Traffic Effects on New Concrete, and Corrosion

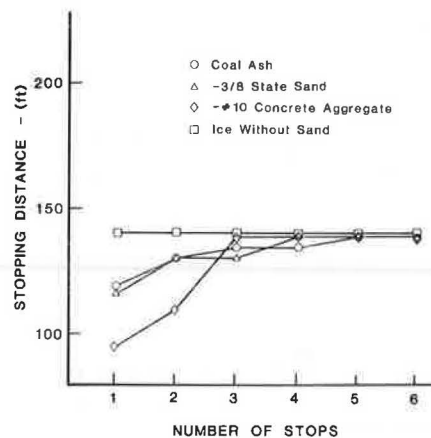
Figure 11. Effects of different sands on stopping distance for repeated stops on smooth road ice.

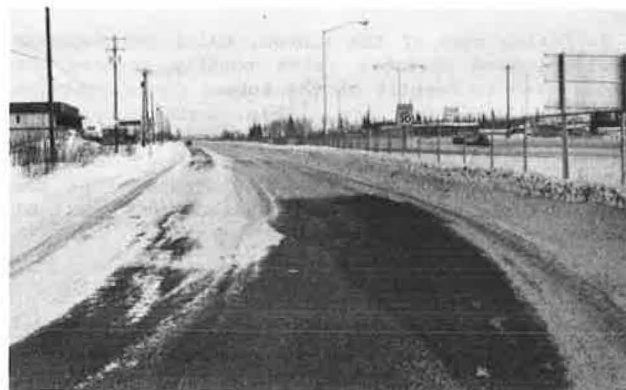
Figure 12. Demonstration of ice-free benefits of rubber-modified asphalt pavement (foreground) versus ice-covered normal pavement (background), Feb. 1980.

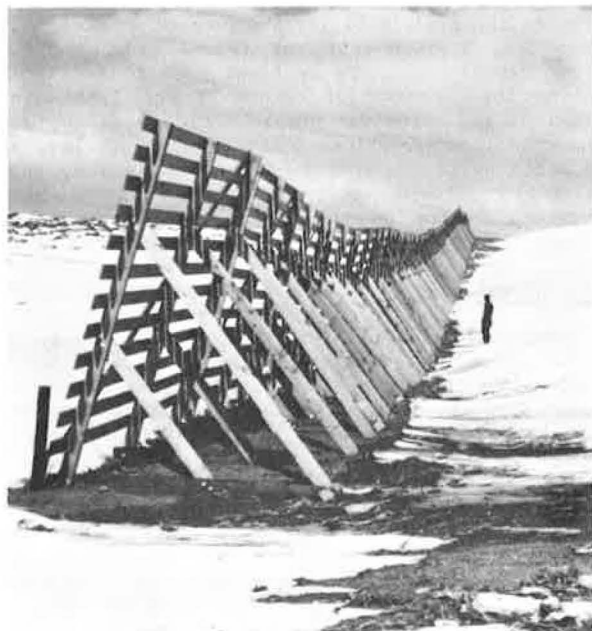
Figure 2. Standard 3.78-m snow fence used on I-80 (Mile 254.2, Feb. 18, 1972).

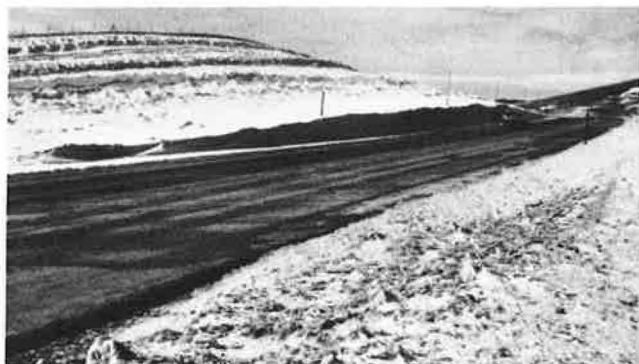
Figure 4. Snow accumulation at Mile 269.5 on Feb. 19, 1971, before installation of snow fences.

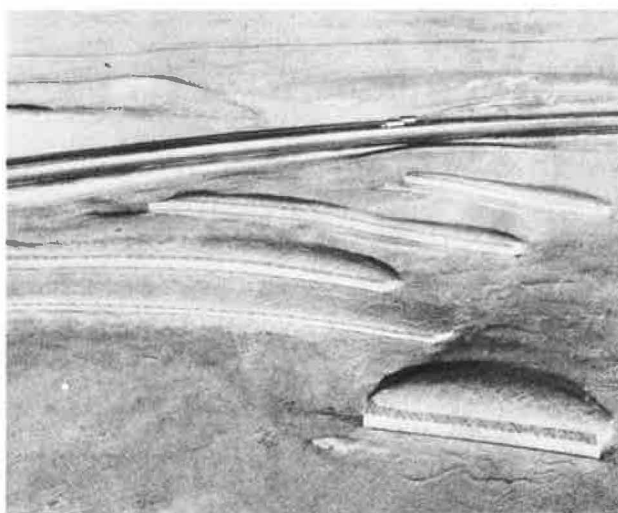
Figure 6. Aerial view of system protecting cut at Mile 269.5 on Feb. 11, 1972.

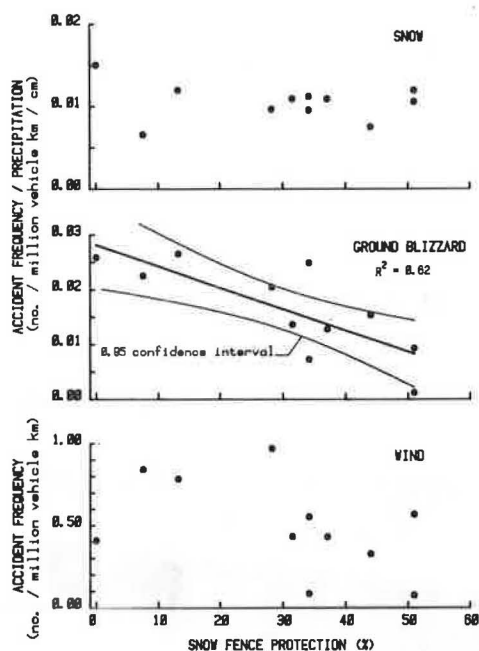
Figure 8. Snow, ground blizzard, and wind accidents in relation to percentage of highway protected by snow fence.

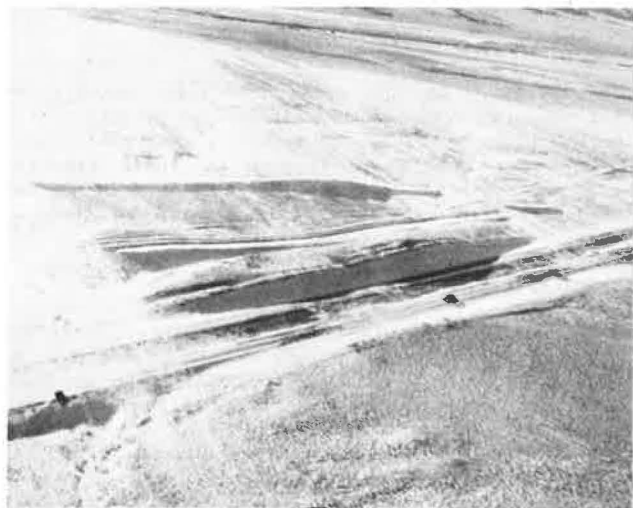
Figure 9. Aerial view of two rows of 3.78-m snow fence showing effect of fences on visibility (Mile 263, Feb. 11, 1972).

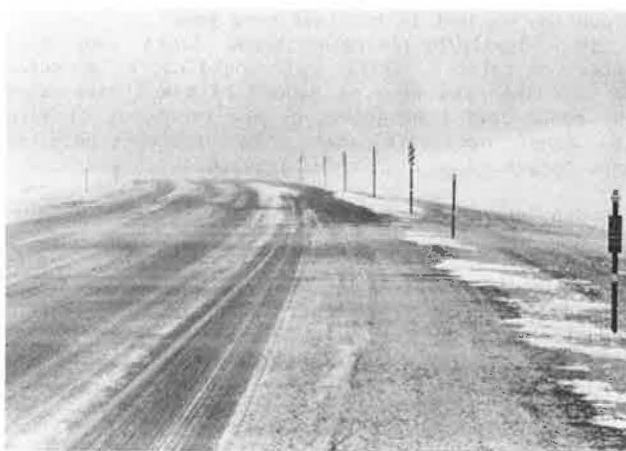
Figure 11. Visibility of same area as in Figure 10 inside area protected by two rows of 3.78-m snow fence.

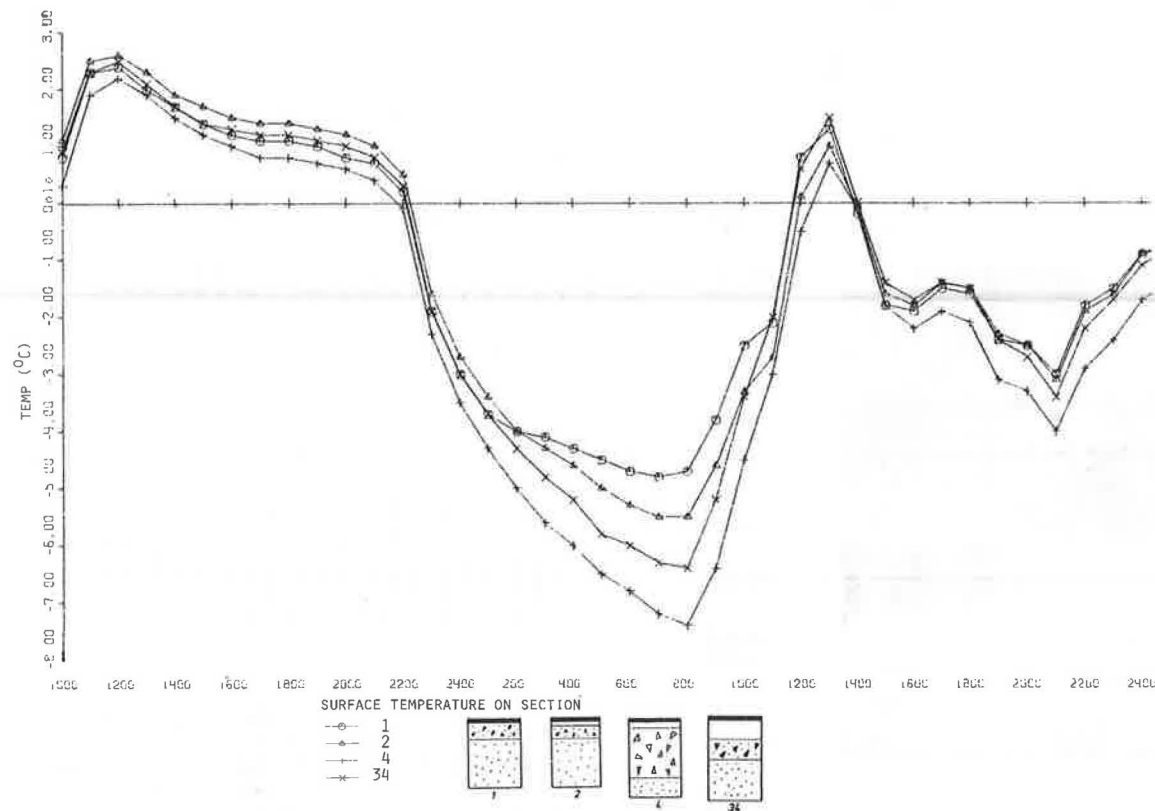
Figure 7. Surface temperature on uninsulated Sections 1, 2, 4, and 34, November 17-18, 1977.

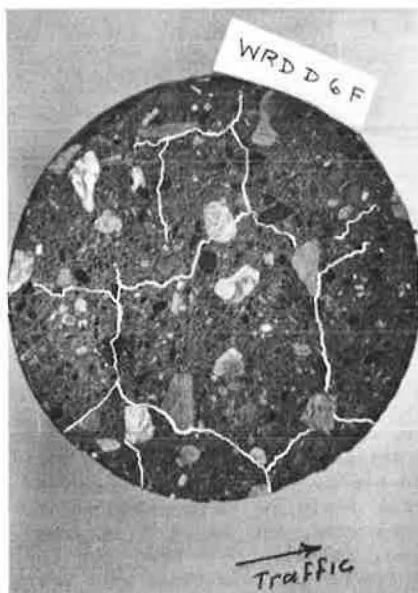
Figure 9. Trace of cracks on polished surface of 4-in-diameter concrete core.

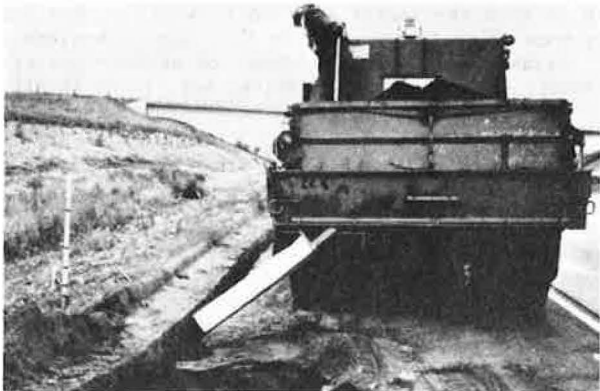
Figure 7. Placement of coke breeze.

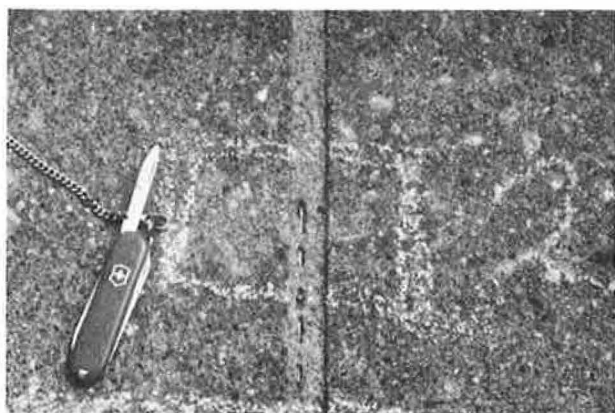
Figure 9. Five centers of acid attack in grout.

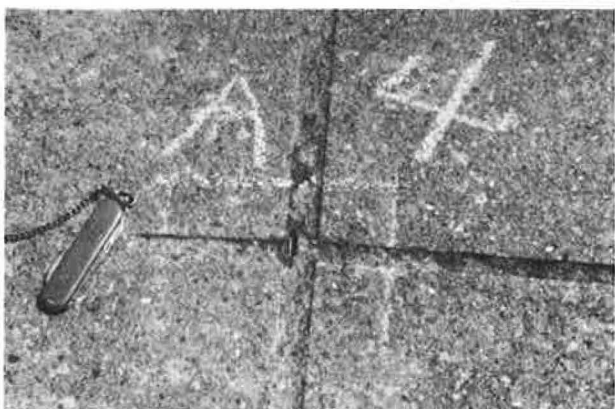
Figure 10. Single center of acid attack in grout.

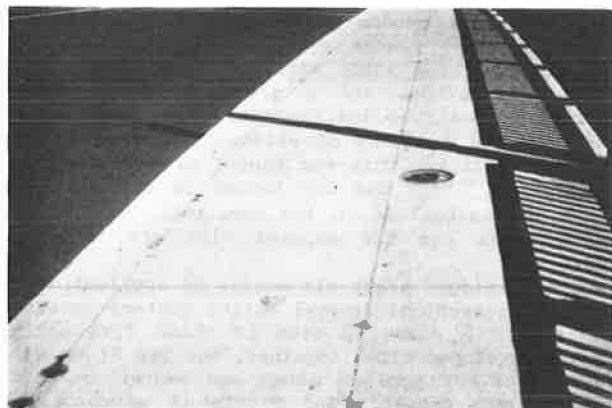
Figure 12. Municipal bridge: centers of acid attack along anode wires in sidewalk.

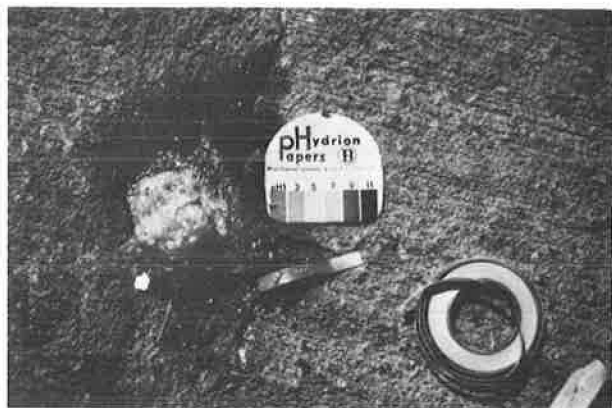
Figure 13. Municipal bridge: acid attack center,  $\text{CO}_2$  foam and pH < 1.

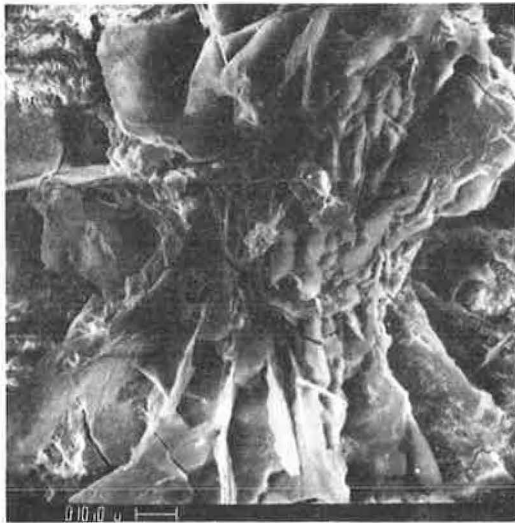
Figure 2. Boxwork of rust crystals in concrete (scale =  $10\mu$ ).

The lathlike and fretwork crystal forms shown in Figures 1, 2, and 3 are common forms for goethite (4). The bulk of the massive or globular rust seems to be limonite, which would not show up in the X-ray because limonite is noncrystalline. The rust laths were found in rusty spots at the surface of concrete as much as 2 in above the corroding reinforcing steel. Figure 6 was made at such a location.

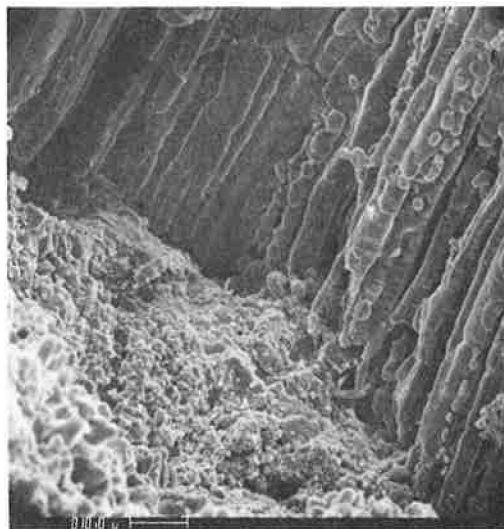
Figure 8. Columnar crystal growths of halite in concrete.

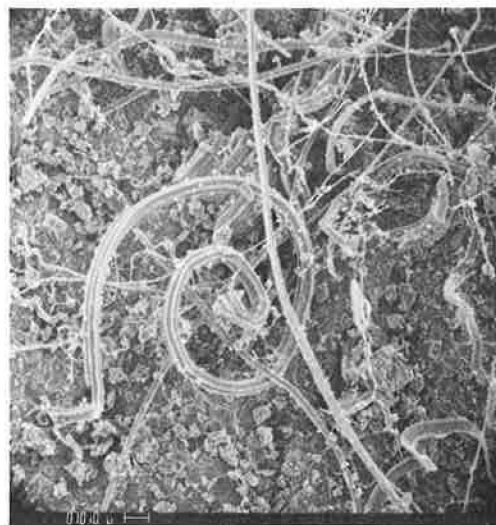
Figure 9. Spiral, ribbon, and fiber crystal growths of halite in concrete.
