# Safety Treatment of Roadside Drainage Structures

HAYES E. ROSS, JR., DEAN SICKING, T.J. HIRSCH, HAROLD D. COONER, JOHN F. NIXON, SAMUEL V. FOX, AND C.P. DAMON

The purpose of the research was to develop traffic-safe end treatments for cross-drainage and parallel-drainage structures that would not appreciably restrict water flow. Preliminary designs were first evaluated by computer simulation, by use of a test pit in which the clear open space and grate spacing could be varied, and by use of an earth berm similar in geometry to a driveway. Promising designs were then subjected to full-scale prototype testing by using both subcompact and full-sized automobiles. Finally, guidelines for implementation of designs were developed by using a cost/benefit analysis. Traffic-safe culvert end treatments can be achieved as follows. For cross-drainage structures, (a) all culvert ends not shielded by a traffic barrier should be made to match the existing side slope with no protrusion in excess of 4 in (10.2 cm) above grade, (b) culverts with clear openings 30 in (76.2 cm) or less need no safety treatment other than that mentioned in a, and (c) culverts with clear openings greater than 30 in ca

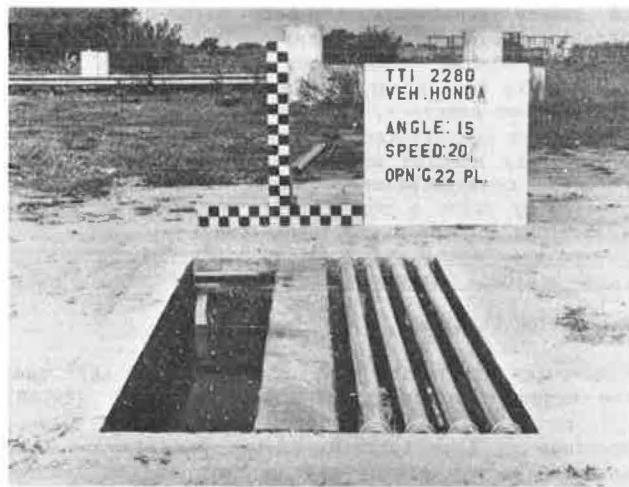
Figure 2. Test pit installation.

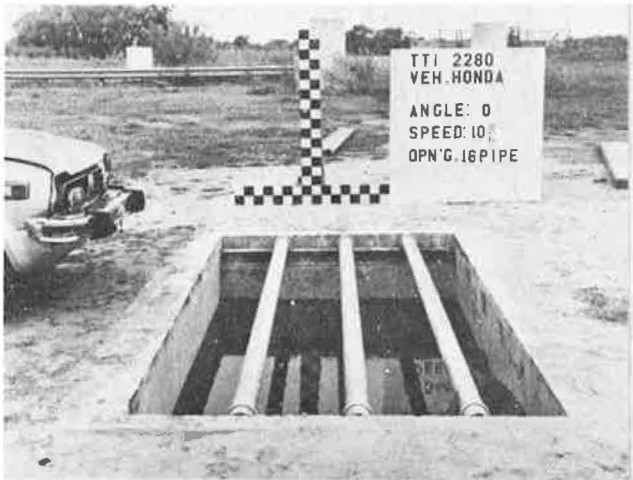
Figure 4. Test pit with 16-in grate spacing.

On completion of the clear-opening tests, the pit was used to determine the maximum permissible grate spacing. A total of 22 live-driver tests were conducted for this purpose. Table 2 gives a matrix of the grate-spacing tests conducted. The grates were 3-in (7.6-cm) schedule-40 steel pipe anchored to a steel beam that allowed adjustments of the pipe to any desired spacing. Figure 4 shows the pit setup for a 16-in (40.6-cm) grate spacing. Each grate configuration was evaluated with the 1974 Honda Civic. A 1975 Plymouth Fury that weighed about 4500 lb (2043 kg) was also used to evaluate the larger grate spacings.

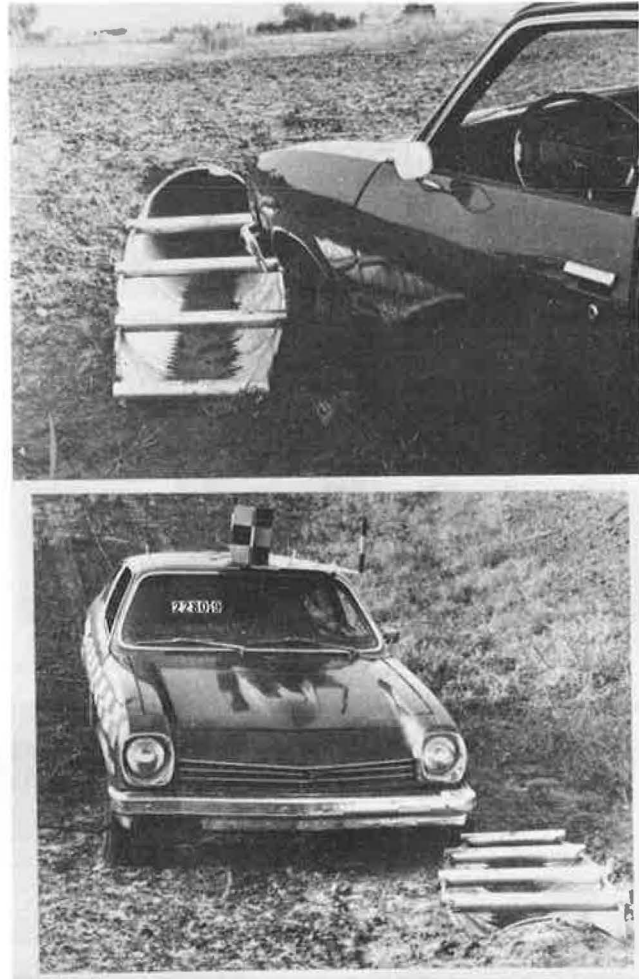
Figure 16. Test site, tests 9-1 and 9-2.

The final two tests (tests 9-1 and 9-2) were selected to verify the tentative conclusions reached as a result of the simulation work and the full-scale slope and culvert testing. A full-scale prototype of a ditch and driveway configuration was constructed as shown in Figure 15 and the photographs of Figure 16. Test 9-1 was conducted at 40 mph (64.4
