Solar Radiation Effects on Frost Action in Soils

CHESTER W. JONES

Engineers should be aware of solar radiation effects of frost action in soil foundations on the performance of surface structures. Damage to concrete canal drop structures and lining from frost heave on shaded sides in contrast to sun-exposed sides is described. To demonstrate passive solar effects on frost penetration, winter temperatures were measured on the concrete surfaces and in the soil subgrade beneath black-painted and unpainted concrete linings on shaded and sun-exposed sides of a small canal. Periodically, data on air temperatures, snow cover, and cloudiness were collected and incident radiation and radiation reflected from the different concrete surfaces were measured. Frost penetrated 37 percent less on the painted, sun-exposed side than on the unpainted, sun-exposed side. Because of longwave, nighttime radiation, frost penetrated 28 percent more on the painted shaded side than on the unpainted shaded side. For the unpainted concrete, frost penetrated 9-13 percent less on sun-exposed than on shaded sides.

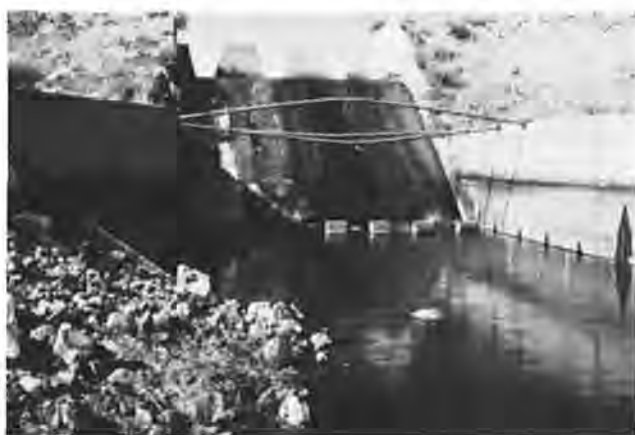
Figure 1 shows a rectangular inclined canal drop of reinforced concrete affected by frost action. This canal runs east-west and the inward deflection of concrete walls has been mostly on the south side where shading occurs in winter; the lateral force of soil frost action on the wall is apparent from the bending of the 75-mm-diameter steel pipes added for support. Some of the wall backfill on the shaded side has been removed to relieve pressure, and weep holes have been drilled to lower the water table. The sun-exposed wall is relatively undamaged although the drainage from weep holes shows the presence of groundwater. The reinforced concrete floor of the chute has also been damaged from differential frost heave; greater heave occurred in the south half than in the north half.

Figure 1. Damage caused by frost action in soil on shaded south side of canal drop structure.

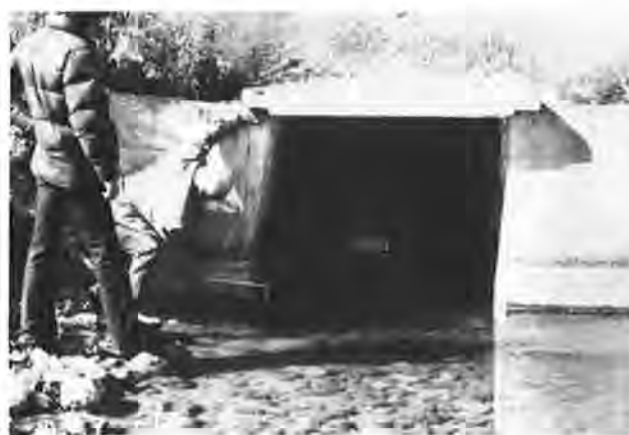
Frost damage on the outlet of a rectangular inclined drop of reinforced concrete is shown in Figure 2. Here the top of the south wall of the east-west oriented structure has tipped inward about 200 mm. As a maintenance procedure, a concrete cap superimposed with soil has been added to prevent

Figure 2. Wall deflected inward by frost pressures in soil.

possible collapse of the wall.

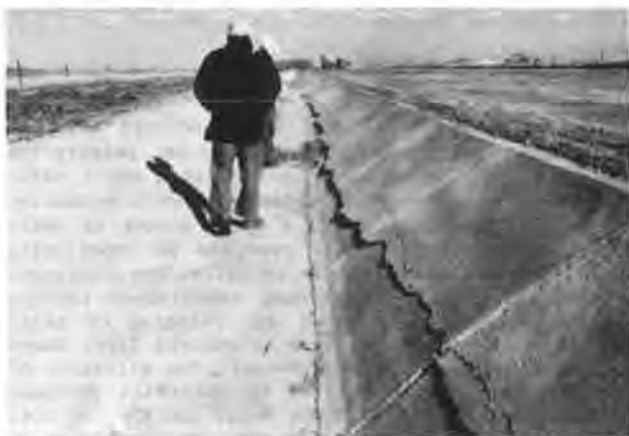
Figure 3. Breakage during spring thawing period of concrete canal lining on south side of east-west oriented canal.

Figure 3 shows frost-heave damage to a 65-mm-thick slip-formed concrete lining in a small canal. At the crack in the side slope, the upper portion of the lining is offset upward an amount about equal to the lining thickness. This canal is oriented east-west and the greatest damage by far is on the south-side slope, which is completely or partly shaded at times when the sun is low over the southern horizon in winter. The damage occurred mostly during a two-week period in March after a particularly cold winter. Apparently, during the winter, frost action in the soil subgrade heaved the concrete relatively uniformly without causing noticeable cracks. When thawing occurred in March, the soil under the north slope, exposed more or less directly to the sun, thawed faster than that on the south side and the concrete was broken by the differential settlement. Although other factors such as the insulating effects of snow may have been involved, a study of the angle of the sun on the lining in winter (Figure 4) offers a possible basis for explaining the slow uni-

Exploration at the end of March showed ice lenses still under the south slope. Subsequently, after complete thawing of the soil, the offset was reduced to about 25 mm. For north-south oriented canals, insolation is more even on both sides of the canal and damage from frost heave is usually much less.

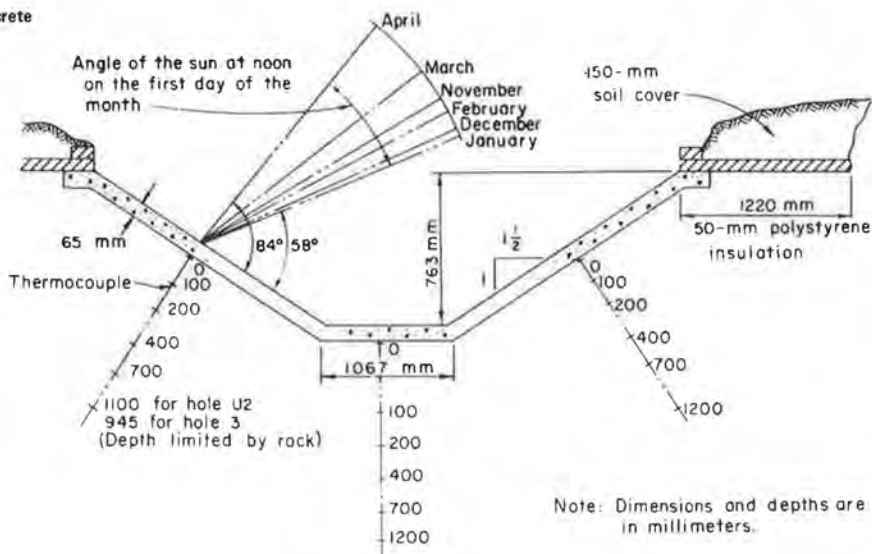
Figure 4. Cross section of concrete lining and angle of sun on sun-exposed slope.

The intensity of insolation on a plane surface depends on the angle of the sun's rays with the surface; the highest intensity is when the angle is 90°. A plot of sun angles on the sun-exposed north side of the canal lining is shown in Figure 4; these were computed from the angle of the side slope and with the latitude and the declination of the sun.

A cross section of the lining with the location of thermocouples beneath the concrete is shown in

Figure 4. Thermocouples were installed by (a) coring a 100-mm hole through the concrete; (b) augering a hole in the soil below, perpendicular to the concrete surface; (c) placing the thermocouples, which were loosely attached at the desired spacing to a lath in the hole; (d) refilling the hole around the thermocouples with a soil-water slurry; and (e) filling the concrete hole with fresh concrete. The thermocouple wires were of the polyvinyl-coated, copper-constantan type. They were connected to multiple-position switches mounted on steel posts. A thermocouple to record air temperature was located about 1 m from the ground surface in a specially constructed wooden box attached to one of the switchbox posts. When temperatures were to be measured, a digital thermometer was connected to one of the switches and the temperature at each thermocouple was read by switching from one to another.

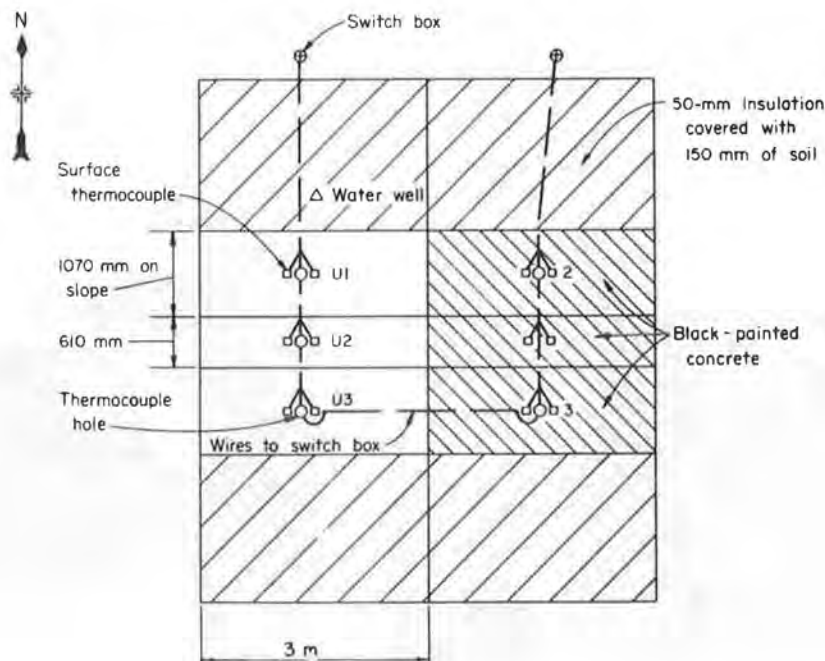
Figure 5. Plan of frost test section.

The test sections consisted of two adjacent sections of concrete lining, each about 3 m in length (Figure 5). Polystyrene insulation 50 mm in thickness with a 150-mm soil cover was placed on each side of the canal lining to prevent frost penetration from outside the lining.

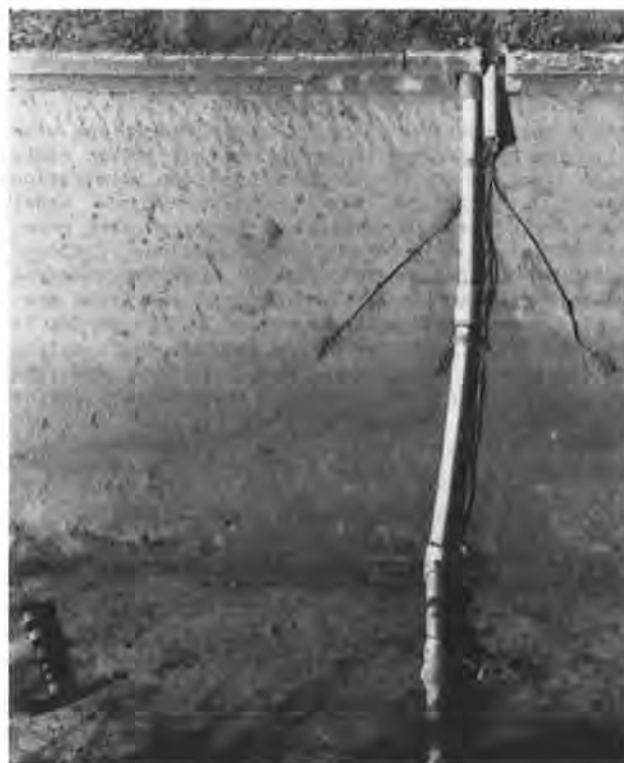
After a thorough cleaning of the concrete surface, one section of lining was covered with one coat of primer and two coats of black vinyl acetate paint (Figure 6). Surface thermocouples were installed in pairs on the sides (Figure 7) and bottoms of the painted and unpainted test sections. The thermocouple tips were attached to the concrete with screws and black or clear silicone sealant.

Figure 7. Thermocouples for measurement of surface temperatures on unpainted concrete lining.

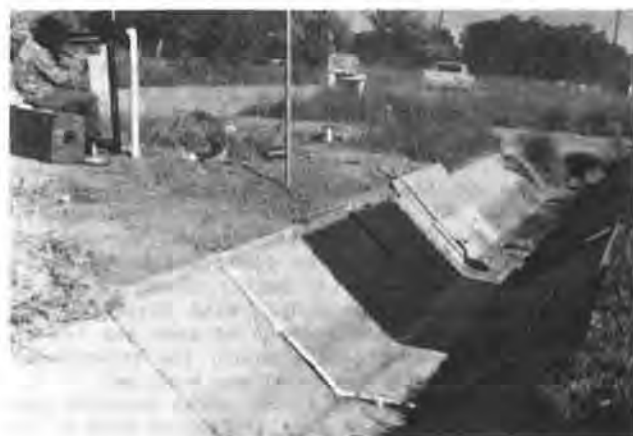
Figure 6. Black-painted concrete lining with unpainted control section in foreground.

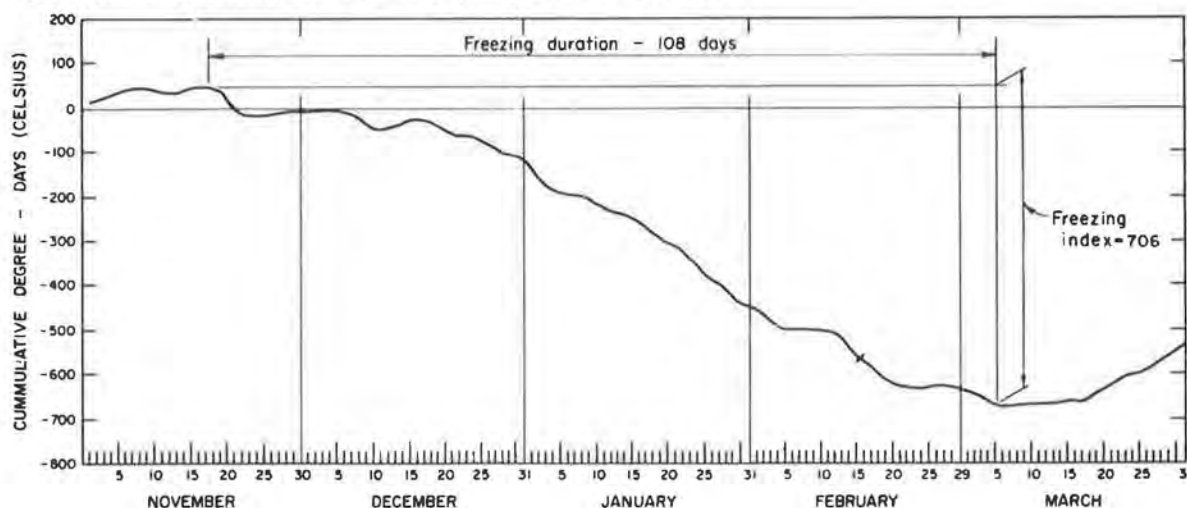
Pavillion is located at 43°50' north latitude and 108°41' west longitude at an elevation of 1660 m. A cumulative degree-days curve, based on air temperatures recorded at Pavillion, is given in Figure 8; this type of curve is useful for comparing temperatures in different locations (6). This shows that the freezing index was 706 Celsius degree-days; each degree-day is the algebraic difference between the average of maximum and minimum daily temperatures and 0°C. The freezing duration for the winter of 1977-1978 was 108 days.

Figure 8. Cumulative degree-days curve for Pavillion, Wyoming, for winter of 1977-1978.

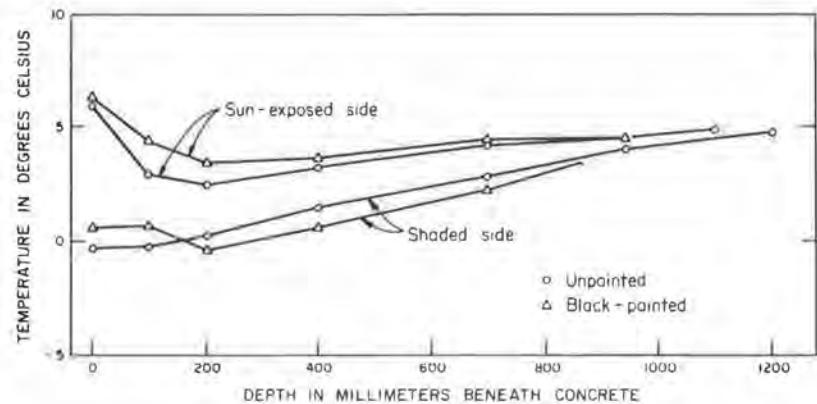
Averages of all temperatures measured at each thermocouple beneath the concrete are plotted in Figure 9. The temperatures of both black-painted and un-

painted concrete were higher on the sun-exposed side than on the shaded side by about 6°C at zero depth (bottom of the concrete) and less than 1°C at 1000 mm. Compared with the unpainted concrete, the higher average temperatures beneath black-painted concrete on the sun-exposed side and lower temperatures beneath this type of surface on the shaded side are also seen.

Figure 9. Averages of temperatures measured below concrete canal lining during winter of 1977-1978.

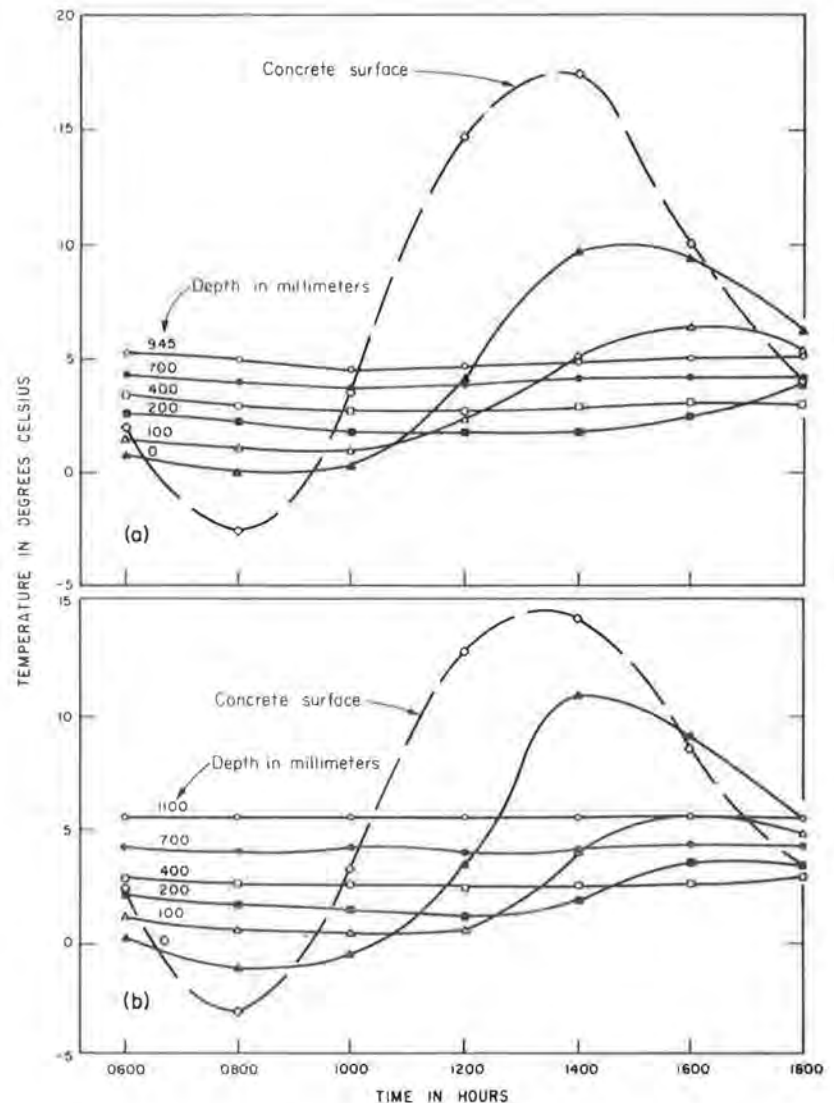
An example of a one-day record of concrete surface and soil subsurface temperatures is shown in Figures 10 and 11. On clear days or when clouds were not heavy, the plots of temperatures during the day show a wide variation between temperatures at

the surface and beneath the concrete on the sun-exposed side. As would be expected, this was much less on the shaded side.

Figure 10. Temperatures on surfaces and in soil beneath (a) painted and (b) unpainted concrete canal lining, December 13, 1977.

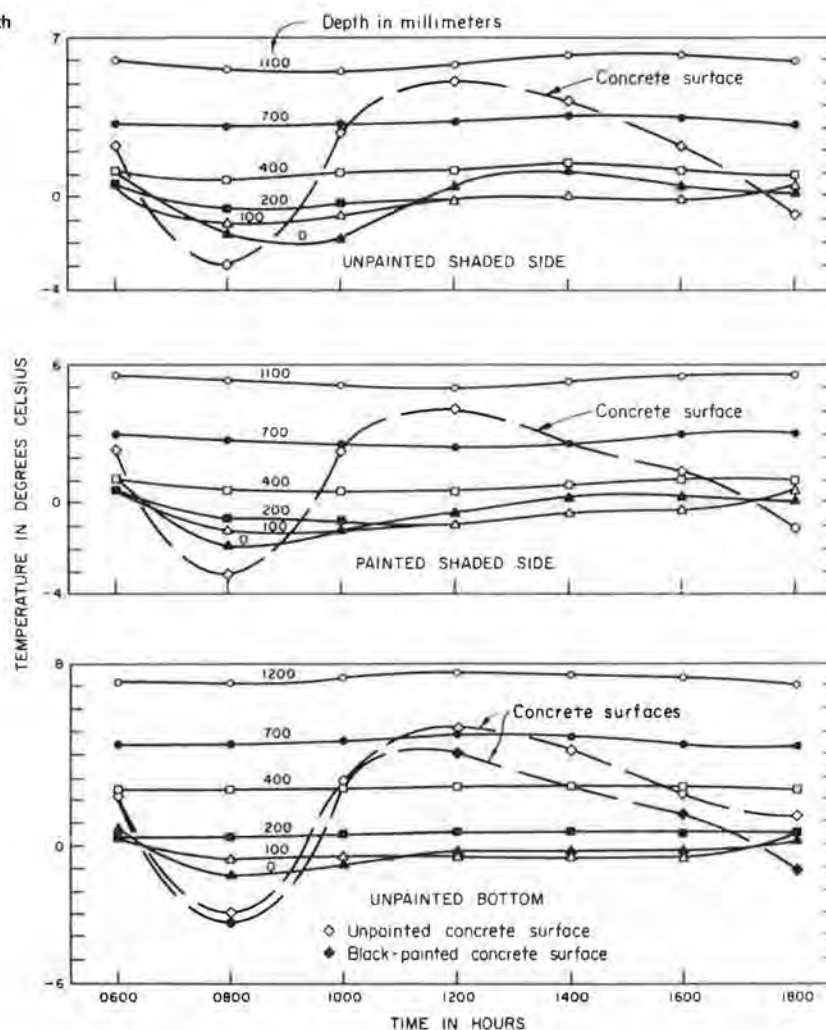
Figure 11. Temperatures on surfaces and in soil beneath painted and unpainted concrete canal lining on shaded sides and on unpainted bottom, December 13, 1977.

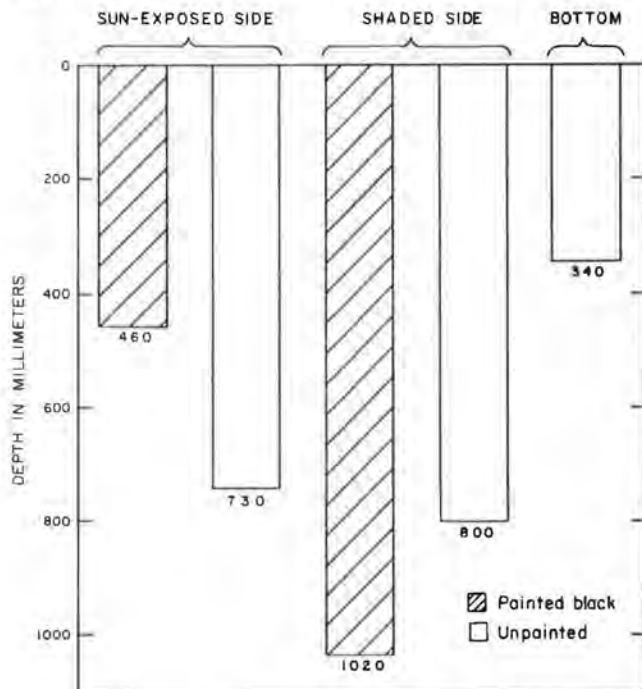
A plot of maximum frost penetration is shown in Figure 12. Although the black surface generally absorbed more radiation than the unpainted concrete during the day, this was offset by the longer-wave radiation from the black surface at night. Therefore, although the black surface reduced frost penetration 37 percent on the sun-exposed side, it caused an increase in penetration of 28 percent on the shaded side.

For the unpainted section, frost penetration was 9 percent less on the sun-exposed side of the canal compared with that on the shaded side. During the preceding winter, temperatures on the same section indicated that frost penetration was about 700 mm on

Figure 12. Maximum frost penetration beneath concrete canal lining.

the sun-exposed side compared with 800 mm on the shaded side; the difference was 13 percent.
