## Performance of Various Thicknesses of PCC Pavement

JOHN I. HELMERS AND VERNON J. MARKS

If adequately designed and high-quality material and good construction practices are used, portland cement concrete is very durable. This is demonstrated by the oldest pavement in Iowa (second oldest in the United States), which was paved in 1904. It performed well for 70 years without resurfacing. The design thickness is an important factor in both the performance and cost of pavement. The objective of this paper is to provide a 30-year performance evaluation of a pavement constructed to determine the required design thickness for low-volume secondary roadways. In 1951 Greene County and the Iowa Highway Research Board of the Iowa Department of Transportation initiated a 4-mile (6.4-km) demonstration project to evaluate thicknesses that ranged from 4.5 to 6 in (11.4-15.2 cm). The project, which consisted of 10 research sections, was formed pavement placed on a gravel roadbed with very little preparation except for redistribution of the loose aggregate. Eight sections were nonreinforced except for centerline tie bars, and no contraction joints were used. Mesh reinforcing and contraction joint

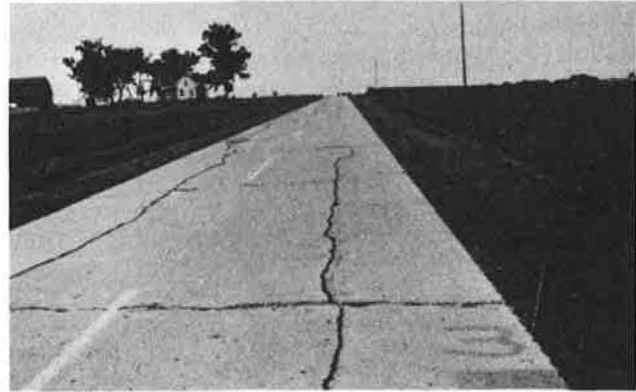
Figure 4. Typical pavement condition of 4.5-in nonreinforced slab in section 3.

Typical surface appearance of the pavement is shown in Figure 4 [4.5-in (11.4-cm) nonreinforced] and Figure 5 [6-in (15.2-cm) nonreinforced]. Even though transverse joints were not sawed, the random cracking in the 6-in pavement produced a relatively uniform spacing and an orientation nearly perpendicular to the centerline. Most of the transverse cracking occurred early in the life of the pavement. In the thinner sections, little additional cracking developed after the first two years. Transverse cracks continued to develop in the 6-in pavement through 28 years but at a declining rate.

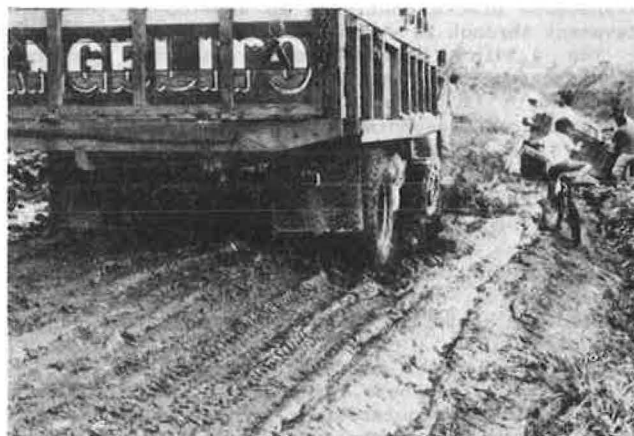
Figure 1. Failure of unsurfaced road.

Many unsurfaced roads constructed in accordance with the best design technology have failed well before their predicted life expectancy. Such an unexpected failure is shown in Figure 1. Normally, these failures are attributed to the development of very high moisture content in the subgrade, moisture substantially greater than the in situ moisture content found in the natural subgrade prior to construction. This moisture buildup in localized subgrade areas cannot be predicted; it is frequently attributed to changes in topography, drainage, and environmental factors that develop during and after construction. It is rarely assumed that all of the natural subgrade would become saturated because this would lead to conservative, low-strength values for the natural subgrade that would generate thick and costly pavement.
