Recycling Bituminous Concrete Through Use in Cement-Treated Base: Case Study, Fredonia Streets

KATHRYN M. DREASEN AND JOHN E. LAWSON, JR.

The reconstruction of a low-volume road through Fredonia, Arizona, was the first pavement structure constructed under contract to the Arizona Department of Transportation (ADOT) that incorporated an old road base, including ground bituminous concrete, into a cement-treated-base (CTB) design. The shortage of nearby suitable road-base material resulted in the consideration of stabilization of the existing pavement structure. If cement stabilization was to be used, ADOT experience indicated that an asphalt-rubber stress-absorbing membrane interlayer would be required to inhibit reflective cracking through the asphalt surface. Three different structural sections were constructed based on varying soil types and availability of recyclable road base. On this particular project, the use of a CTB that incorporated reprocessed bituminous concrete and aggregate base from the previous pavement structure saved ADOT approximately \$120 000. This savings is based on a structurally equivalent pavement that consisted of full-depth asphaltic concrete and costs b

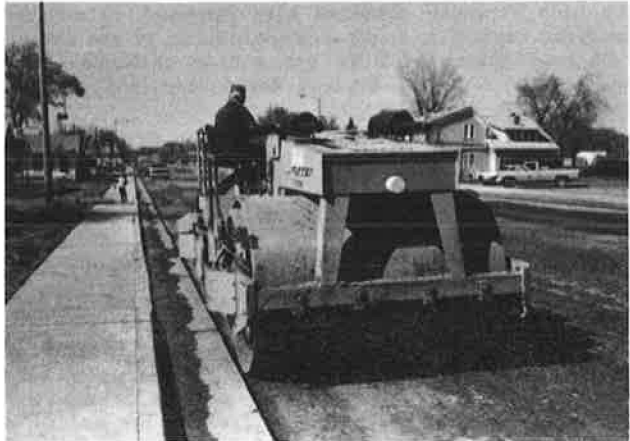
Figure 6. Finishing with pneumatic roller.

5. Compaction was achieved in 2 h by means of a vibratory steel-wheeled roller. Finishing was completed with a pneumatic roller (see Figure 6).

Percent compaction was checked at random in one location in the 300-ft run. Special provisions specified compaction at 95 percent of maximum density by using ARIZ Test Method 230 (Field Density by the Sand Cone Method). Compaction was easily achieved by three passes of a 9T vibratory steel-wheeled roller. Surface irregularities were smoothed out by using a rubber-tire roller.

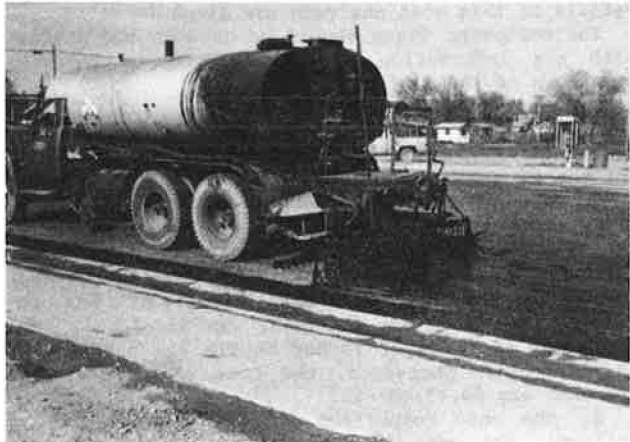
Figure 7. Placing of asphalt-rubber SAMI.

No traffic was allowed on the treated base for 48 h after the curing seal had been applied. An asphalt-rubber SAMI was placed by the Arizona Refining Company (ARCO) across the full roadway width in accordance with specifications (see Figure 7). The chip spreader followed immediately behind the ARCO asphalt-rubber spreader. Several weeks later, the AC was laid in 2-in lifts over the three sections.

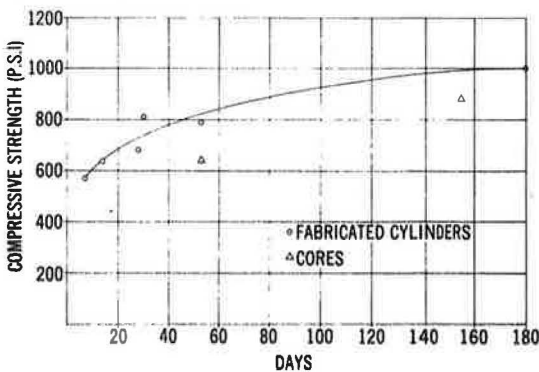
Figure 8. Average compressive strength of cores and laboratory-fabricated cylinders.

Table 2 illustrates these compressive strengths. The averages and standard deviations of the compressive strengths were determined for the five different curing periods. A plot of the average gain of compressive strength with time is shown in Figure 8. This graph represents a 1.7 percent strength gain/day from the 7th to the 14th day, a 0.5 percent strength gain/day from the 14th to the 28th day, a 0.5 percent strength gain/day from the 28th to the 56th day, and a 0.2 percent strength gain/day from the 56th to the 180th day. This gradual gain of strength is to be expected in cement-stabilization projects, provided that cold weather is not encountered early in the curing process.

In addition to this testing, cores were taken from the roadway at various time intervals and tested for compressive strength. A 53-day-old core taken from the roadway broke at 640 psi. Cylinders fabricated in the laboratory from roadway-mixed material broke at 732 psi at 56 days. This difference represents a 12.6 percent increase in strength from laboratory compaction and curing to field compaction and curing. Cores were again taken from the roadway at approximately 155 days; the average compressive strength was 880 psi. The remaining cylinders fab-

4. CTB continues to gain strength with time. The 155-day-old cores had a compressive strength of nearly 900 psi. Strengths of this magnitude lead to skepticism concerning the conservativeness of the structural coefficients awarded to CTB. If long-term strengths in the range of 1000 psi were predictable, perhaps structural coefficients more compatible to those awarded to AC could be assigned to CTB. Part of the long-term evaluations will compare the performance of the so-called structurally inequivalent sections and determine if a higher structural coefficient could be awarded to the CTB based on its performance.
