# Rural Cold Recycling

STEWART R. SPELMAN

Rural cold recycling in two eastern national parks is discussed and recent data are presented on a reevaluation of the existing pavement on one project. The first project discussed was built in the Cape Cod National Seashore Park in Massachusetts. This project consisted of recycling an existing pavement in place for use as a base material for a new bituminous concrete pavement. The roadway was closed to traffic during the construction except for emergency traffic. This project was successful and presented no problems. The second park project consisted of recycling an existing bituminous pavement after removal in Catoctin Mountain Park near Thurmont, Maryland. Part of this project used an emulsion as a compaction aid for the recycled material, which was used as a stabilized base under the new pavement. This project had a number of problems. The results of recent Dynaflect measurements and pavement core evaluations are discussed and compared with earlier measurements and the original mix design data.

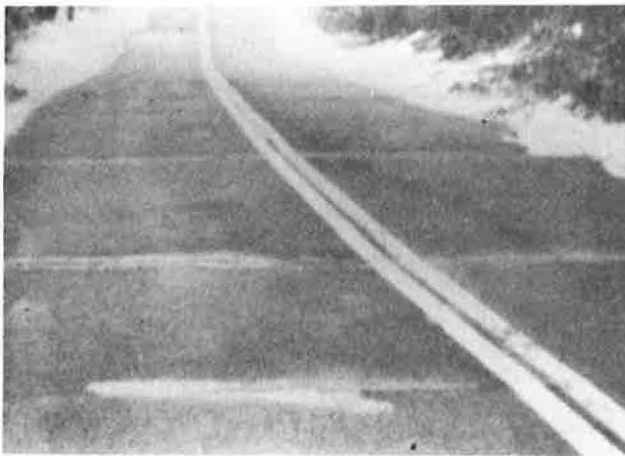
Figure 1. Transverse cracks in existing pavement prior to construction, Cape Cod National Seashore Park, Oct. 1978.

The recycling was accomplished by scarifying, windrowing, pulverizing, reshaping, and compacting. Figures 1-4 show the condition of the roadway before recycling, after construction in 1979, and in June 1982.

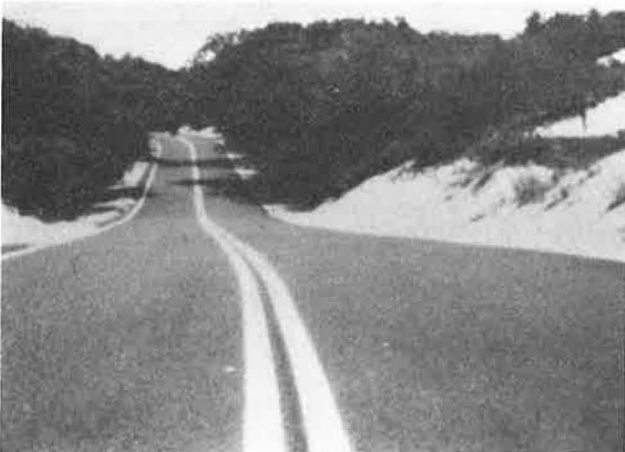
Figure 2. Completed pavement, Cape Cod National Seashore Park, June 1979.

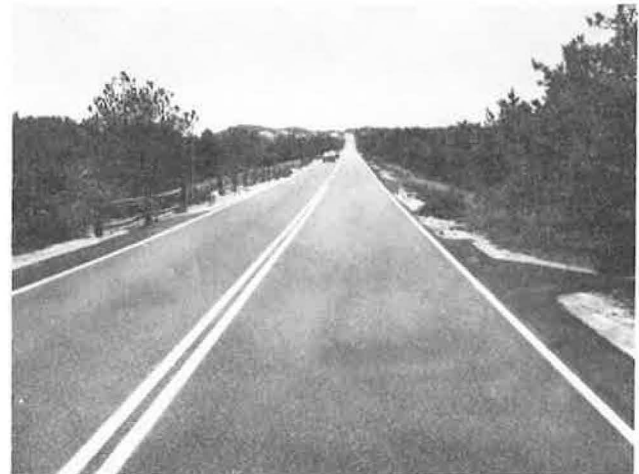
Figure 3. Completed pavement on Province Lands Road in Cape Cod National Seashore Park, June 1982.

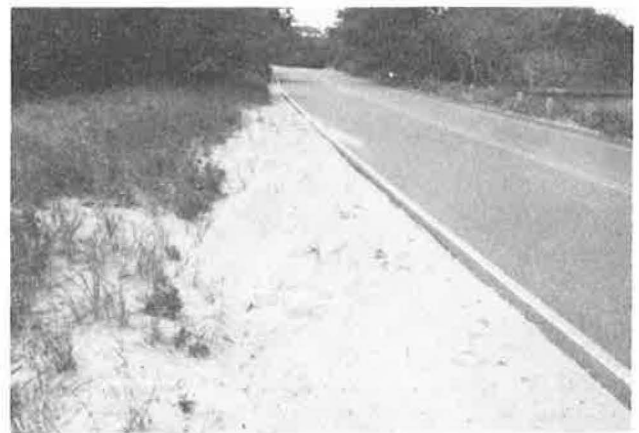
Figure 4. Completed pavement on Moor's Road in Cape Cod National Seashore Park, June 1982.

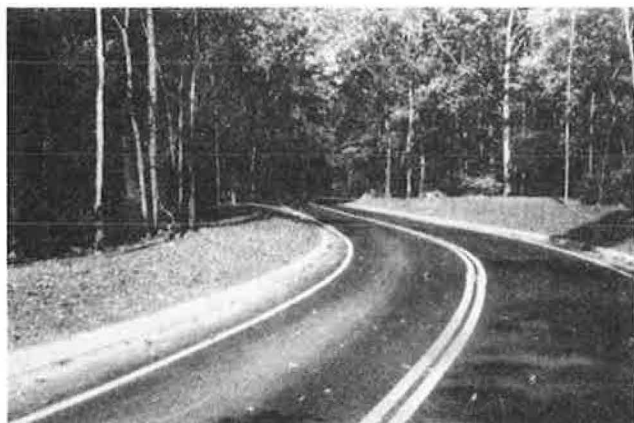
Figure 5. Completed pavement in Catoctin Mountain Park, June 1979.

park, mixed with crushed stone and an emulsion in a portable pugmill, placed on the prepared subgrade with a Barber-Greene paver, and compacted with a 10-ton Hyster roller. A wearing course of 5 cm of dense-graded bituminous concrete was placed over the recycled base material. Figures 5 and 6 show the completed pavement in June 1979 and June 1982 (1).

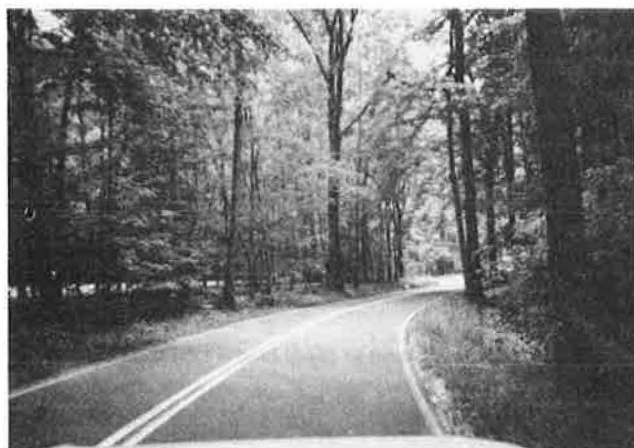
Figure 6. Completed pavement in Catoctin Mountain Park, June 1982.

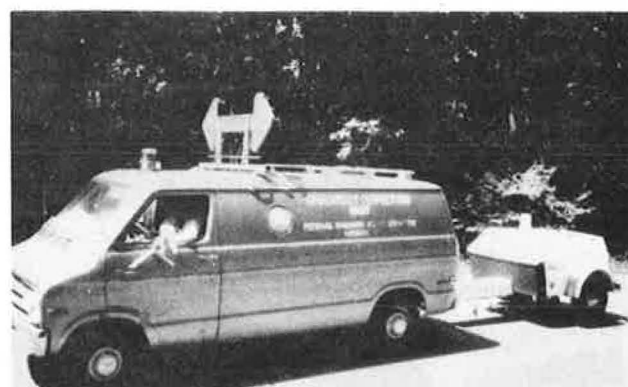
Figure 8. Close-up of Dynaflect van and trailer.

Dynaflect measurements were taken in July 1982 (Figures 7 and 8) and the Dynaflect maximum deflection (DMD), surface curvature index (SCI), and base curvature index (BCI) were determined for each section of the roadway. Table 1 gives information about the sections. Table 2 presents the criteria of the Federal Highway Administration's Eastern District Federal Division for DMD, SCI, and BCI, and Table 3 presents the values obtained.

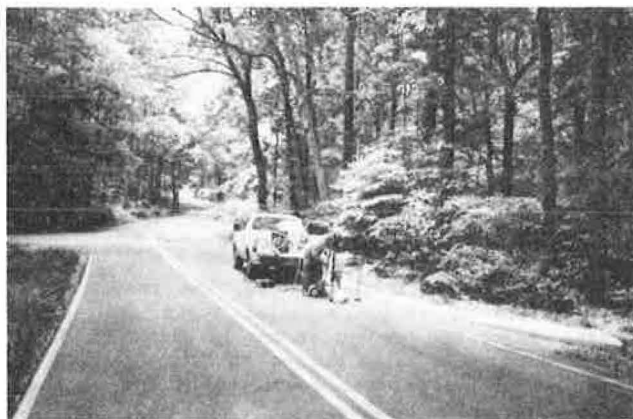
Figure 9. Cutting cores with portable electric core drill, Catoctin Mountain Park, June 1982.

From each of five locations in the roadway, one set from sections 1, 4, and 6 and two from section 2. The locations were selected so that samples of the different recycled base materials would be obtained. It was hoped that the recycled base material could be removed in whole pieces so that some laboratory strength measurements could be made on these materials. Figures 9, 10, 11, and 12 show the coring operation and representative cores removed from the pavement. It can be seen that the recycled material was not retrievable in core form. The use of a diamond core bit that required water as a coolant undoubtedly contributed to the disintegration of the recycled base material during the coring operation.
