Bridge Joint Maintenance

RONALD L. PURVIS AND ROLAND H. BERGER

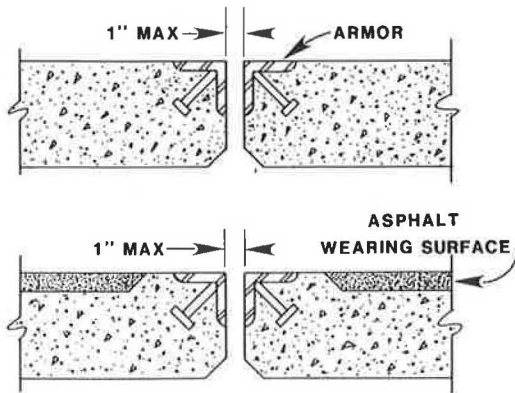
Figure 1. Open butt joints.

Butt joints are commonly used where only rotation must be accommodated, or with minor thermal movement, since this joint provides no transition for traffic between adjacent edges of the deck. Armoring is usually provided, although installations have been used without it. A typical detail is shown in Figure 1.

It is difficult to protect the metal facing from corrosion. The joint will often fill with noncompressible materials and thus become inoperable. When used with asphalt overlays, the armoring should extend to the surface elevation. A joint transitional dam is required to achieve this. Otherwise, raveling of the wearing surface can occur over the joint. Normal maintenance includes periodic clearing of roadway debris from the opening, painting, and roadway surface repair adjacent to the armor plate or dam.

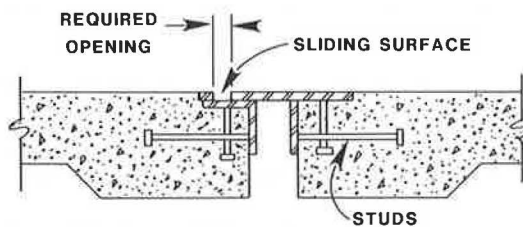
Figure 2. Plate joint.

Plate joints are used for movements between 1 and 3 in. It was the predominant type of bridge expansion joint used with steel-framed structures prior to the development of neoprene joints. The joint is normally designed to be self-supporting without reliance on the concrete deck for support. This is accomplished by supporting the joint on the end diaphragm and/or the ends of stringers. A typical detail is shown in Figure 2. A similar detail has been used on concrete structures.

These joints are difficult to maintain. It is common for plates to become loose, which creates a loud noise as traffic crosses, and occasionally they become completely detached, which results in a safety hazard. There are several reasons for this, depending on the particular design. Much of the problem can be attributed to the inadequate consolidation of the concrete under and around the plates. Also, the anchors corrode and are subject to fatigue under the continuous pounding of the traffic. In other instances, the roadway surface around the plates deteriorates, which increases the impact on

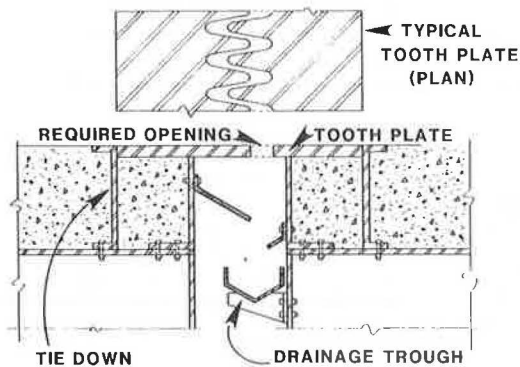
Figure 3. Tooth joint with drainage trough.

When accommodation for movements greater than 3 in is needed, a tooth or cantilever joint can be used. A typical detail is shown in Figure 3. These joints operate well when properly maintained. Maintenance requirements are similar to those required for plate dams.

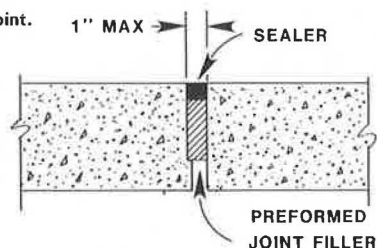
Figure 4. Filled joint.

A filled joint is similar to the butt joint already described and is used to accommodate the same degree of movement. Usually a premolded joint material is attached to one face of the joint or supported from below by an offset in the vertical face of the slab. A sealing compound is poured at the roadway surface to seal the opening. Figure 4 shows details of a typical filled joint.

Maintenance requirements include periodic cleaning, replacement of the surface seal and filler as necessary, and repairs to the roadway surface adjacent to the joint.

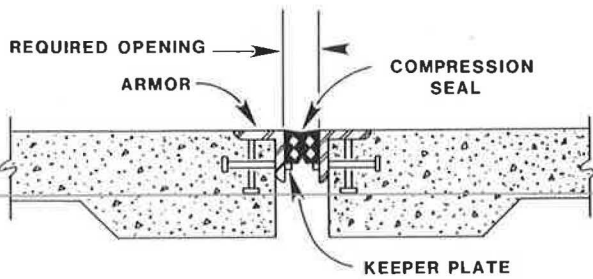
Figure 5. Compression seal.

Compression seals are used for movements up to 2.5 in. A typical detail is shown in Figure 5. Considering the limited time of use, they seem to have the best success record for remaining watertight if constructed properly. Tests by the Florida Department of Transportation (DOT) have shown that premolded compression joint seals in place for 15 years have performed superior to previously used materials (1, p. 463). Because it is squeezed into the opening so that it expands and is compressed with the joint movement, it is critical that the opening be dimensioned properly for the particular size seal. If the opening is too large, it will separate from the deck in cold weather. If the opening is too small, the seal will be damaged by the compressive forces in hot weather. Also, if the opening is too small or the seal is placed too close to the surface, it will be damaged by traffic in hot weather as it bulges due to compression. Particular problem areas on these seals are the cuts necessary to make bends around curbs and parapets.

With the size unit shown in Figure 5, maintenance requirements are minimal. Periodic cleaning and roadway repair are normally all that is required. When evidence of leakage is discovered, immediate steps should be taken to correct the situation by repair or replacement of the seal.

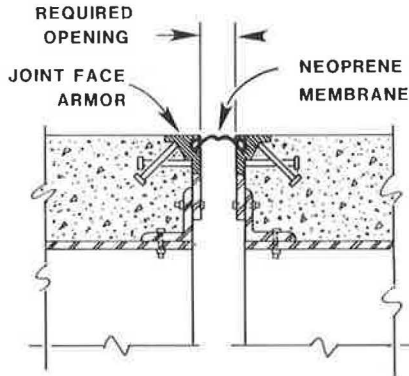
Figure 6. Membrane seal.

A membrane joint consists of a flexible sheet of neoprene rigidly attached to the two metal facings of the joint. The material is bent in the shape of a "U" and flexes with the movement of the bridge. This joint can accommodate movements of ± 6 in. A typical detail is shown in Figure 6.

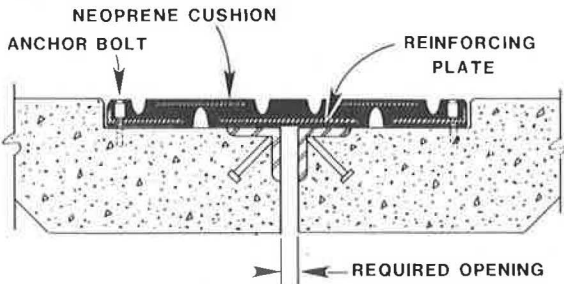
Figure 7. Cushion joint.

The cushion seal joint is made up of a reinforced neoprene pad that is rigidly attached to each side of the joint. The inherent characteristics of the material permit it to expand as the joint opens and to shrink as the joint closes. The internal reinforcement permits the neoprene slab to span the joint. These joints have been used to accommodate movements of 4 in and more. A typical detail is shown in Figure 7.

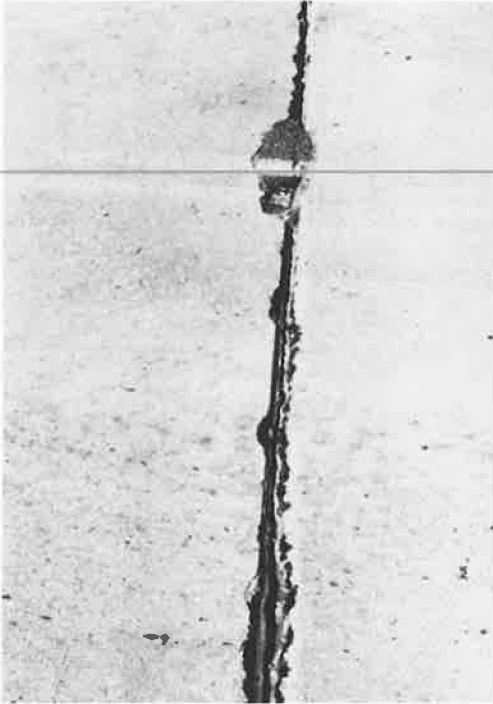
Figure 8. Joint edge damage.

Damage to the edge of the concrete adjacent to joints often results in leakage and a poor riding surface. This could be caused by poor design or construction. Figure 8 shows an example of this. An armor joint design could prevent the problem or the concrete chamber may be insufficient. Sometimes the initial damage is caused during construction by using the deck before the concrete has reached adequate cure. Excessive edge pressure on the concrete at any time, either during or after construction, caused by crossing the deck with steel-wheeled rollers or steel track equipment without adequate protection will also cause this damage. Irregularities in the grade of the deck between the two spans will also contribute to edge failure.

The width of the damaged area around the joint and other maintenance or repair work needed on the bridge will influence the method used to correct this damage. If the damaged area is narrow and the remaining concrete in the deck is sound, the joint may be widened by sawcutting and adding a compression seal. A more durable solution, particularly if the joint must be recast, is to add an armored device to reinforce the edge of the concrete.

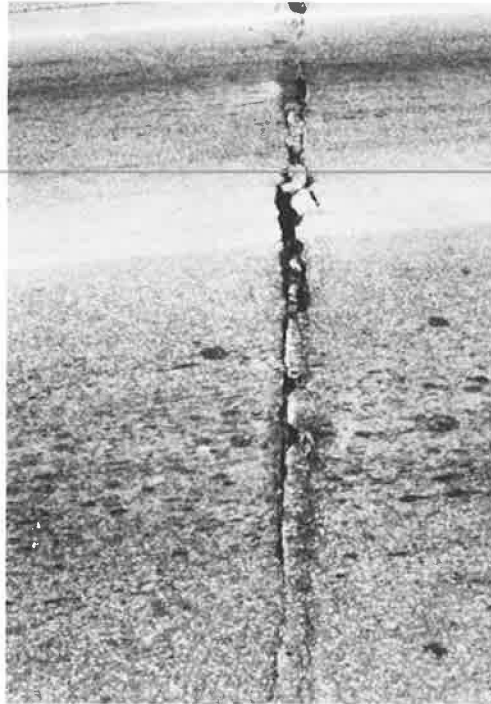
Figure 9. Wearing surface raveling.

In the past it has been common practice to pave over a concrete deck with a bituminous wearing surface, thereby completely covering and obscuring the deck joints. This temporarily hides the joint problems while improving the riding surface. The deck movement causes cracking and raveling of the surface at the joints. Figure 9 shows an example of this.

The wearing surface prohibits inspection and maintenance of the joint seal. If wearing surfaces or overlays are required on a bridge, the joints should be redesigned to accommodate the change. The joint opening may be continued to the elevation of the new surface by adding joint transition dams. If

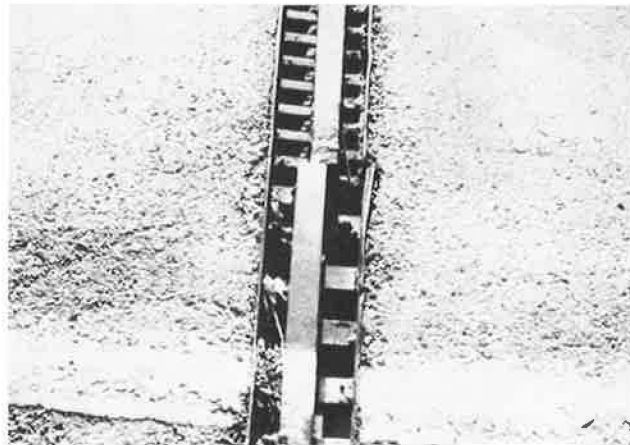
Figure 10. Loose joint plate.

As stated previously, it is common for steel plates to become dislodged from the anchoring system. Figure 10 shows an example of this. Because these joints are not watertight, repairs often include redesigning the opening to include a waterproof seal. This can be done by adding a lip to hold the seal in place, injecting epoxy to fill voids, or removing and replacing a portion of the deck around the joint.

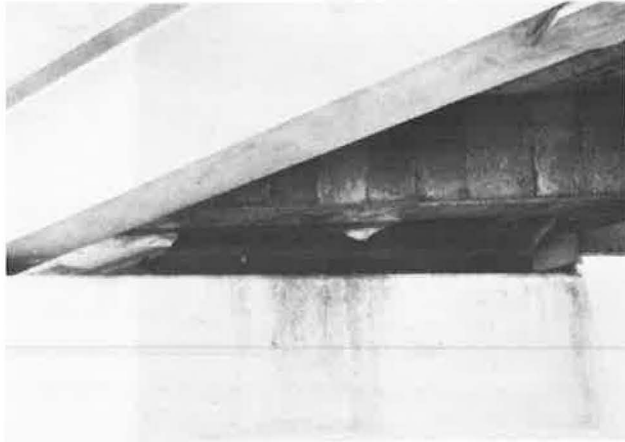
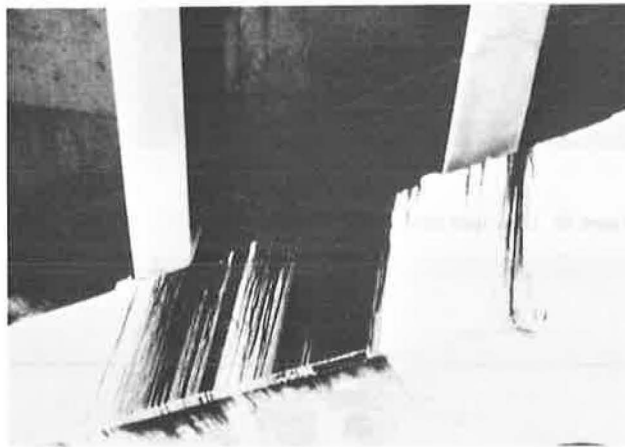
Premolded joint fillers frequently deteriorate or become loose and fall out of the joint. Figures 11 and 12 show examples of the filler material protruding below the deck surface. Repairs in instances such as this should include removal of all joint material, followed by thoroughly cleaning the opening. A compression seal should then be installed. This may require removal of a portion of the deck and recasting to accommodate the joint armor and anchorage.

Figure 11. Dislodged joint filler.

Figure 12. Dislodged joint filler.

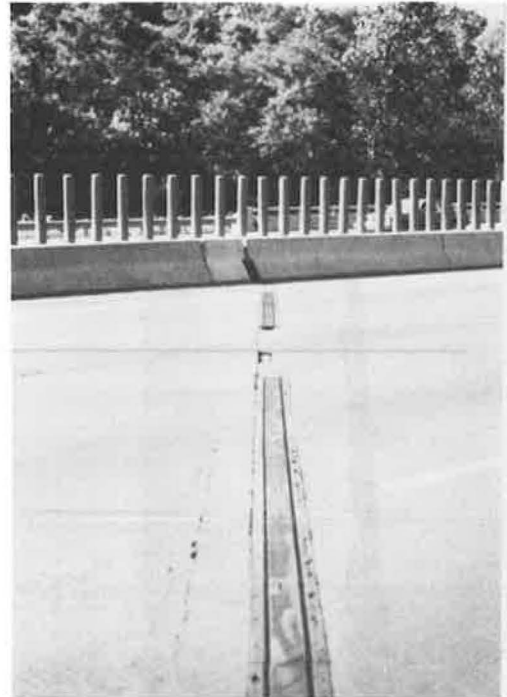
Figure 13. Cushion seal failure.

As stated previously, one of the major problems with the use of elastomeric cushion seals is the failure of the anchoring device and the subsequent loss of the joint. Figure 13 shows the loss of entire sections of the joint. The voided areas have been filled with bituminous material as a stop-gap repair. Ultimately, a new elastomeric cushion must be

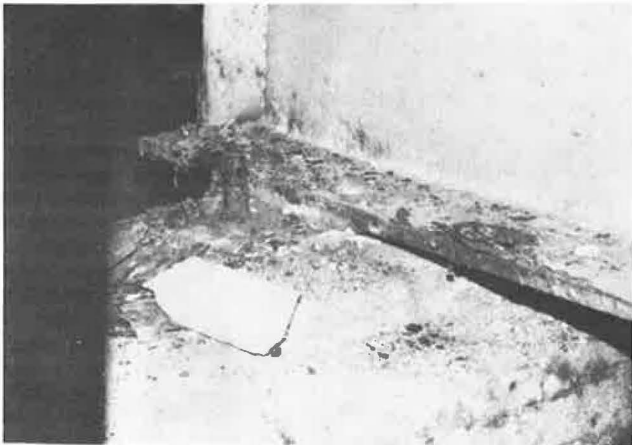
Figure 17. Bearing deterioration.

ings are exposed to moisture and debris, which cause deterioration and corrosion (see Figure 17). Often the bearings that were designed to accommodate the superstructure movement will become frozen due to the corrosion, which places stresses in other members of the structure that have not been designed to resist these forces. This causes serious distress problems in members, such as beams, seats, or substructure supports. Often a concrete beam will develop a diagonal crack that begins on the bottom of the beam at the end of the bearing and extends back and upward (see Figure 18). The force may also cause the cap to crack in a similar manner (see Figure 19). When bearings become frozen, the movement is transferred to other bearings, which causes joints to jam or open excessively. It may also cause adjacent bearings to tilt or slide beyond their design limits. The pressure created by the frozen bearings has been known to cause substructure

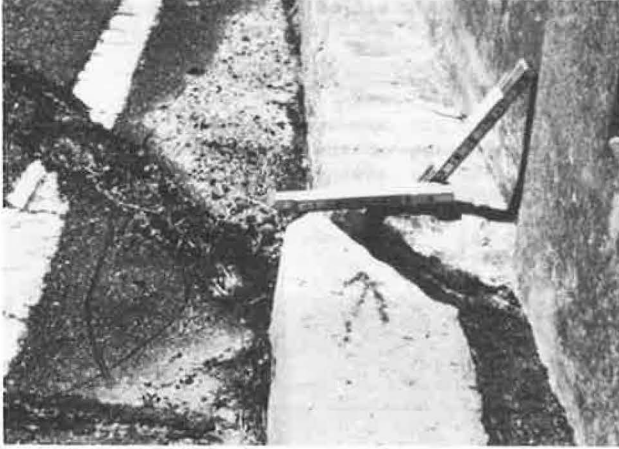
Figure 20. Misalignment.

columns to crack or tilt. On skewed bridges, this problem can cause the superstructure to be forced out of alignment (see Figure 20).

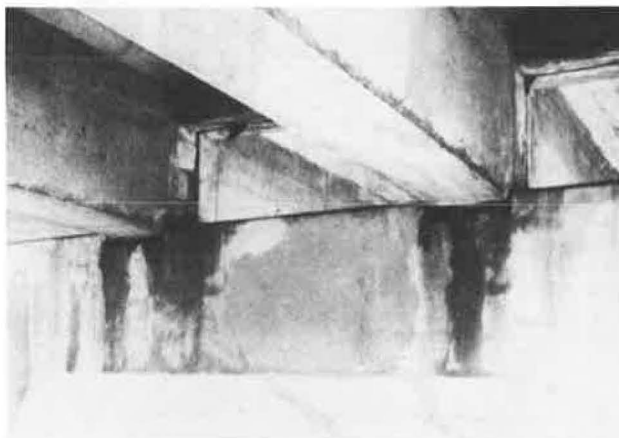
Figure 22. Cap damage.

Leaking joints are commonly evidenced by discoloration on the sides of the substructure (see Figure 22). This causes eventual concrete deterioration

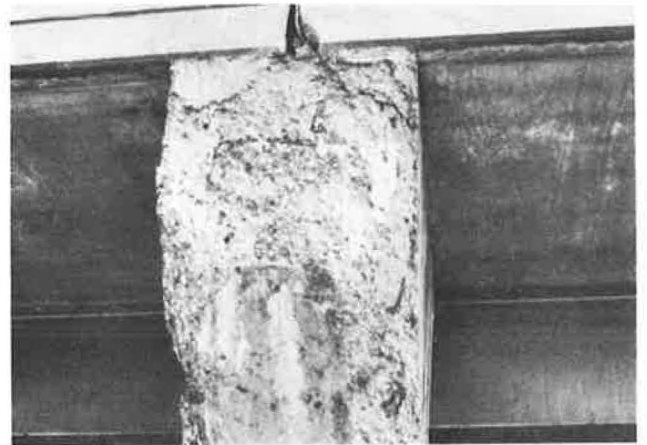
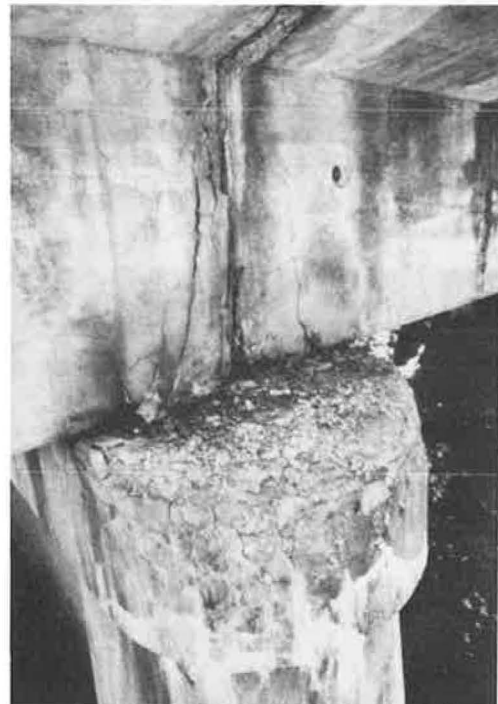
and spalling. On structures with end diaphragms that extend down to the top of the cap, the water drains down the end of each cap, thereby causing significant concrete deterioration (see Figures 23 and 24).

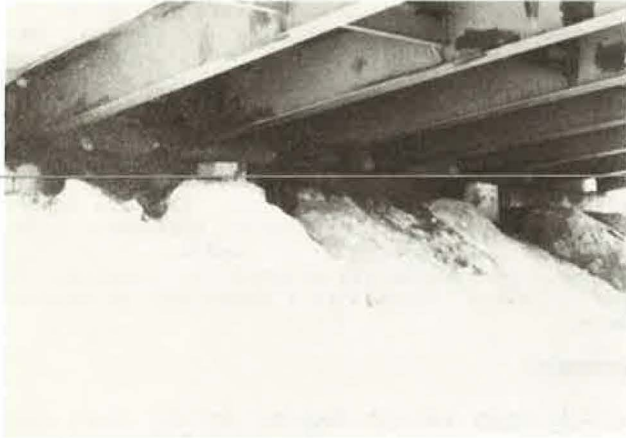
Figure 25. Embankment erosion.

Drainage through joints at abutments can cause erosion of the soil embankment (see Figure 25). If no provisions are made to check this erosion, it can undermine the footing and expose the piles.
