# New York State Department of Transportation Bridge Inspection and Rehabilitation Design Program

FRANK S. LeDOUX, AARON S. LEVINE, AND ROBERT N. KAMP

The New York State Department of Transportation bridge inspection and rehabilitation design program was developed to provide a formalized procedure to be used in making effective rehabilitate/replace decisions for a variety of bridges. Use of the procedure also provides most of the information required for preparation of contract documents if the rehabilitation option is selected. This paper provides detailed information about the steps included in the procedure, a discussion of the criteria used in making the rehabilitate/replace decision, and a case study that shows the application of the procedure to a specific bridge. The Department has successfully used the procedure for 150 bridges, and 100 more are currently included in the program, which requires its use. The use of the procedure has resulted in sound rehabilitate/replace decisions and contract documents for cost-effective bridge restorations.

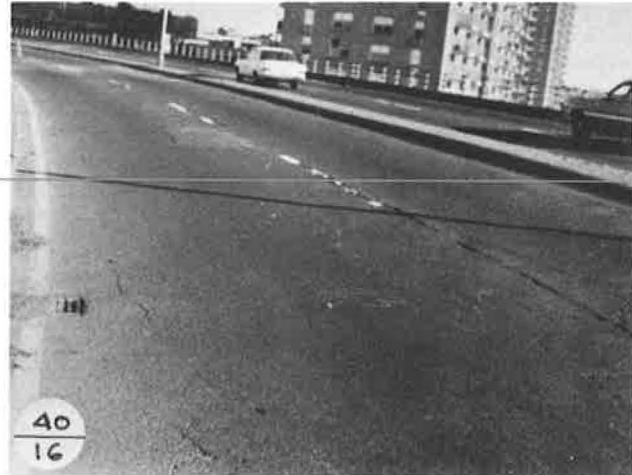
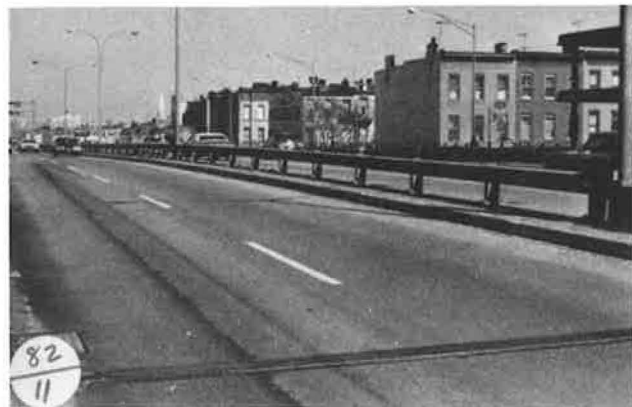
Figure 5. View of roadway.

In general, the viaduct carries four lanes of traffic on two 24-ft roadways (one in each direction) separated by a 4-ft-wide raised-concrete median and flanked by 18-in safety walks at both fascias for a total width of 55 ft between railings, as shown in Figure 5.

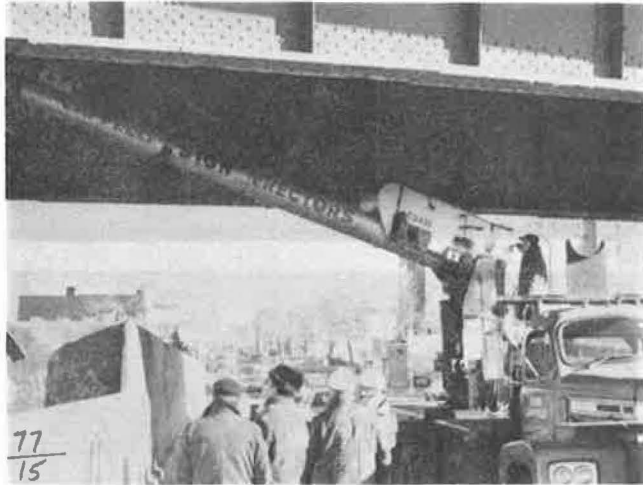
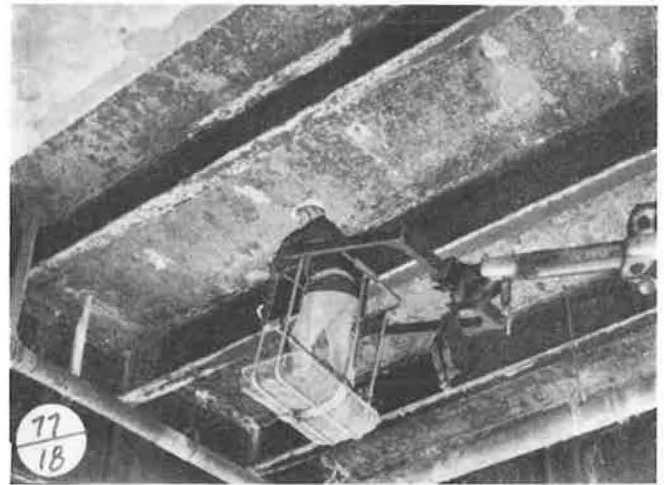
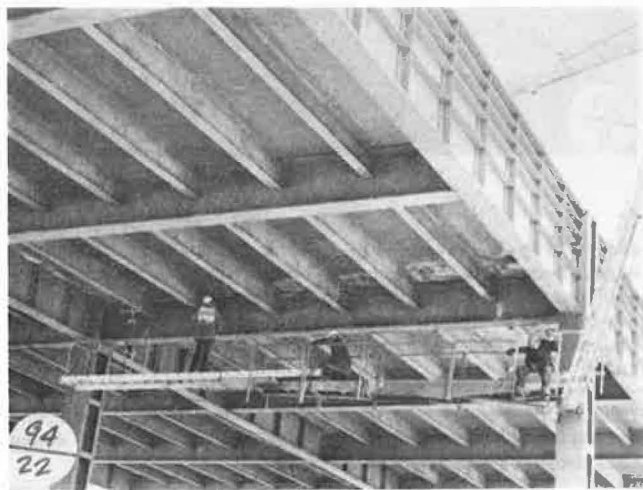
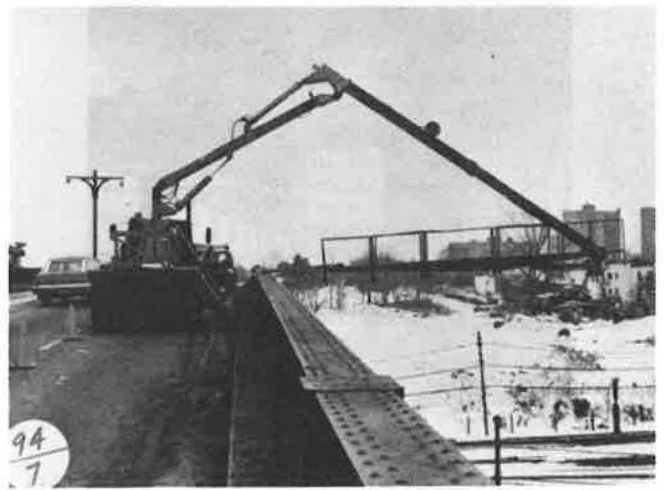
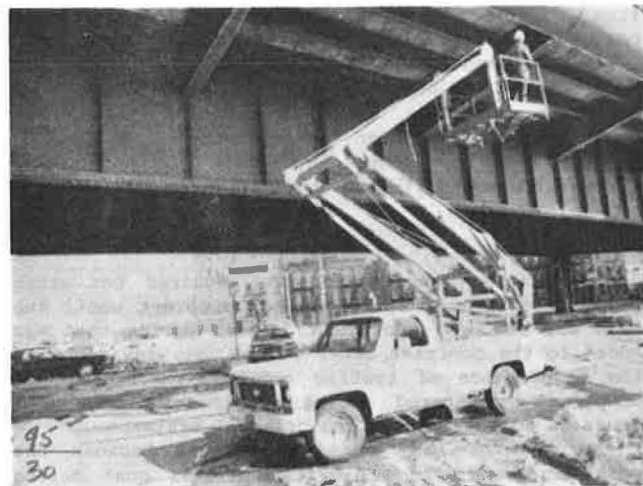
Figure 6. Inspection equipment.

A wide variety of equipment was used to provide access to the viaduct, as shown in Figure 6. Approximately 2000 color photographs were taken during the course of the inspection for documentation of conditions. This figure was made from some of the photographs. Office work and acquisition of supplemental data progressed at the same time the field activities were under way. The bridge rehabilitation project report and preliminary plans were distributed for review in September 1978.

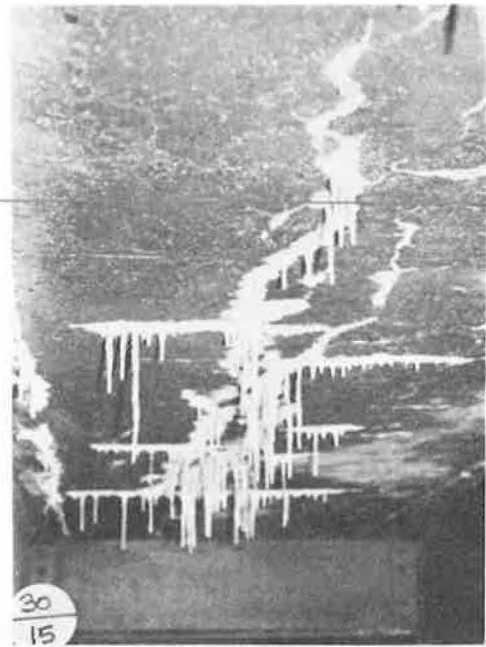
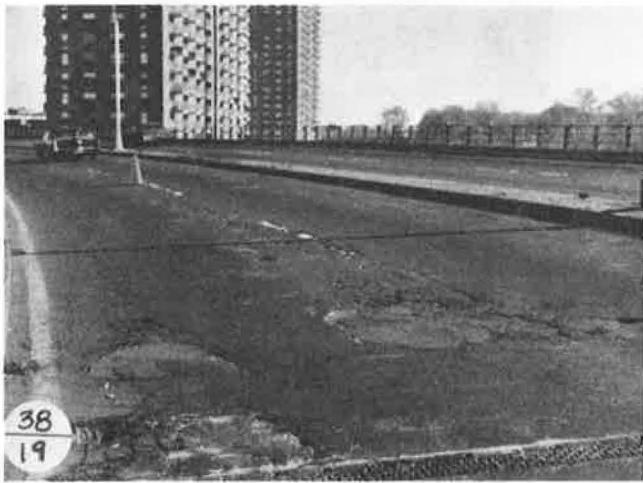
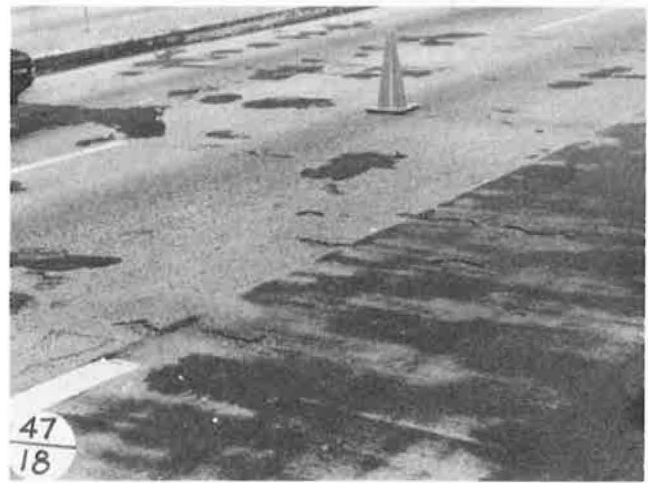
Figure 7. Deck deterioration.

1. The deck had deteriorated beyond the point of being repairable and complete replacement was recommended. Figure 7 show typical deck conditions.
2. New joint systems were required because the existing systems were not functioning, as shown in Figure 8.
3. New drainage systems were needed because the existing systems were beyond repair, as shown in Figure 9.
4. A new railing system was included because the existing system was deficient, as shown in Figure 10.

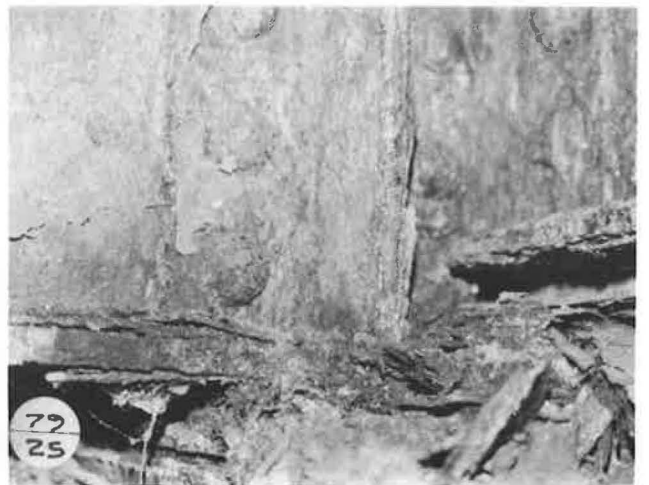
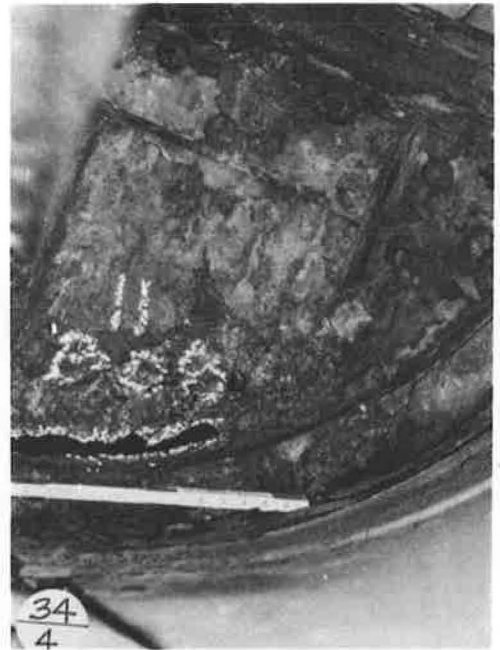
Figure 11. Deteriorated steel member.

5. Some 30 percent of the 1600 steel members were recommended for some kind of repair or replacement, primarily because of deterioration brought about by leaking deck joints or faulty deck drainage, as shown in Figure 11.
