TRANSPORTATION RESEARCH RECORD 903

Bridges and Culverts

TRANSPORTATION RESEARCH BOARD

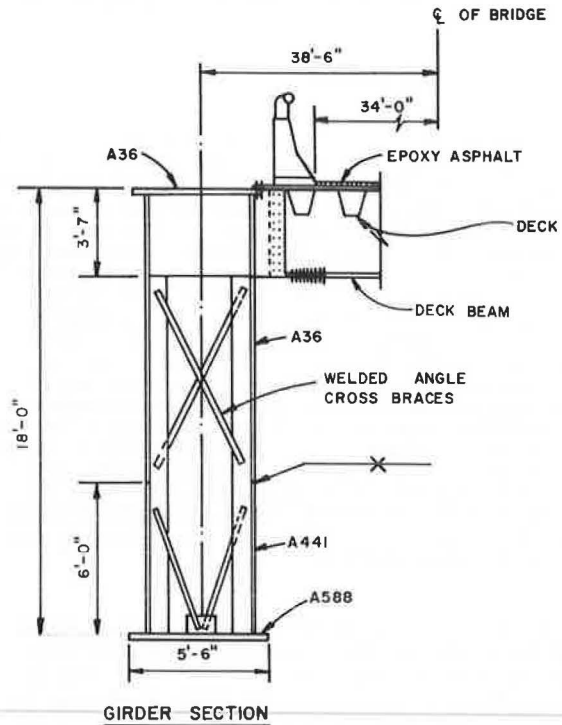
Figure 3. Representative details of deck and tie girder.

Additional instrumentation was installed at locations of details where conditions were believed to be susceptible to fatigue crack growth or where special study of strain response was desired. These details included (a) ends of horizontal stiffeners, designated group G; (b) reinforcement around vent openings, group H; (c) openings for lower deck hangers in the bottom flange, group I; and (d) junctions of deck beams and web plates, group J, as shown in Figures 5-8. A total of 12 details were instrumented by using two-element gages. The gages were located close to the detail. Wiring diagrams for the gages are shown in Figure 9. During most of the testing period, the longitudinal and transverse elements of the three-element gages were wired

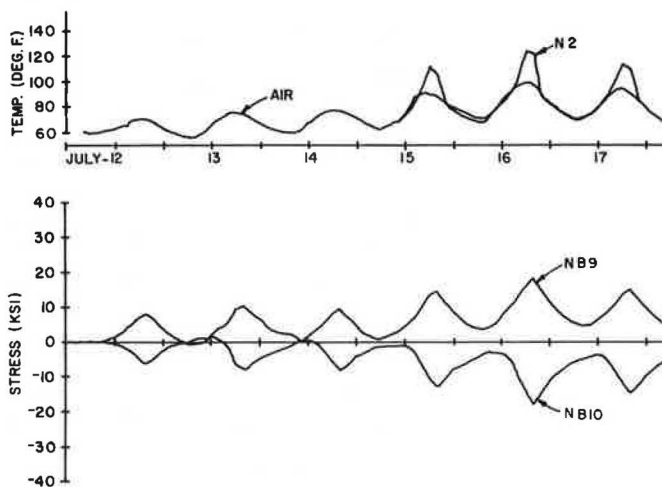
Figure 15. Strain gages NB9 and NB10 and thermocouple N2 and air.

north web of the north tie girder. Longitudinal stresses computed from strains are plotted for gages NB9 and NB10, which are located on opposite sides of the web plate midway between stiffeners. Bowing of the plate apparently occurs daily. The maximum daily stress range is approximately 20 ksi, although the average stress is fairly uniform.

Data from strain gages on the tie girder web plates indicate that out-of-plane bending occurs. Figure 15 shows this effect at section B on the

It is evident from these figures that the stress variations are repeatable and closely related to temperature. The heavy traffic periods in the morning and afternoon have little apparent effect.

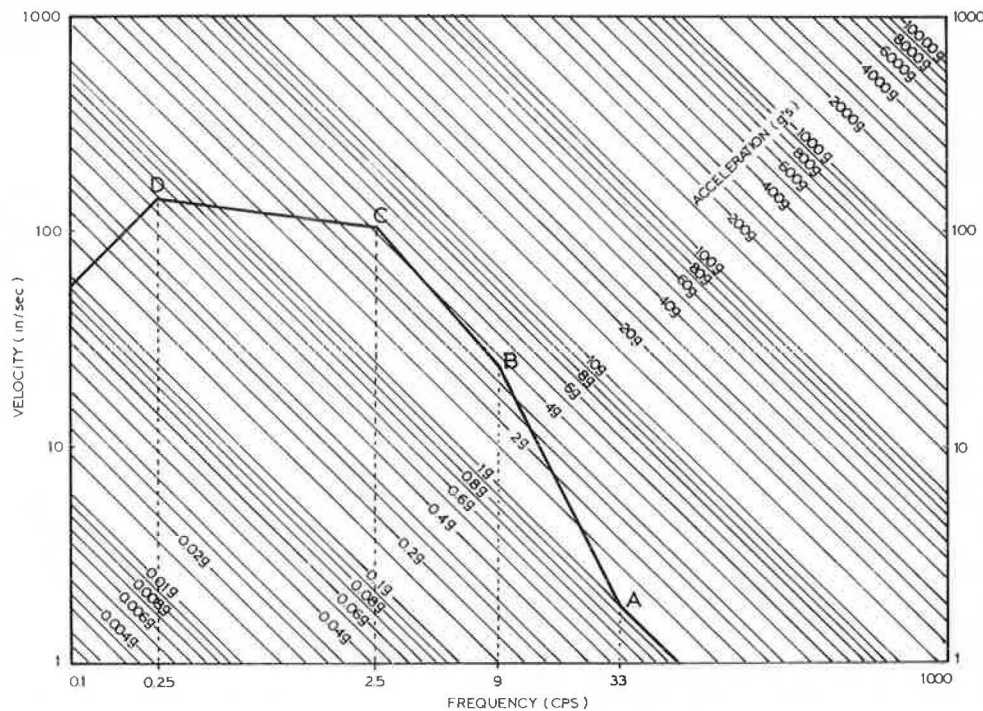
Figure 2. Horizontal response spectrum for 1.0-g maximum ground acceleration.

loads and masses are also computed and are used to determine the equivalent dynamic force, as given by Equation 2. This dynamic force is then applied uniformly to the structure, and the resulting deformations and actions are determined.

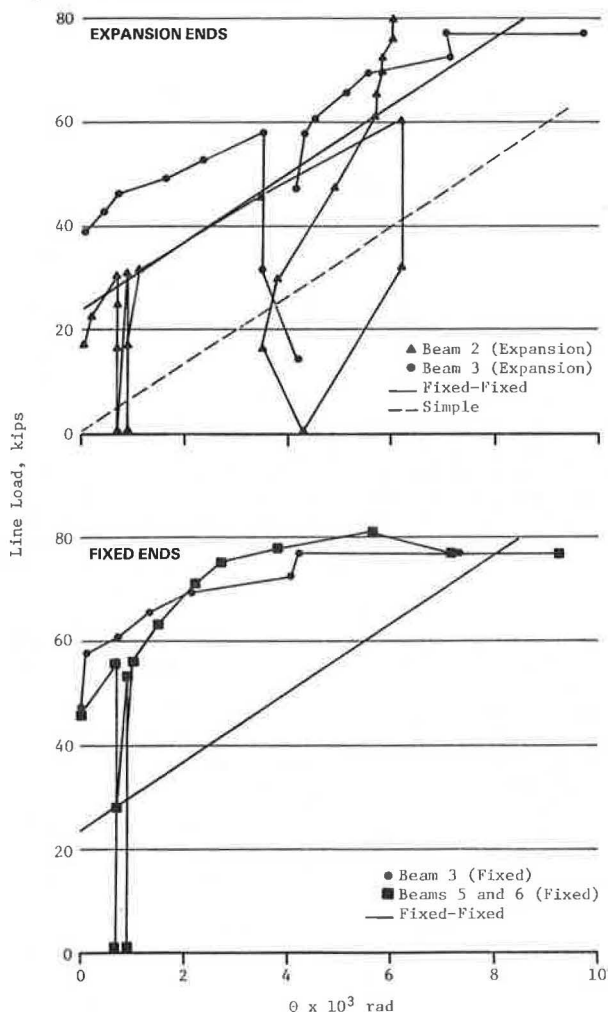
Figure 6. Load versus end rotation.

is suggested by the rotation data, which indicate a constant value of end restraint after release. The intersection point for the two linear segments was selected by fitting the "best line" with the simple-beam slope.

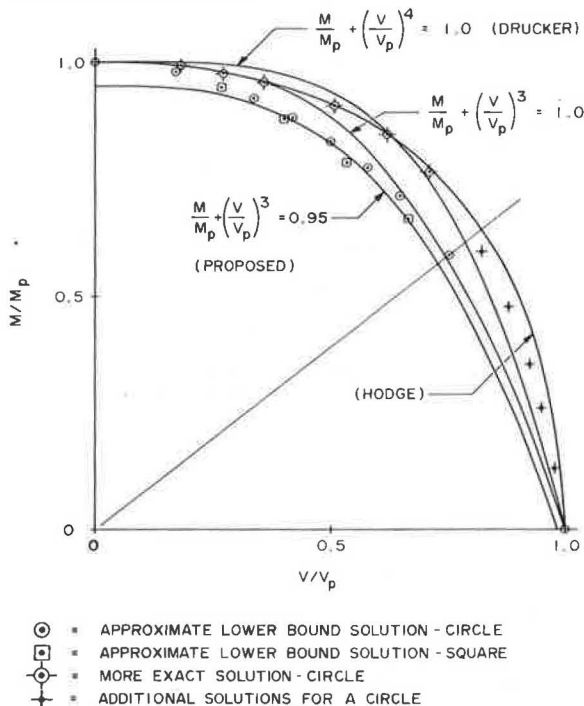
^aRecommended by AISI.^bMain members/secondary members.**Figure 2.** Interaction curves for pins subjected to shear and moment.

The problem of pin capacity in combined shear and bending is best approached with an interaction curve. Figure 2 shows the results of three approximations to determine a suitable interaction curve. The following considerations are noted:

1. Points marked ⊙ represent lower-bound solutions obtained for a circular shape by assuming some portion of the cross section to be yielded in bending and to carry no shear. The remainder of the cross section was assumed to be elastic in bending and shear. The maximum shear stress was equal to the shear yield stress. When plotted as a normalized interaction curve, lower-bound points computed as described above plot in the same location regardless of the choice of yield criterion. The magnitude of the shear force is, of course, a function of the yield criterion.

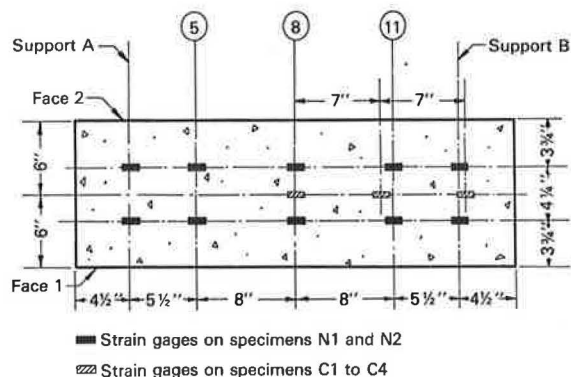
Figure 3. Location of strain gages on reinforcing bars in plan view.

forcement of specimens consisted of 15 #4 bars for N1 and C1, 7 #4 bars for N2 and C2, 5 #5 bars for C3, and 3 #3 bars for C4 for the specimen width of 1 ft (30.5 cm). The resulting reinforcement ratio at the middle of the specimen (axis 8) varied from 0.0119 to 0.0013 and near the quarter-span (axes 5 and 11) from 0.0172 to 0.0019 (Table 1). Electrical resistance strain gages 3/8 in (0.95 cm) long were located on the reinforcing bars (see Figures 2 and 3). In specimens N1 and N2, the strain gages were located at the top and bottom of each bar, 20 gages in each specimen. In specimen N1, the gages were attached to the bars of the lower layer. In specimens C1-C4, the gages were placed at similar locations at the bottom of each bar, 3 gages in each specimen (Figure 3). The strain readings were corrected to obtain the strain and stresses at the centroid of the reinforcement in all specimens on axes 5, 8, and 11 and at the supports. Specimens N1 and N2 were equipped with strain gages placed on concrete in addition to those placed on the reinforcing. This paper includes the results of strain measurements in the steel only.

The load was applied at the top of specimens through the spherical head of 600 000-lb (2670-kN) capacity testing machines with 15 000-lb (66.7-kN) increments in the N tests and with 30 000-lb (133-kN) increments in the C tests. The test results are presented as reinforcement stress as a function of load at five locations in the N specimens, at approximately the quarter-span (axes 5 and 11), the middle span (axis 8), and the supports and at three locations in the C specimens.

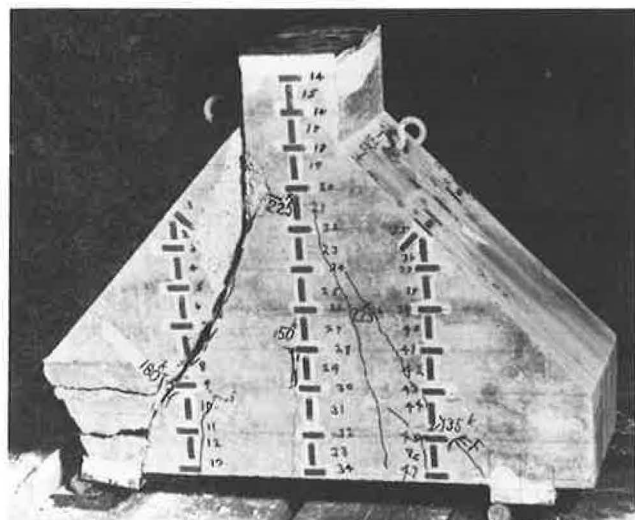
Figure 6. Specimen N2, face 1, after failure.

An additional specimen--C5, built with plain concrete--was tested. It failed under a load of 33 kip (147 kN), about half the load that caused the failure of specimen C4. This is an indication that even an insignificant amount of reinforcement, as in specimen C4, improves considerably the loading capacity of the specimen, a fact known by the designers of footings but not treated by the reinforced concrete design codes.

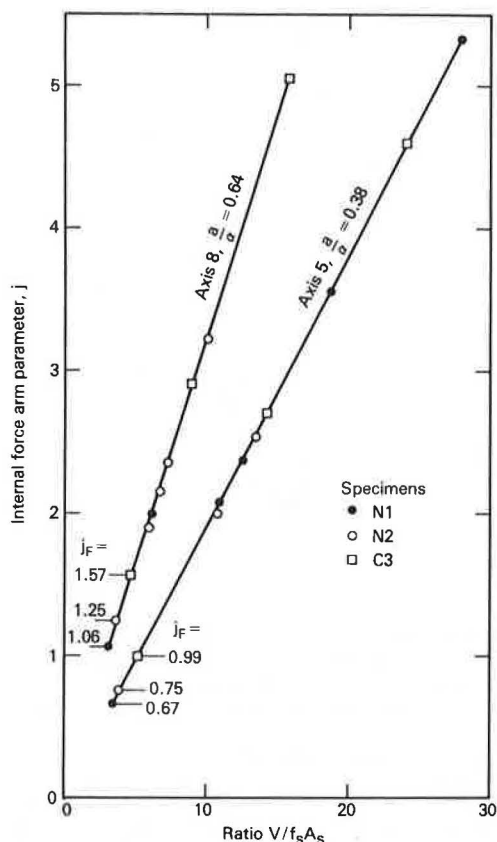
Figure 9. Internal force arm parameter (j) as a function of ratio of load to force in steel reinforcement ($V/f_s A_s$).

that Equation 3 provides a satisfactory method for determining the parameter j_F . Equation 3 provides the means for designing the reinforcement for a given load V_u by using Equation 1 for the stresses in steel at the failure load. Data given in Table 2 indicate that the specimens failed at stresses in steel approximately equal to yield stress. A reduction factor of approximately 0.85 can be used. The ultimate stress corresponding to the given ultimate load will consequently be $f_{su} = 0.85f_y$.

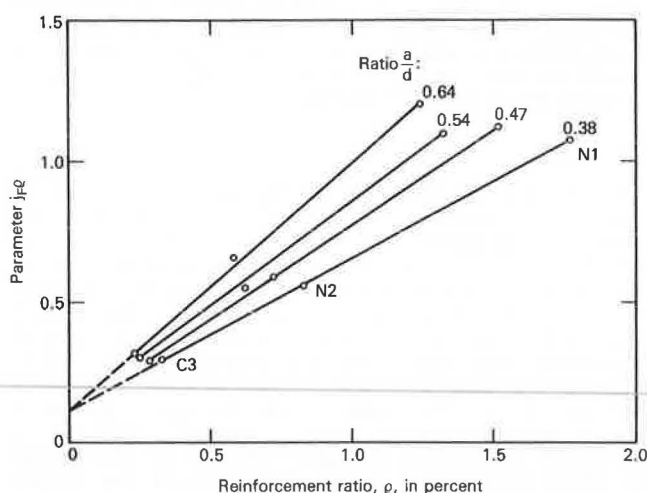
Figure 10. Parameter $j_F \rho$ as a function of the reinforcement ratio, ρ , and arm-to-depth ratio a/d .

Note: Shear span/depth ratio (a/d) = 0.38, 0.47, 0.54, and 0.64 for sections 5, 6, 7, and 8, respectively.

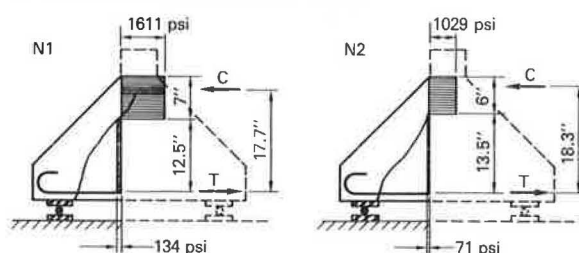
Figure 11. Normal stress distribution in concrete in specimens N1 and N2 at last observed strain at axis 7 prior to failure.

An analysis done for specimens N1 and N2 by using the actual values of j_F results in the normal stress distribution diagrams shown in Figure 11a, b. This analysis assumes the neutral plane at the intersection of the major crack with the cross section at axis 7. Observed strain, given load, reinforcement data, and the magnitude of the parameter j_F (Equation 3) are used. The compressive stress block is assumed to be rectangular. If the rectangular compressive stress block is used, tension stress below the neutral plane must be present to satisfy the condition of equilibrium. Calculated tension stresses are shown in Figure 11. If a parabolic stress distribution or a triangular compressive stress diagram were assumed, the tension stress below the neutral plane necessary for equilibrium would still exist but would be smaller. If a similar analysis were made at axis 8 (instead of axis 7) with $j_F = 1.06$ (for N1) and 1.25 (for N2), the tension necessary for equilibrium would be larger than in the example analyzed for axis 7 because the resultant C of stresses in concrete is located at axis 8 outside the cross section ($j_F > 1$) (Table 4). The magnitudes of the stresses calculated for specimens N1 and N2 are shown in Figure 11.

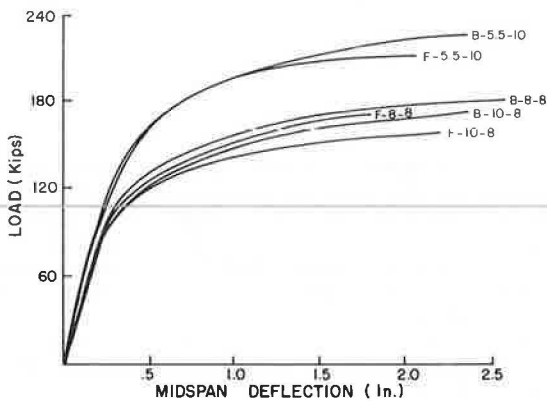
Figure 5. Load-deflection curves for all specimens.

loading. However, it should be noted that a preexisting crack across a shear transfer plane, such as can be caused by shrinkage in an actual deck, has been shown to significantly reduce the shear transfer strength (12).

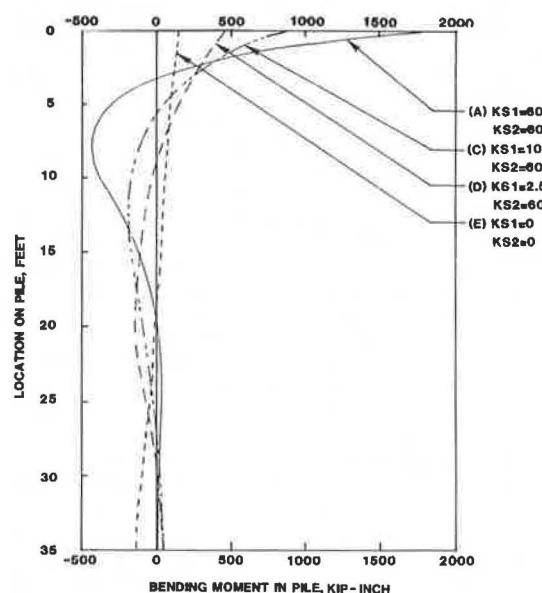
Figure 15. Bending moment in pile.

Pile bending moments for four sets of soil constants are shown in Figure 15. For the more firm soil ($KS = 60$ pci), the maximum moment is 1842 kip-in. The maximum moment at the top of the pile is controlled primarily by the modulus of subgrade reaction KS_1 . Holding KS_1 constant and doubling KS_2 will have less than a 5 percent influence on the maximum moment. At the top of the pile, the maximum moment causes tension on the inside edge of the flange. Going down the pile, the moment goes to zero and increases to cause tension on the outside edge of the flange. These maximum moments are about 23 percent of the top maximum moments and occur at 7-10 ft below the top of the pile.

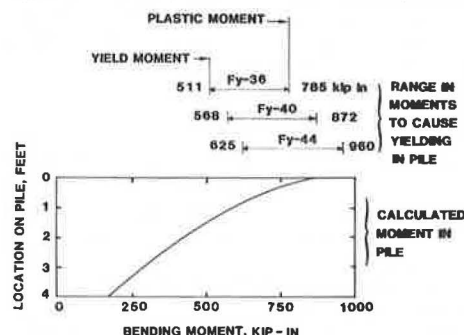
Figure 16. Comparison of calculated, yield, and plastic moments.

fits the actual pile deflections are shown in Figure 16. The lower portion of Figure 16 shows a plot of the calculated moment in the pile, and the upper portion shows a plot of the range in moments to cause yielding in the pile for different yield strengths of steel. The yield moment occurs when the outer fiber of the flange reaches the yield stress. The plastic moment occurs when the strain has been sufficient to cause yielding at middepth of the member. The guaranteed minimum yield strength (F_y) for the pile steel was 36 ksi. Very little steel would be produced at that level, and the average value would be closer to 40 or 44 ksi. If 44 ksi is used as the yield strength of the steel, then yielding took place in less than the top 1 ft of the pile, and at the top of the pile the yielding was only on each outer one-fourth depth of the flange.

Are the calculated stresses in Figure 16 correct, since the model was based on an elastic analysis and the stress near the top of the pile was beyond the elastic limit? The error is believed to be minor because the yielding was not sufficient to form a plastic hinge.

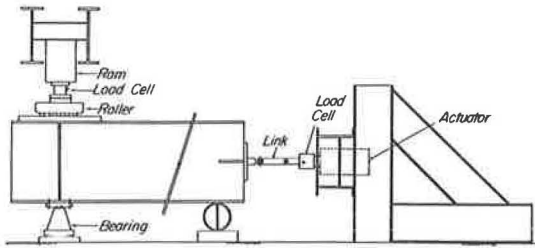
Figure 5. Side view of test setup.

The vertical load chain consisted of the H-frame, hydraulic ram, load cell, swivel head, roller nest with a known effective coefficient of friction, a steel plate with a highly polished surface, the simulated bridge girder, the test bearing, a steel reaction plate, and the reaction floor. The horizontal load chain consisted of the triangle frame, the actuator of the closed-loop hydraulic testing system, the load cell, a loading linkage to prevent out-of-plane forces, and the simulated girder (Fig-

ure 5). Lateral brace mechanisms were used to stabilize the girder against out-of-plane rotations, and a pipe roller was used to support the unloaded end of the bridge girder.

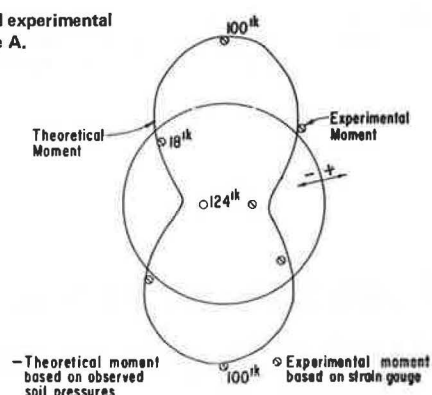
Figure 4. Theoretical and experimental moments: zone 11, plane A.

The correlation between the experimental moments, based on soil-stress readings, and the theoretical moments, based on strain gauges, using the neutral point method was excellent for plane A (see Figure 4). These moments were of considerable magnitude--i.e., 100 ft-kip.

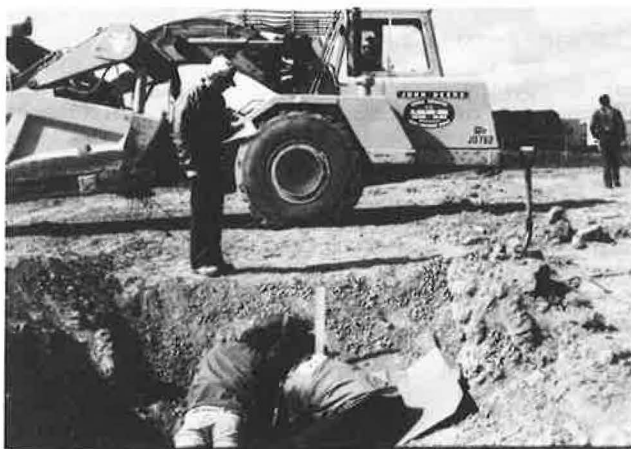
Figure 2. H-20 standard truck load (32-kip axle load), simulated with John Deere scraper, being positioned for deflection measurement.

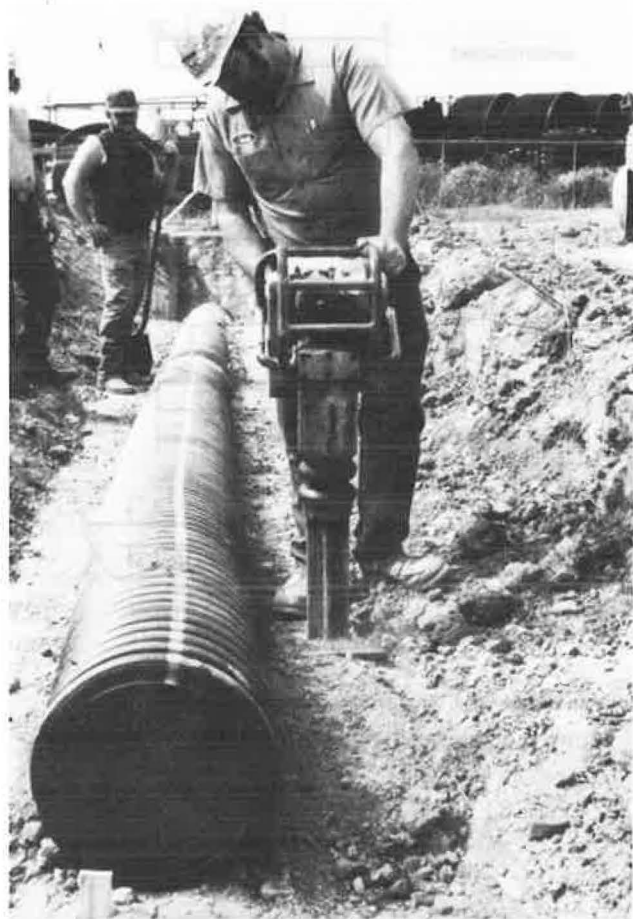
Figure 4. Compacting backfill with powered tamper.

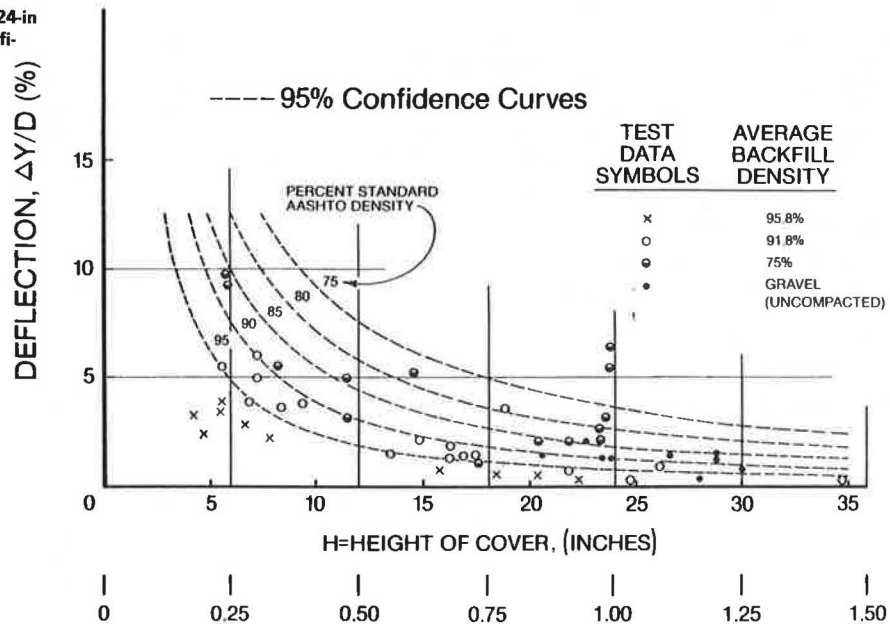
Figure 6. Deflection versus cover height for 24-in pipe under H-20 loading with 95 percent confidence level curves for five backfill densities.

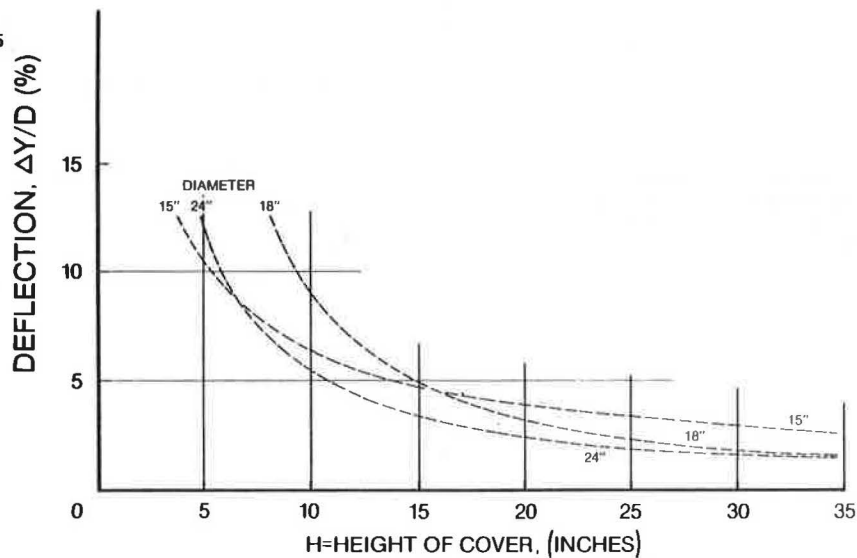
Figure 7. Plots of 95 percent confidence values for deflection versus cover height at 85 percent soil density under H-20 loading.

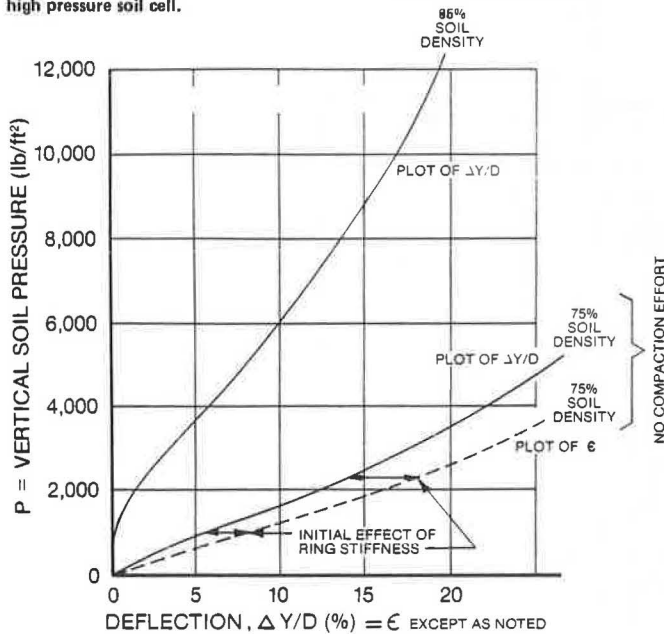
Figure 10. Vertical deflection versus vertical soil pressure for 24-in pipe in high pressure soil cell.

The data plots in Figures 10 and 11 show a tendency toward steeper plots for the 24-in pipe than for the 18-in pipe. All other conditions appear to remain equal. This does not mean that pipe stiffness is significantly greater for the 24-in pipe nor that pipe stiffness has significant effect on deflection. In fact, all deviations in pipe deflection for any soil density and pressure are within one standard deviation of vertical soil strain at the same density and pressure for all diameters. Uniformity of soil density may be a modifying factor. The wider corrugations of the 24-in pipe may allow higher soil densities between the corrugations. The larger pipe

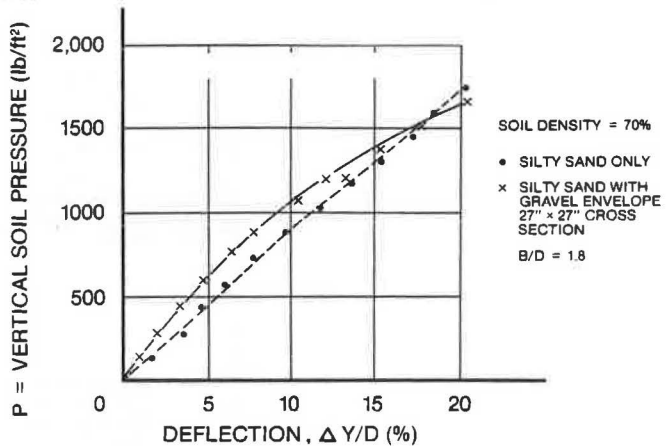
Figure 12. Vertical deflection versus vertical soil pressure for 15-in pipe in high pressure soil cell.

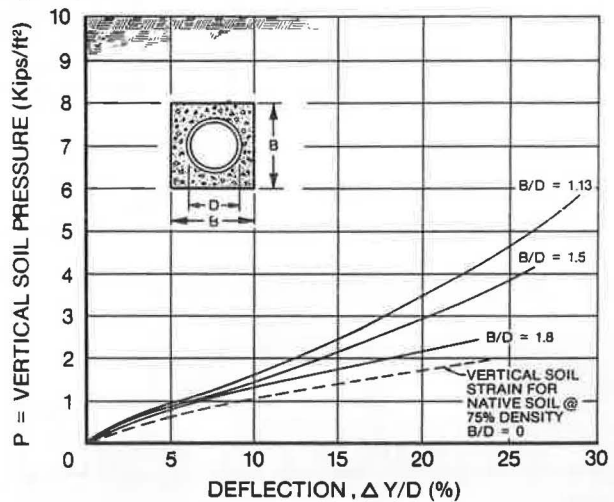
Figure 13. Effect of B/D on deflection (not significant in loose soil for B/D < 2).

gravel, the high internal friction of the gravel forms a semirigid structure and carries virtually the total load with minimal pipe deflection. The response of total gravel backfill is essentially the same as native soil backfill at 95 percent density.

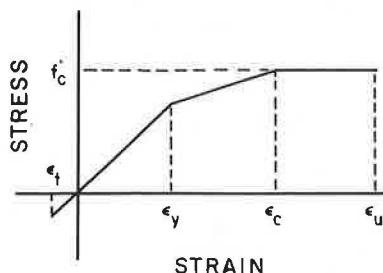
Figure 2. Stress and strain curve for concrete.

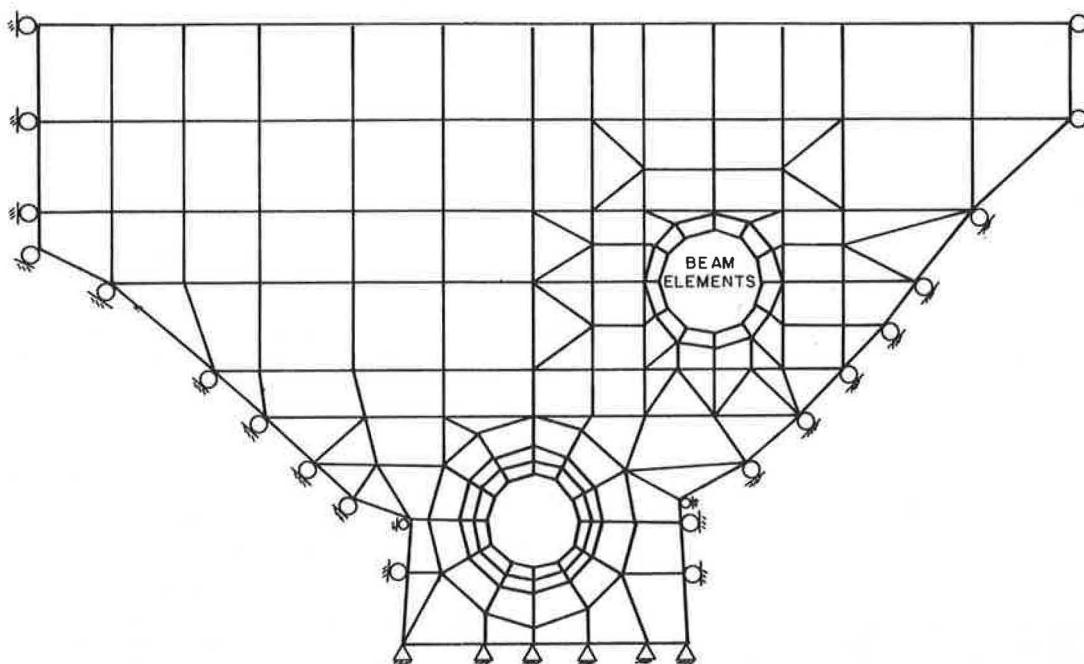
In the second phase of the analysis, the grid shown in Figure 3 was used. Beam elements were used to represent the 213.4-cm (84-in) dummy concrete culvert. Two layers of quadrilateral elements were used to represent the 243.8-cm (96-in) functioning prestressed culvert. The soil was represented by triangular and quadrilateral elements. The grid

Figure 3. Finite element grid.

extended to an elevation of 5.5 m (18 ft) above the top of the dummy culvert. Fill placed above this elevation was represented by a surcharge pressure applied to the top of the mesh.
