Investigation of Moisture Damage to Asphalt Concrete and the Effect on Field Performance—A Case Study

THOMAS W. KENNEDY, ROBERT B. McGENNIS, AND FREDDY L. ROBERTS

An investigation of premature distress and failure of an asphalt concrete overlay placed in 1979 and 1980 is summarized. The primary objective of the study was to determine the probable cause of the distress. The investigation involved an analysis of construction records and laboratory test results performed during and after construction. In addition, specimens and material were obtained from the roadway for use in a laboratory evaluation. The sampling program included the collection of cores, slabs, and stockpile or pit materials. A description and summary of the pavement and distress, construction procedures, and mixture characteristics, along with the findings related to the probable causes of the distress is presented. The basic causes were that (a) all aggregates and the resulting aggregate-asphalt combinations were highly susceptible to moisture damage and (b) the antistripping additive used in the mixture was not effective.

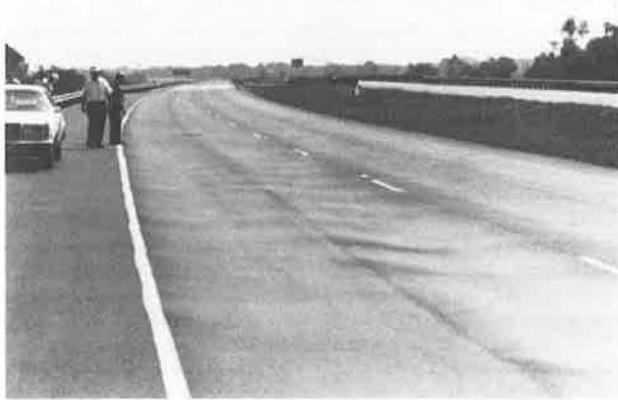
Figure 1. Typical rutting and corrugation distress.

In June 1980, before completion of the contract, distress began to develop on certain sections of the highway (Figures 1-4). Distress was in the form of rutting, shoving, and bleeding. Initially, distress occurred in small areas of the outside westbound lanes; however, distress subsequently developed in

The types of distress observed on the surface were rutting, shoving, and bleeding (Figures 1-4). Four condition surveys were conducted by project personnel from the Center for Transportation Research (CTR) between October 9, 1980, and September 9, 1981. Results are shown graphically in Figure 7. Four pavement distress conditions were designated as

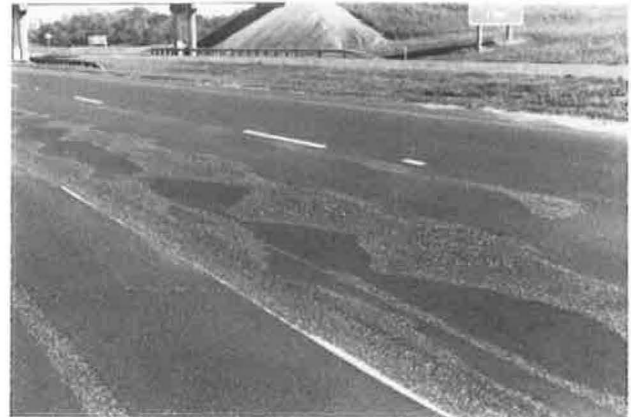
Figure 4. Planning that outlines the longitudinal variation in rutting and shoving distress.

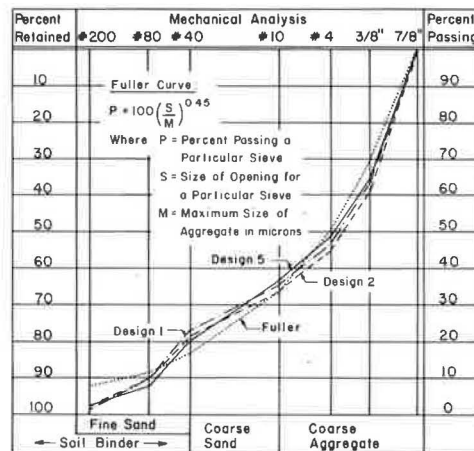
Figure 9. Comparison between binder course design gradations and Fuller gradations.

A comparison between the design gradation and the Fuller gradation, which produces dense, well-graded mixtures, is shown in Figure 9. All three mixture designs have more material retained on the No. 4 sieve than the Fuller gradation. All three mixture

Three different mixtures were used in the binder course of this overlay project, designated as designs 1, 2, and 5 (Table 2 and Figure 9). Mixture

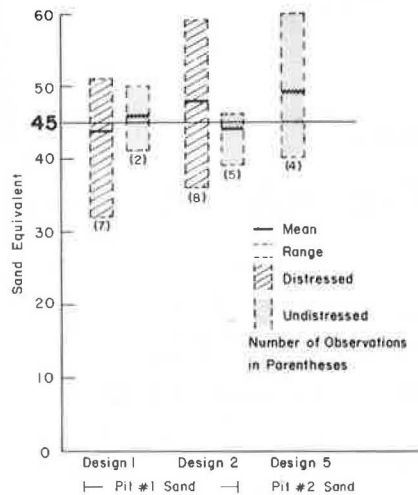
Figure 11. Sand equivalent values.

The average and range of the sand equivalent values, as computed by the residency laboratory during construction, are shown in Figure 11 for each design and category of distress. Designs 1 and 2 contained pit No. 1 sand and design 5 contained pit No. 2 sand. The average sand equivalents for the pit No. 1 and pit No. 2 sands were 45 and 49, respectively. Although these mean values were above the normally acceptable value of 45, 50 percent of the tests on the mixtures containing pit No. 1 sand (designs 1 and 2) were below 45 with values as low as 32 and as high as 59, indicating a high degree of variability in this sand (Figure 11). For the pit No. 2 sand only 25 percent were below 45 and values ranged from 40 to 60.

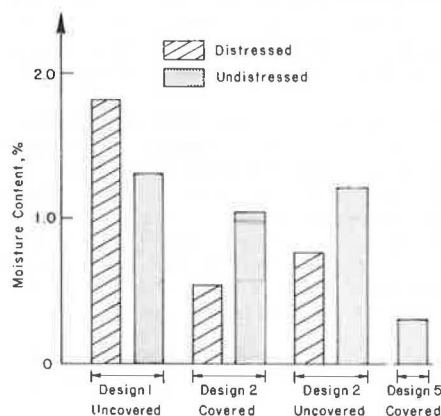
In situ moisture content was determined for slab samples of the binder course mixtures obtained at each coring location. The results summarized in Figure 13 indicate that design 1 and 2 mixtures contained more moisture than the design 5 mixture. This is not unexpected since the design 5 binder course mixture was covered by the wearing course almost immediately after placement and because its density was significantly greater than the densities from the other two designs. In addition, the areas where the design 2 mixture was covered contained less moisture than those areas which were not covered. Thus, it appeared that moisture content was related to distress and needed to be evaluated.

Figure 13. Moisture content of roadway slabs of the binder base course.
