Continuously Reinforced Concrete Overlay of Existing Continuously Reinforced Concrete Pavement

ALFRED B. CRAWLEY AND JOE P. SHEFFIELD

The design and construction of a 6-in. unbonded continuously reinforced concrete (CRC) overlay of a 20-yr-old continuously reinforced concrete pavement (CRCP) are described. This is the first time a CRC overlay has been placed over an existing CRCP. The existing CRCP was an experimental project when built and had several features that were being tried for the first time in Mississippi. One of these features, smooth wire fabric reinforcement, led to the need for the overlay. The CRC overlay project had several items new to Mississippi, including (a) a new, statistically oriented quality assurance specification for rigid pavement; (b) the closing of one side of an Interstate highway to traffic; and (c) plain concrete shoulders paved monolithically with CRC mainline overlay. The distress in the 20-yr-old pavement, design, and construction procedures, contract award provisions, traffic control features, and post-construction evaluation are discussed, and some interim recommendations are presented.

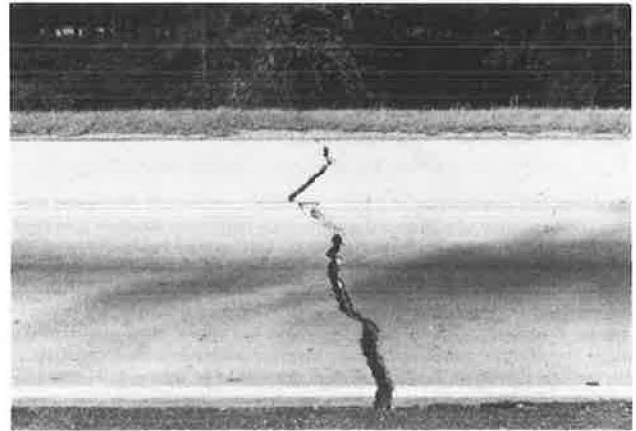
Figure 3. Extra-wide crack in existing CRCP.

and 4 show typical areas of distress. Minor to moderate spalling of the random cracks was evident in some areas, and the spalling was usually much worse in the passing lane than in the right lane. This type of spalling was also noticed in the southbound lanes. The spalling appears to be stabilized and is not considered to be a problem at this time.

In addition to the reasons listed earlier for selecting a rigid instead of a flexible overlay, another factor should be mentioned. Sixty-two distressed areas, as typified by those shown in Figures 3 and 4, needed repair before the overlay was placed. The repair method chosen was to remove the concrete, steel, and asphaltic concrete currently in the distressed area and replace them with hot-plant-mix asphaltic concrete. The resulting joints between the CRCP in place and the new asphalt concrete patch would be active due to longitudinal movement of the CRCP. If a bituminous overlay were placed, these joints would probably propagate through the overlay in a short period of time and would need regular maintenance to keep an effective sealant in place. It was thought that an unbonded rigid overlay would bridge the patched area and preclude the need for regular joint maintenance.

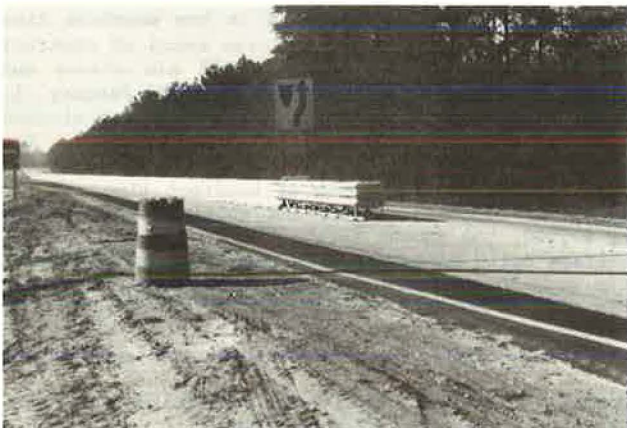
Figure 7. Crossover barrier and attenuator.

bound traffic was diverted to the southbound lanes on December 12. Figures 7-9 show crossover barriers, traffic-control devices, impact attenuators, and lighting. Figure 10 shows a typical view of the southbound lanes, including the double yellow center stripe and snap-back delineators. Portable electric message-board signs were placed at four locations along the southbound lanes to remind motorists of the two-way traffic.

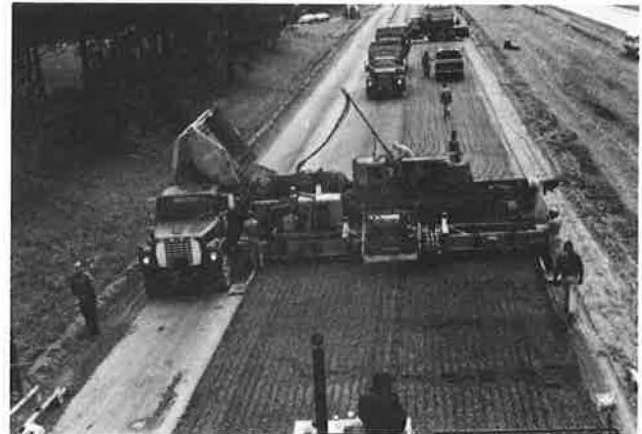
Figure 11. Rear view of concrete spreader.

The contractor used a modified concrete spreader (see Figure 11) to spread concrete about 8 in. thick across the two 12-ft-wide traffic lanes and to place both longitudinal reinforcement and the centerline tie bars. The longitudinal bars were fed through tubes and positioned at the proper height. Plans called for 2.5 in. of concrete cover above the reinforcement. To reduce the possibility of the deformed bars becoming stuck in the feeder tubes, a mechanical system was installed on the spreader to rotate the tubes slowly back and forth. The centerline tie bars were inserted by a reel-like device, and the shoulder tie bars were placed by hand. Steering of the spreader was controlled by an electronic sensor traveling on a string line. Concrete was delivered to the spreader in side dump trucks.

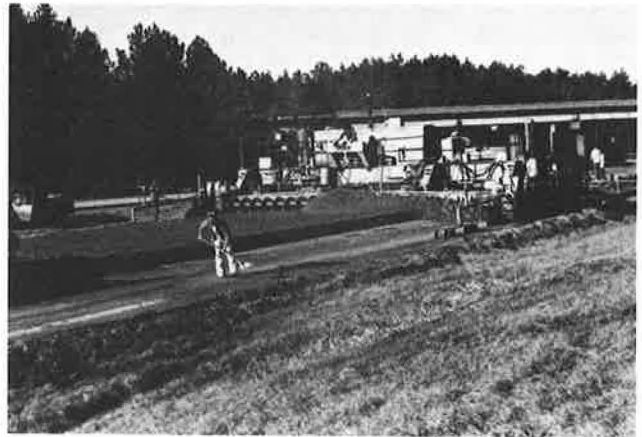
Figure 12. Front view of concrete paver.

The slip-form paver used was modified to pave the entire 38-ft-wide roadway in one pass (see Figure 12). Twin augers on the front of the paver spread the extra-thick concrete placed by the spreader an additional 4 ft on one side and 10 ft on the other side to form the plain concrete shoulders. To increase production, concrete was also dumped directly in front of the paver on the 12-ft outside lane and on the 10-ft shoulder (see Figure 13). The paver inserted plastic crack initiators longitudinally into the 6-in.-thick slab along the centerline and along the joints between the traffic lanes and the shoulders. An oscillating belt and a burlap drag were used immediately behind the paver. Horizontal alignment of the paver was controlled by a string line. Vertical alignment was controlled by a rolling string line in tangent sections and by separate
