## Field Evaluation of Snowplowable Pavement Markers

JERRY G. PIGMAN AND KENNETH R. AGENT

The objective of this study was to evaluate available snowplowable markers under similar traffic and snowplow operations. Five different markers were tested: Stimsonite 96, Dura-Brite, recessed, Kingray, and Prismo roadstud. The evaluation revealed that the Stimsonite 96, Dura-Brite, and recessed markers were acceptable snowplowable markers, because all three had adequate reflectivity during both dry and wet nighttime conditions. This reflectivity was maintained over the test period, and the markers proved to be durable when subjected to snowplow operations. Nevertheless, considering all available input, the recessed marker is recommended as the most functional and cost-effective marker.

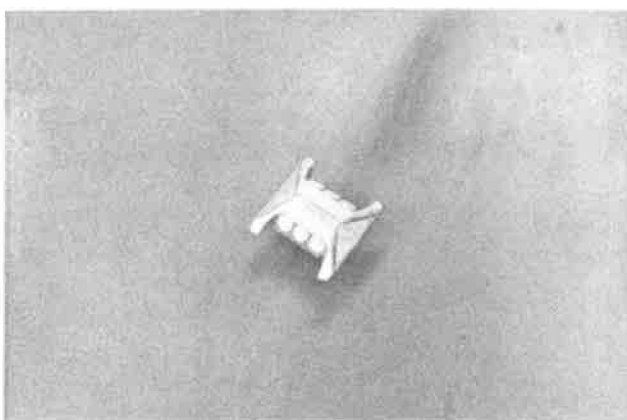
Figure 5. Prismo marker.

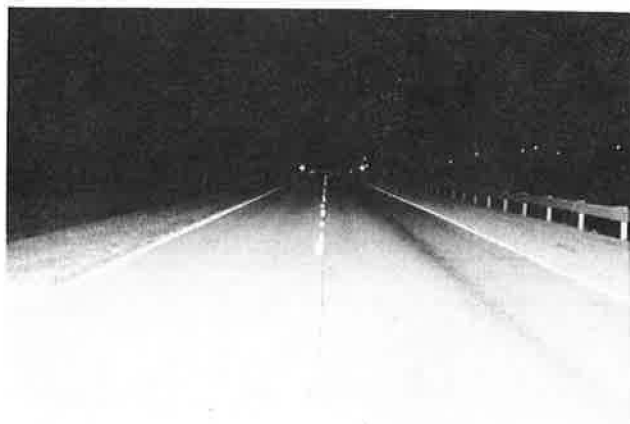
Figure 7. Installation at Fayette County, southbound (order of markers is Kingray, Stimsonite 911, Stimsonite 96, recessed, and Dura-Brite).

A photograph of the southbound Fayette County installation gives a comparison of the Stimsonite

96, recessed, and Dura-Brite markers with a regular Stimsonite 911 marker placed on the pavement surface (Figure 7). The comparison indicated that each of these three snowplowable markers had a reflectivity similar to the regular, raised pavement marker.
