Traffic Delineation, Work-Zone Protection, and Winter Maintenance

TRANSPORTATION RESEARCH BOARD

Transportation Research Record 933

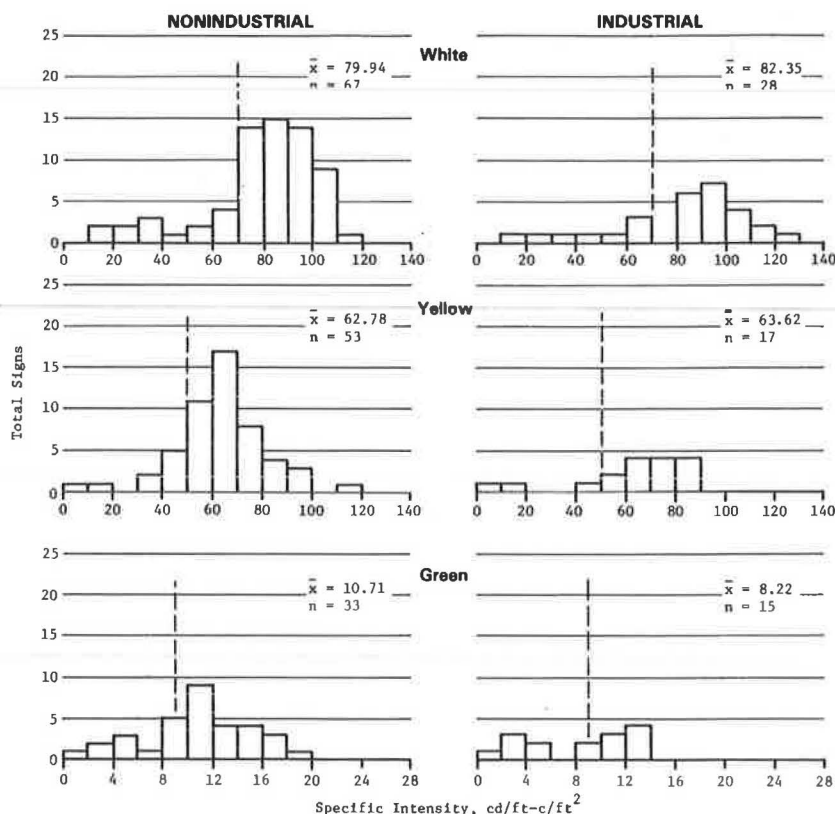
Figure 1. Distribution of brightness measurements before washing.

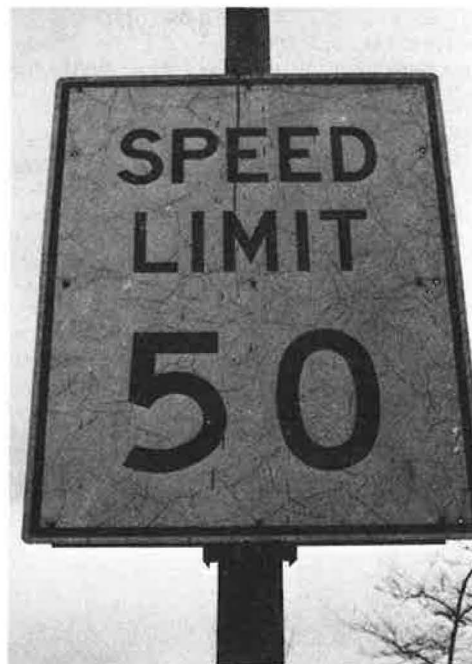
Figure 4. Badly cracked sign, but brightness is still satisfactory, with specific intensity of 94.2 cd/ft^2 .

2. Cracking: Differences in thermal expansion between the sheeting and metal substrate are believed responsible for cracking. Brightness is not directly affected, but daytime appearance may suffer.

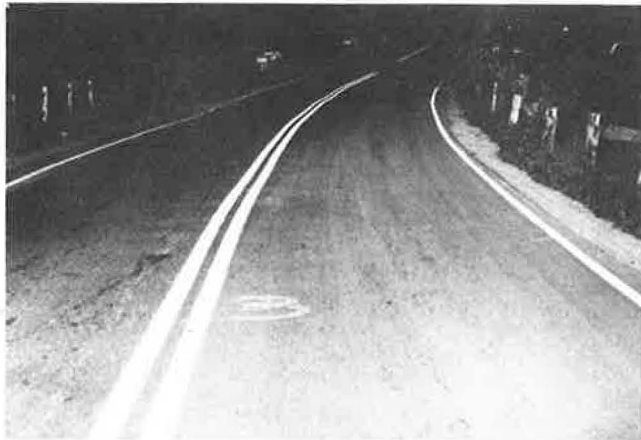
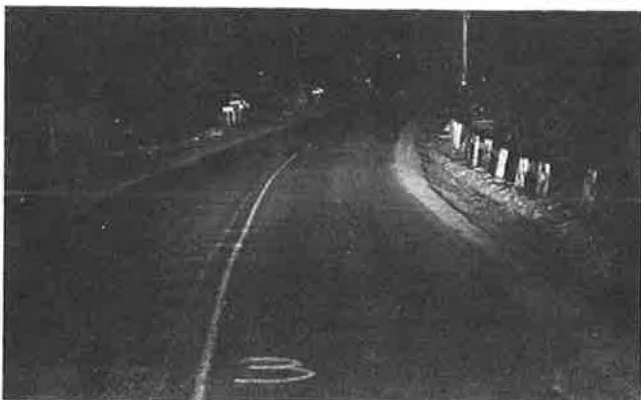
Figure 5. Condition of standard line (left) and commercial premixed paint with 2.5 lb of glass beads per gallon dropped on (right): initially in May (top) and after 9 months in February (bottom).

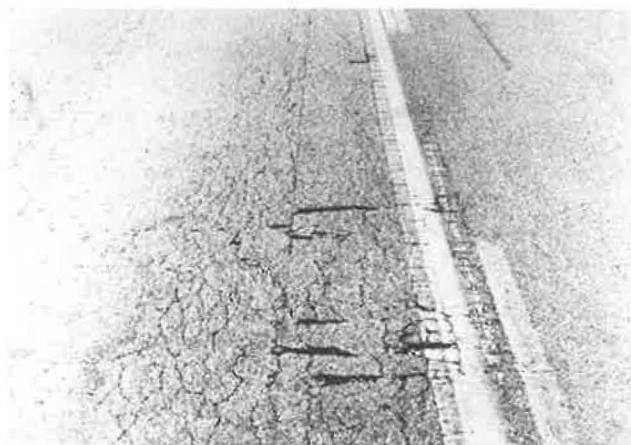
Figure 7. White premixed paint (centerline) after 12 years of service, shown between yellow lines.

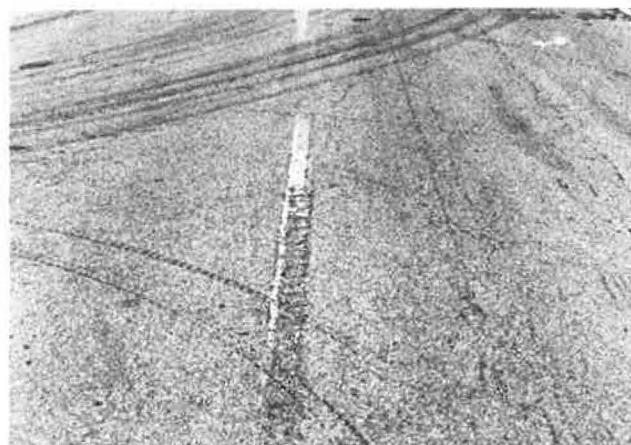
Figure 8. White premixed paint (centerline) still visible after 12 years of service.

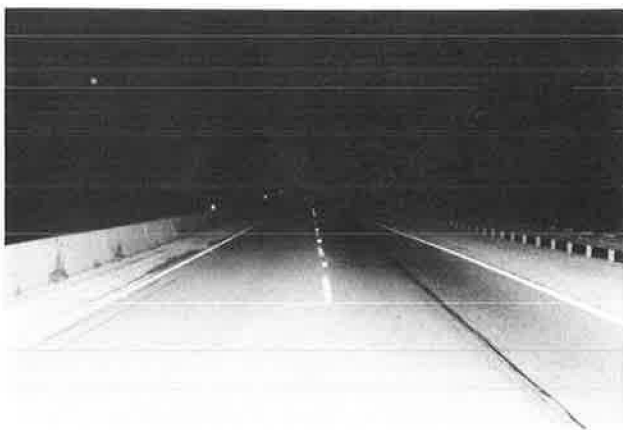
Figure 6. Installation at Garrard County, southbound (order of markers is Kingray, Stimsonite 96, Dura-Brite, recessed, and Prismo).

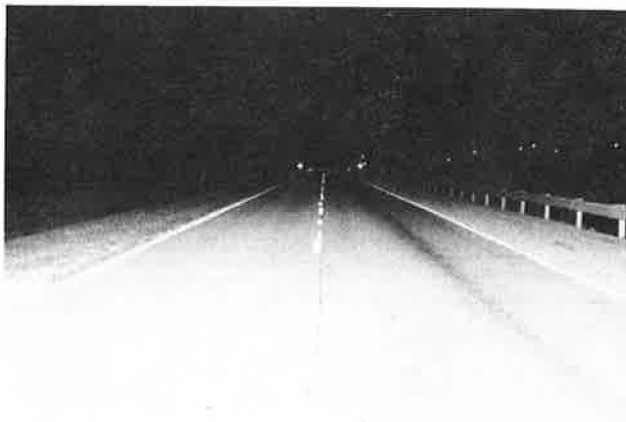
Figure 7. Installation at Fayette County, southbound (order of markers is Kingray, Stimsonite 911, Stimsonite 96, recessed, and Dura-Brite).

96, recessed, and Dura-Brite markers with a regular Stimsonite 911 marker placed on the pavement surface (Figure 7). The comparison indicated that each of these three snowplowable markers had a reflectivity similar to the regular, raised pavement marker.

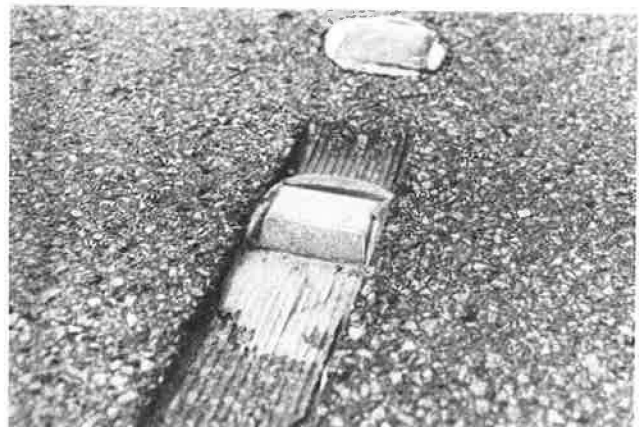
Figure 8. Recessed marker after approximately 1 year of service (before snowplow operations).
