## Crash Cushion for Narrow Objects

DEAN L. SICKING AND HAYES E. ROSS, JR.

A crash cushion designed for narrow objects such as the end of the concrete safety shaped barrier is described. Features of the cushion are as follows: (a) it meets current safety performance standards, (b) it is constructed of readily available materials (steel barrels, thrie beams, steel channels, and steel cables), and (c) it is relatively inexpensive to install and maintain. Also presented in the paper are results of four full-scale vehicle crash tests conducted in accordance with recommended procedures in Transportation Research Circular 191. The crash cushion met the performance standards of the circular and NCHRP Report 230.

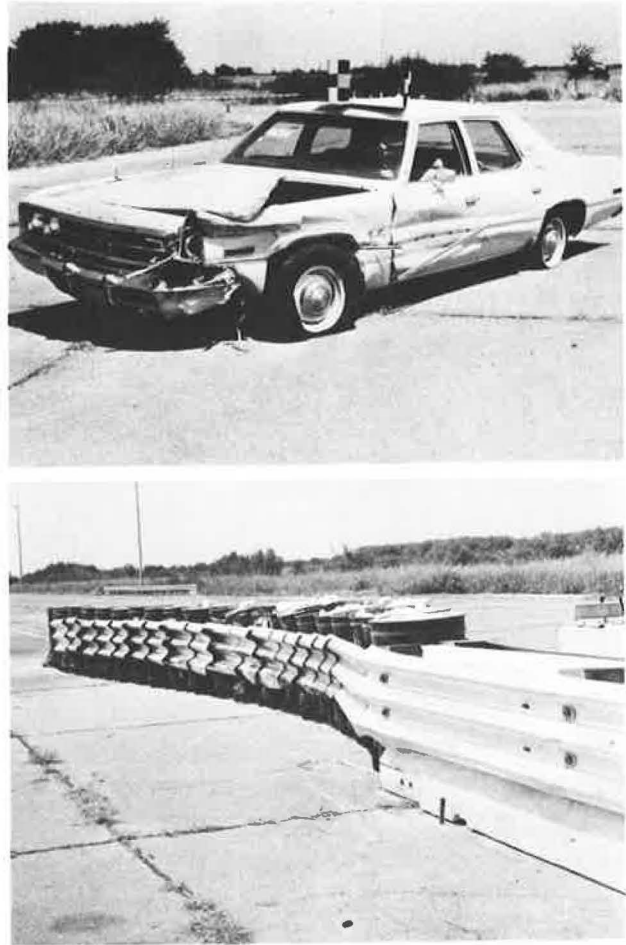
Figure 4. Test vehicle and installation after test 1.

Figure 4 shows the test vehicle and installation after test 1. As shown in this figure, the damage to the vehicle was not severe for a test of this nature. Restoration of the crash cushion required replacement of two 25-ft (7.6-m) sections of three

beam, five drums, and two 37.5-in. (95.3-cm) thrie-beam fish scales. This test was considered successful based on the safety performance and the relatively light damage incurred by the crash cushion.

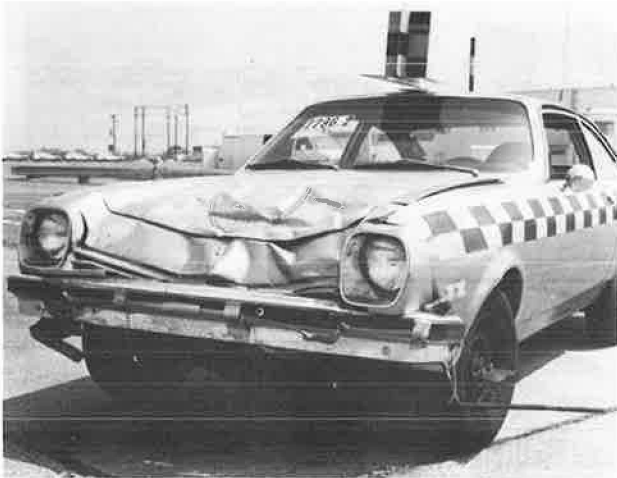
Figure 5. Test vehicle after test 2.

As shown in Figure 5 damage to the test vehicle was extremely light for a test of this nature. Figure 6 shows the crash cushion after test 2. The crash cushion was restored by replacement of 18 steel drums. All other materials were salvageable. The test was considered successful.

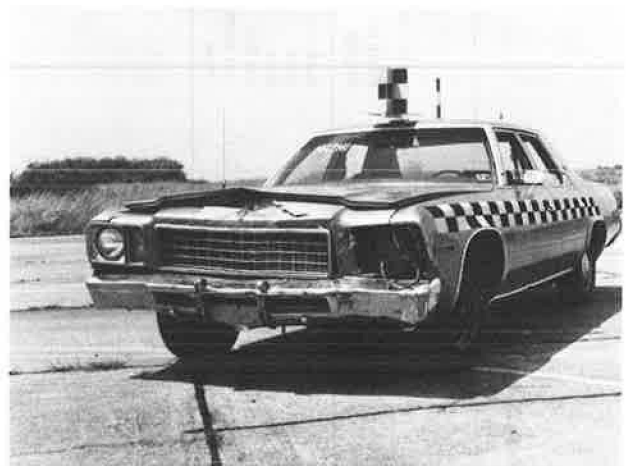
Figure 7. Test vehicle after test 3.

The test vehicle, shown in Figure 7, experienced light damage for a test of this nature. Figure 8 shows the crash cushion after test 3. The cushion was heavily damaged, as would be expected from this test; however, the only unsalvageable materials were 19 steel drums. This test was successful, with the exception of the thrie-beam plate that became detached from drum no. 3.

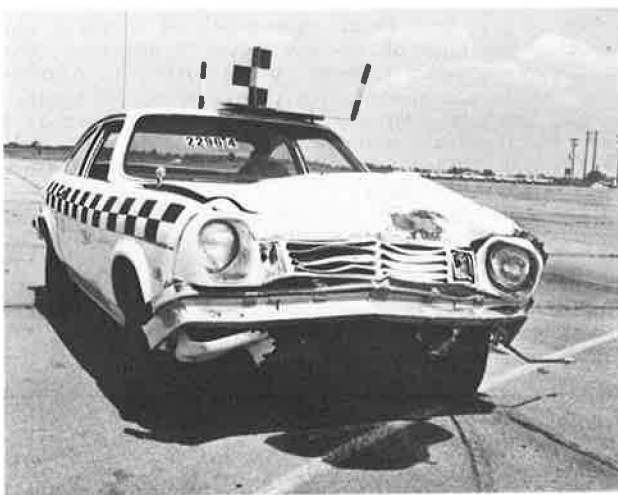
Figure 9. Test vehicle after test 4.

Damage to the test vehicle was moderate, as shown in Figure 9. Figure 10 shows the crash cushion after test 4. Restoration of the crash cushion involved replacement of 14 steel drums. The angle impact test on the nose of a crash cushion is a

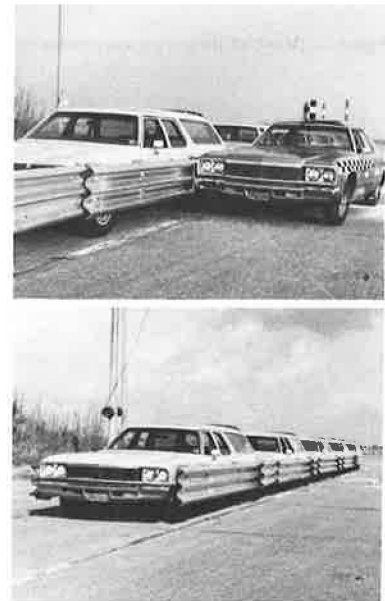
Figure 1. Used car barrier.

Researchers examined many portable construction zone barrier concepts before concluding that the used car barrier was the most promising design considered. This barrier consists of a line of cars connected together with tow bars. The barrier is portable and can be driven to the work site. Special equipment is not required for its setup, and the barrier is relatively inexpensive when compared with other barriers considered.

The used car barrier is shown in Figure 1 and described in Figures 2 and 3. The vehicles used in
